## ***PROPERTY CONDITION REPORT***

**McLaurin Apartments**  
1234 Apartment Drive, Hillsboro, Virginia

**Robert E McCoy Jr., PE**  
Armco Inspections, LLC  
Date of Site Review: July 4, 2008  
Date of Report: July 10, 2008  
**ARMCO Project Number 09-015.1**

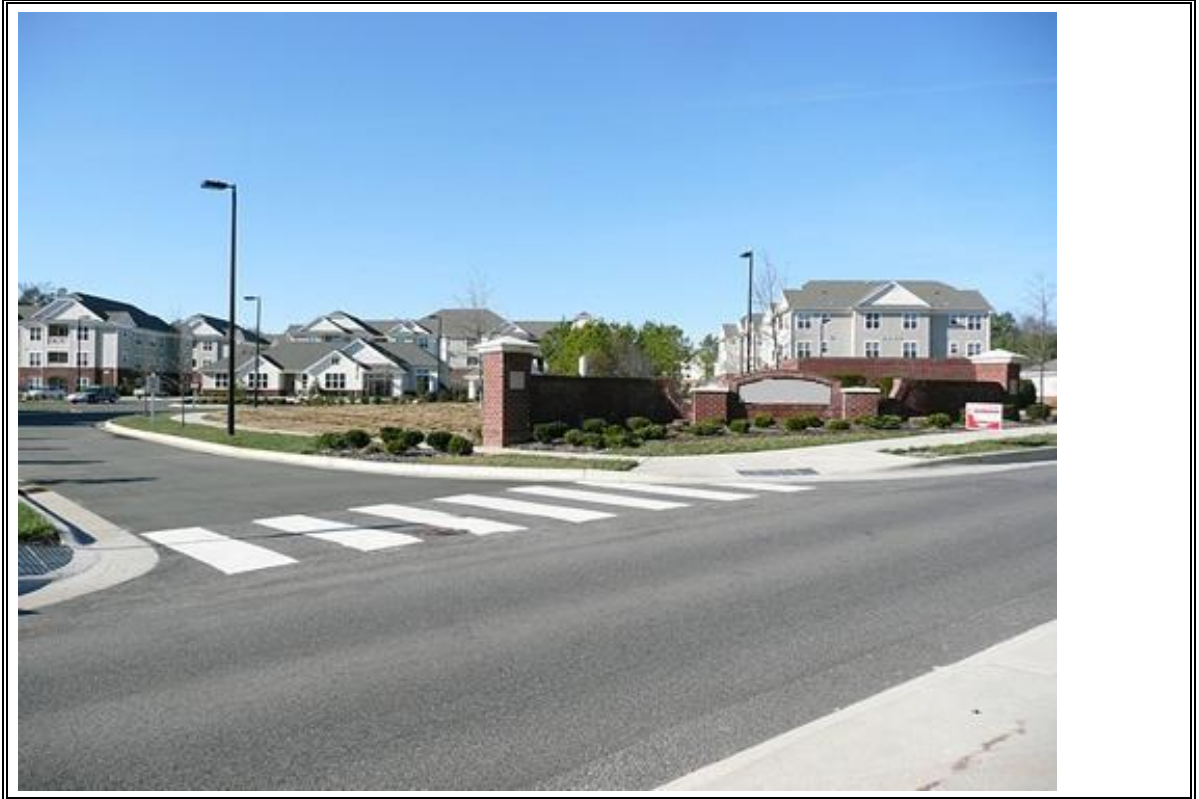
Photograph Number 1: Subject Property entrance from Apartment Drive

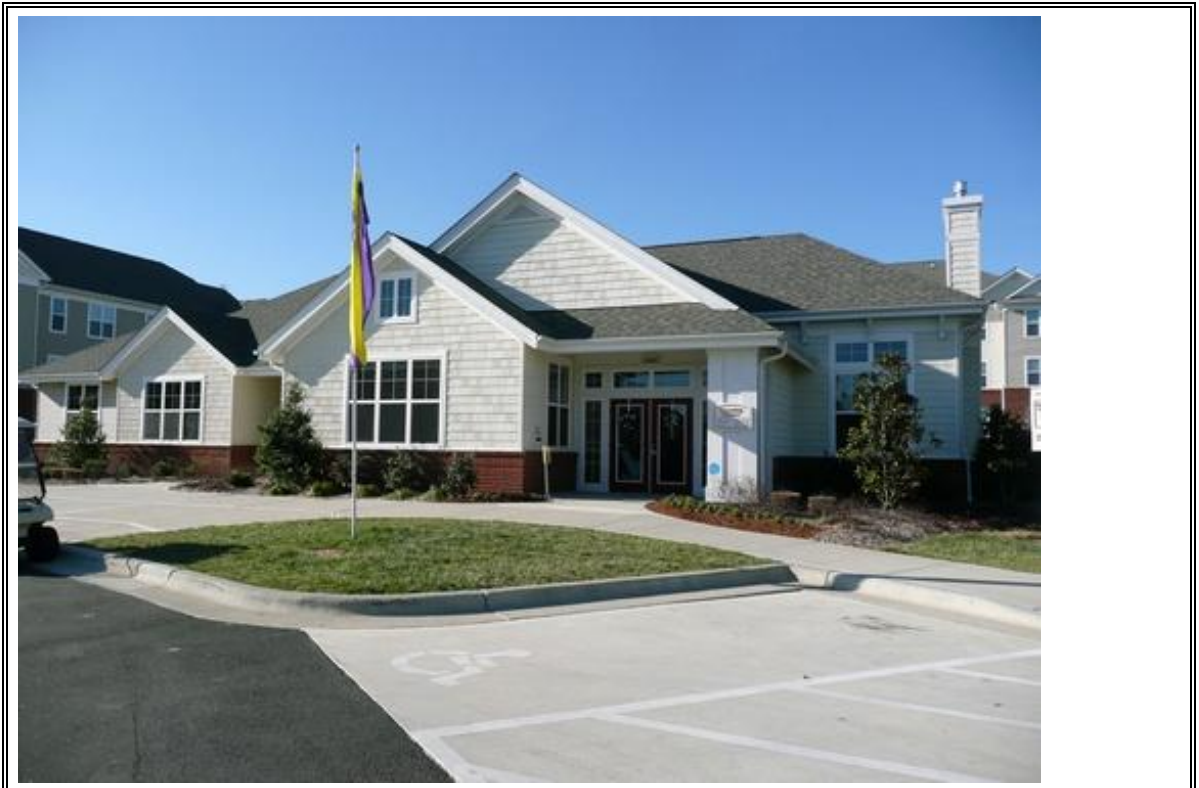
Photograph Number 2: View of Leasing Office – Clubhouse with ADA designated parking

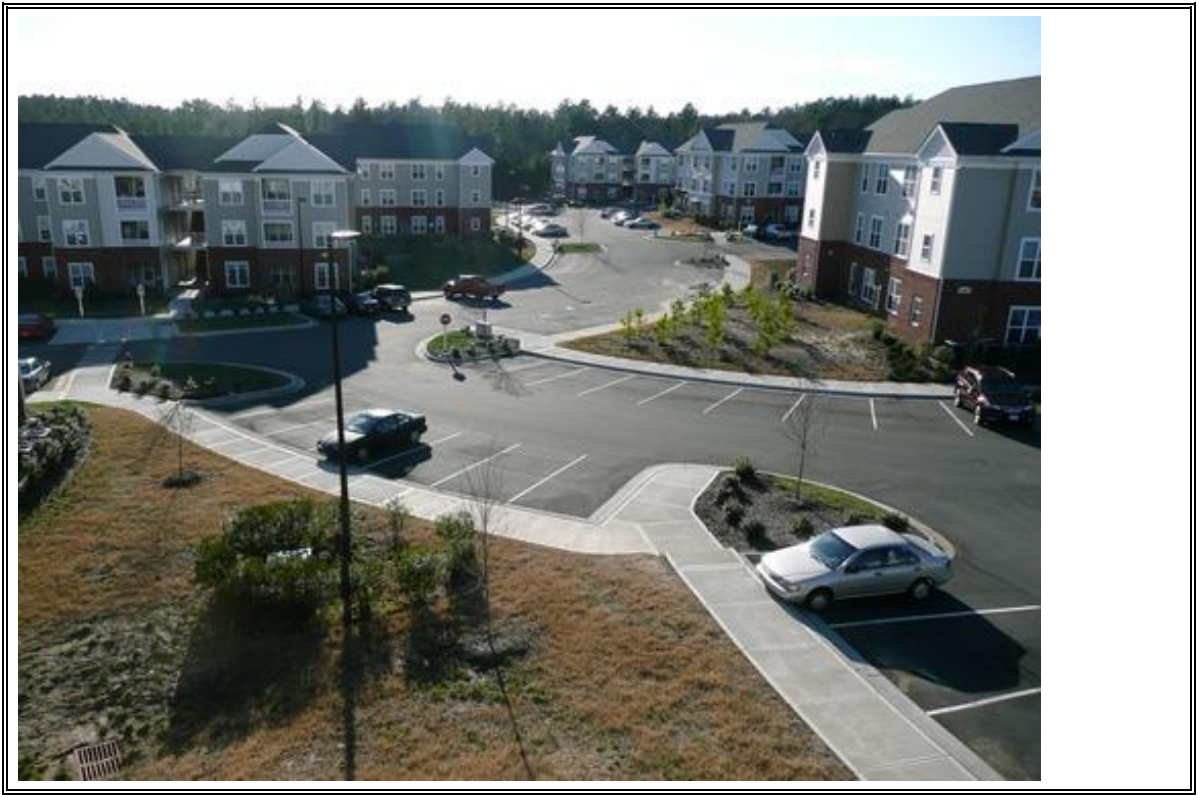
Photograph Number 3: Typical Subject Property interior view – note asphalt and flatwork in good condition

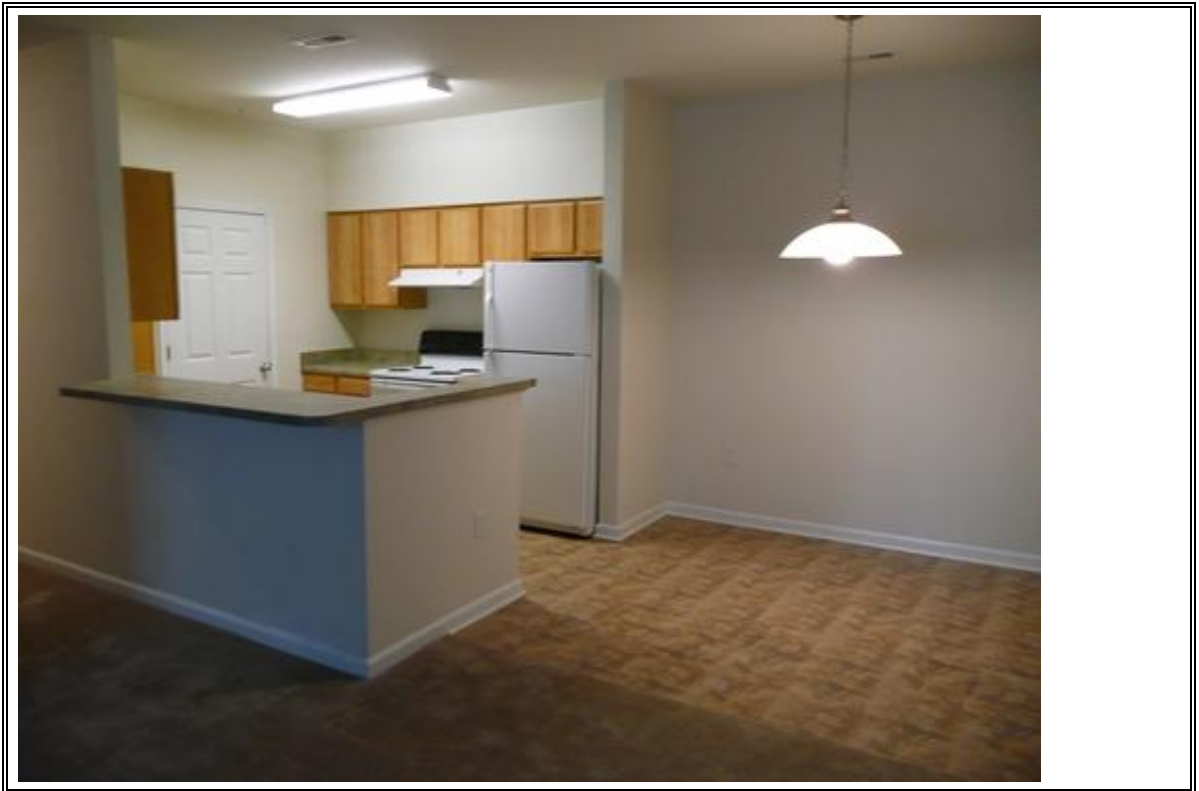
Photograph Number 6: View of one bedroom apartment kitchen and dinette area
