## PROPERTY CONDITION REPORT

### Anytown Shopping Center

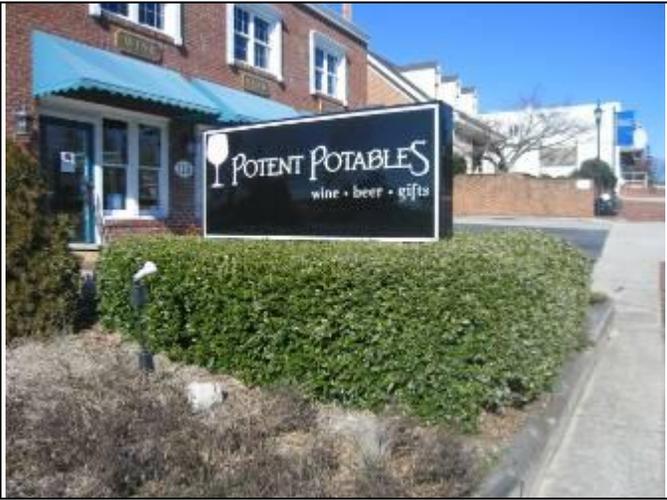
1. Building 115 unit A Signage

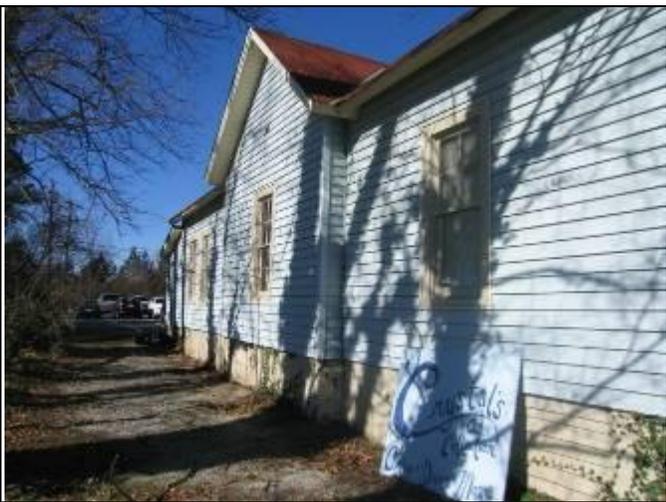
9. Building 113 left side or south elevation – pier and curtain wall foundations

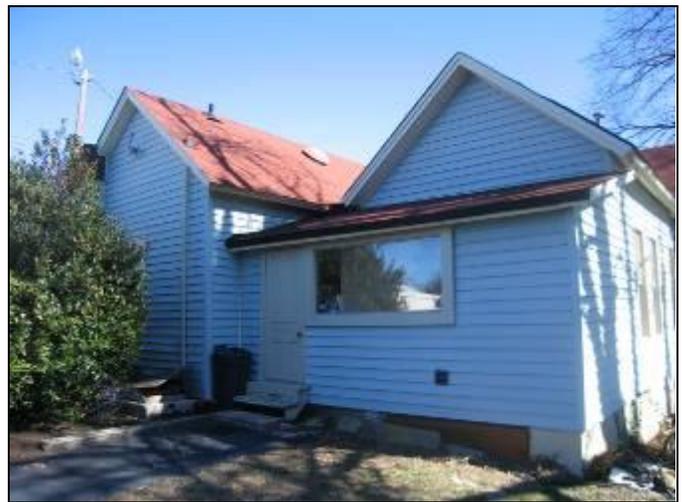
10. Building 113 rear/west elevation and entry from parking area

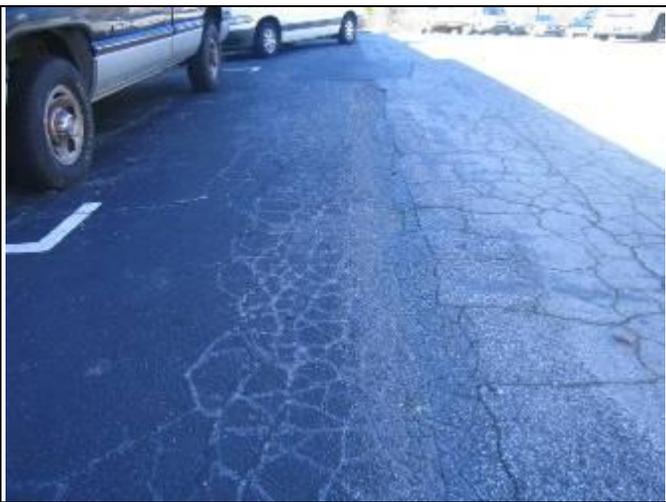
21. Deteriorated asphalt at Building 115 north parking lane

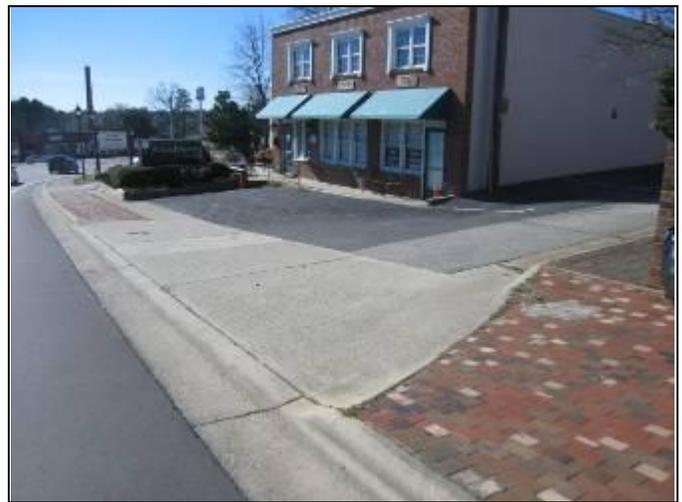
22. Concrete apron at Building 115 access from Main Street

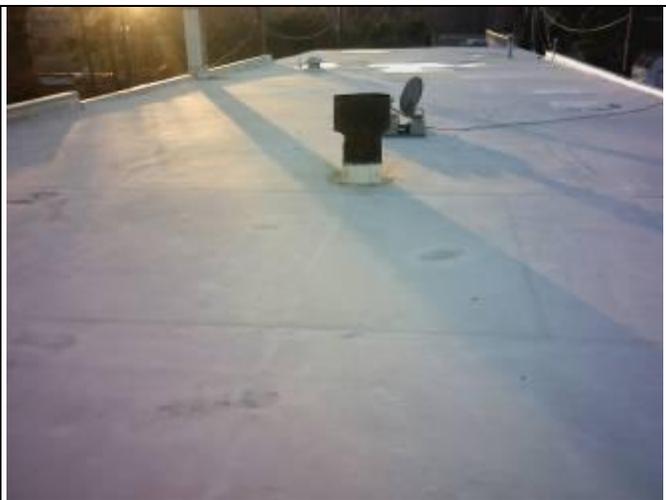
23. TPO roof membrane view west – area of possible moisture in foreground

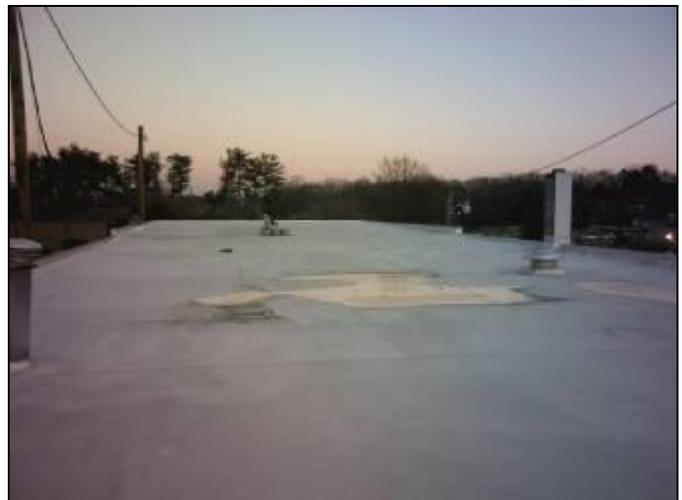
24. TPO roof membrane view east – area of nail pops is center left in photo

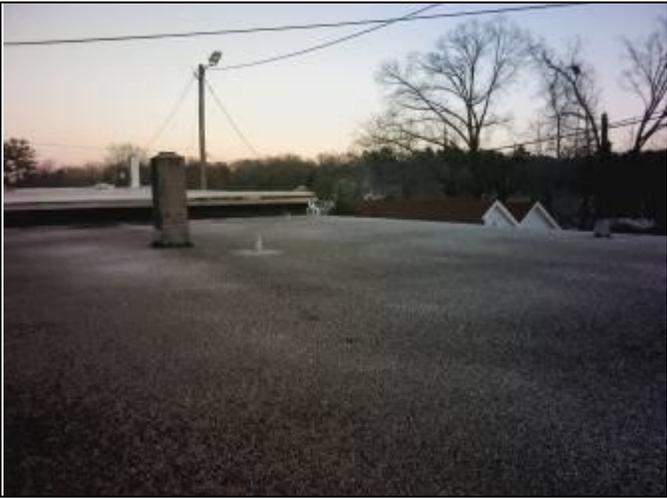
25. Gravel covered asphalt membrane view southeast – damaged gutter at upper left along TPO/BUR

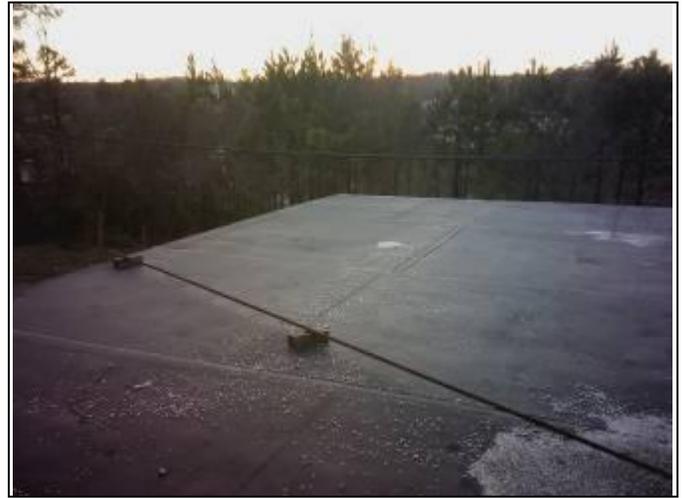
26. EPDM membrane over unit D

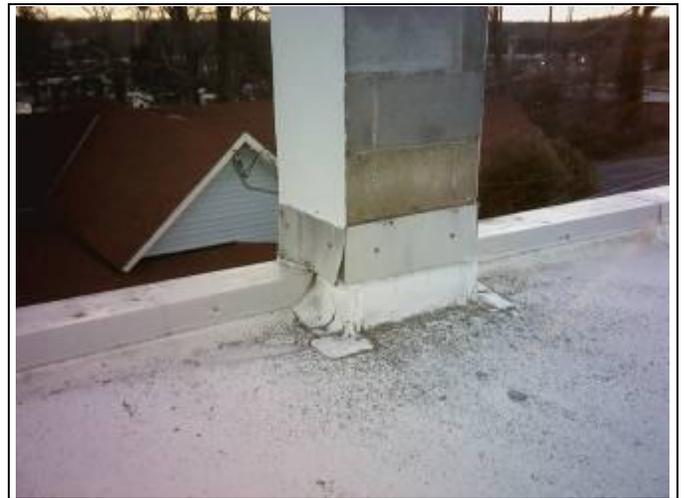
28. Damaged flashing at TPO membrane/block chimney

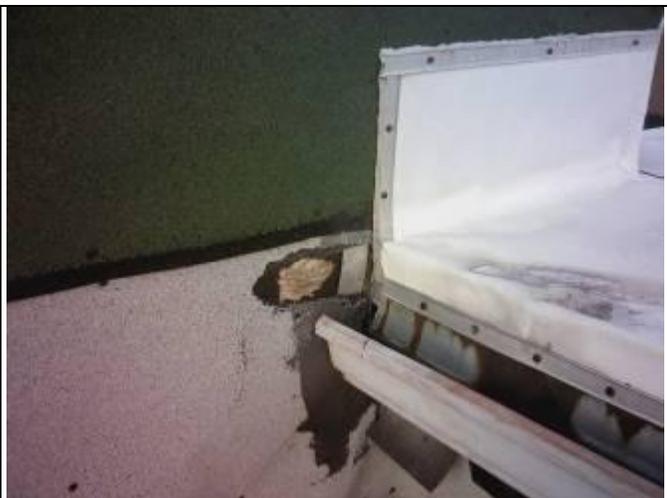
29. Damaged parapet wall covering and flashing at Building 115 north elevation

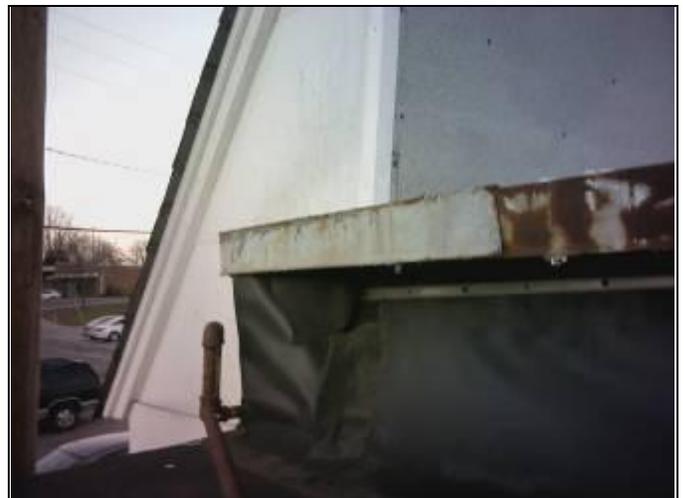
30. Improperly installed or damaged membrane flashing at Building 115 north side at transition from BUR

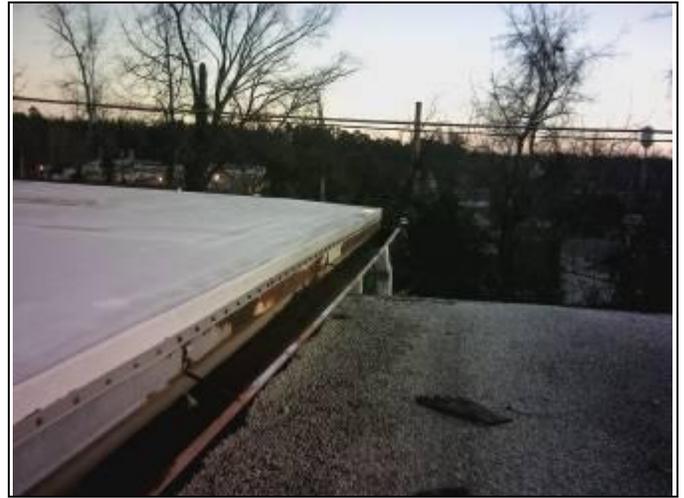
32. Damaged gutter at Building 115 TPO – BUR transition – area of active leakage directly below

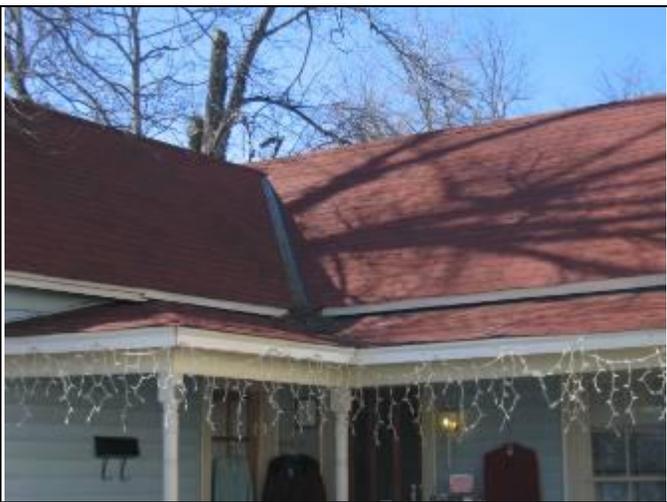
33. Building 113 relatively new asphalt shingle roof with metal valley flashing and no gutters installed

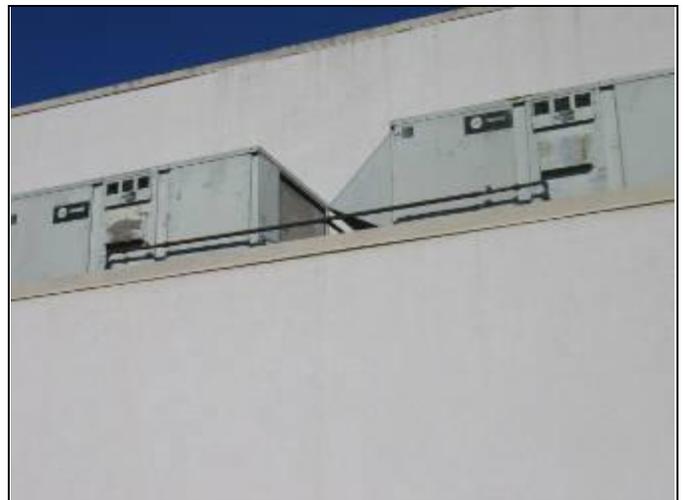
36. Aged Trane integrated gas furnace/air-conditioner units. Left side unit is active – right decommissioned

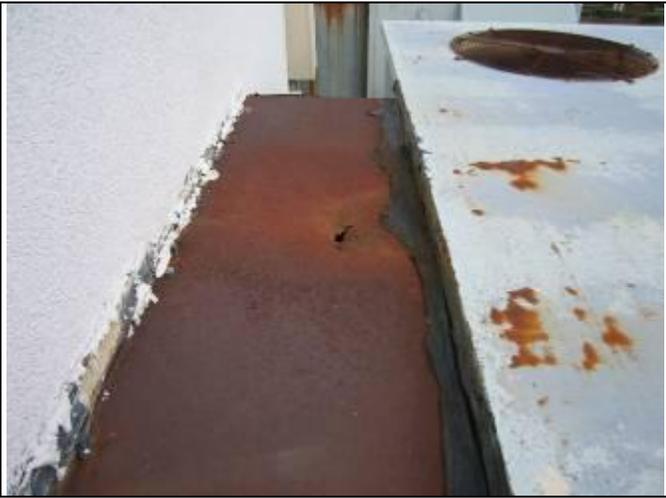
37. Damaged shroud at active Trane "gas-pack" HVAC unit at Building 115

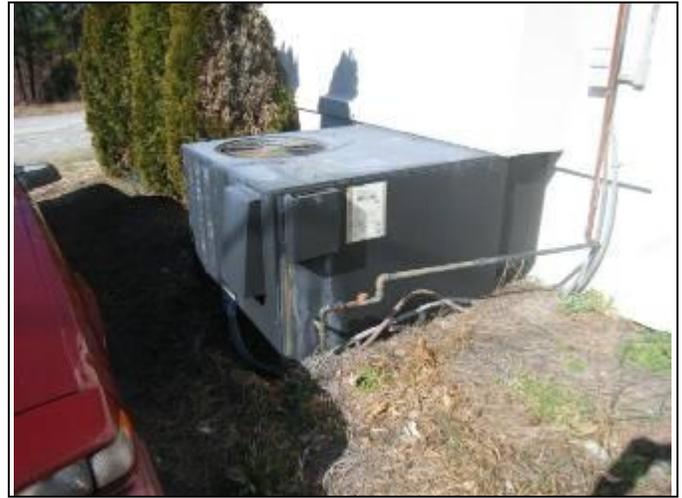
38. Gas pack HVAC unit for tenant space D – leaking natural gas at area of shut off valve

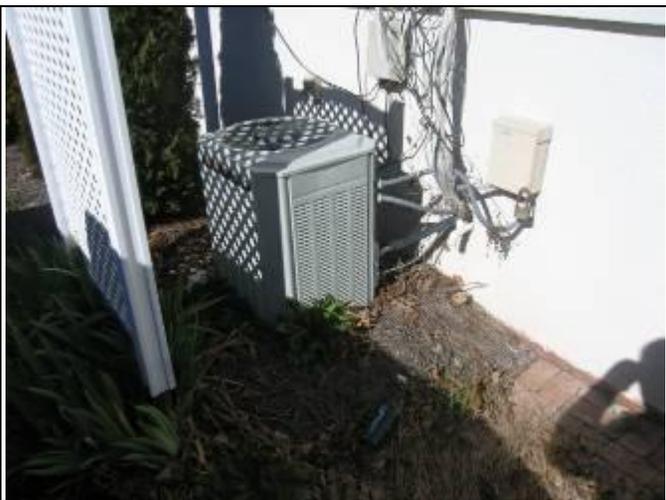
39. Typical Trane heat pump unit with Air Handler in crawlspace – date of manufacture 1989 (1 of 4 units)

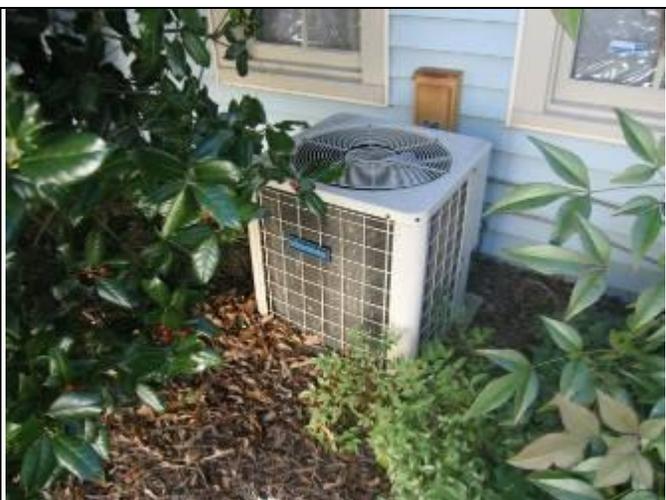
41. Split system air conditioner condensing unit at Building 113 – mfg 1995 by Comfortmaker

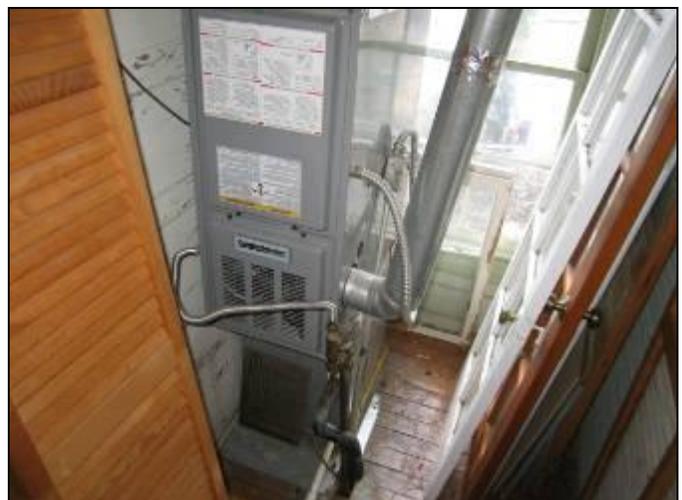
42. Natural gas fired furnace with A/C evaporator and Air Handler by Comfortmaker in Building 113 util closet

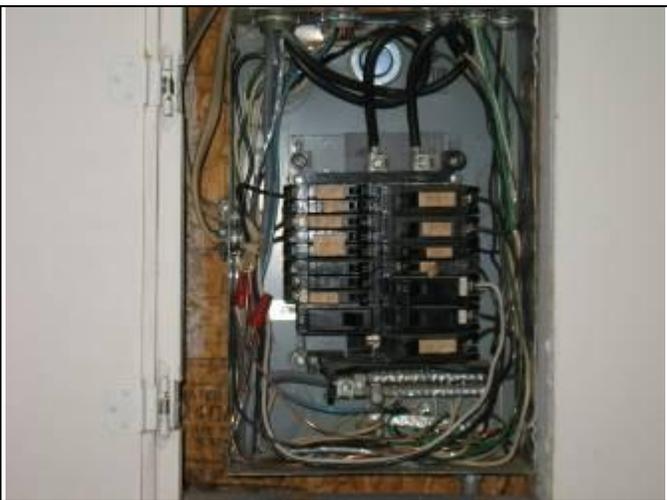
45. Older service panel at unit C Building 115 – no aluminum distribution wiring noted in any panel

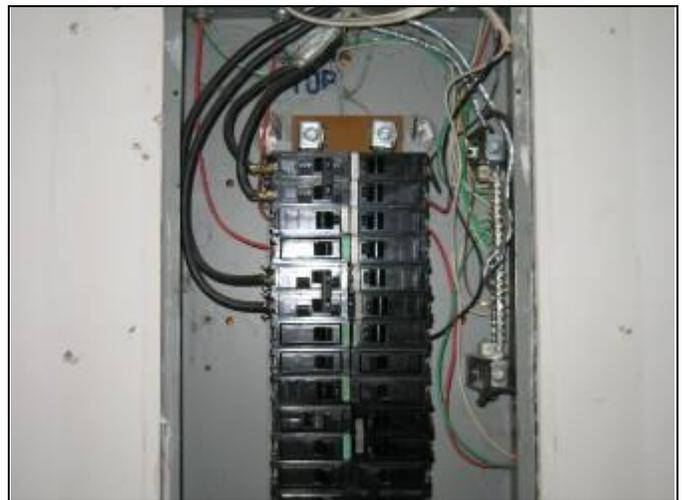
46. Newer breaker panel in unit B - Building 115 has loose breaker/buss assembly

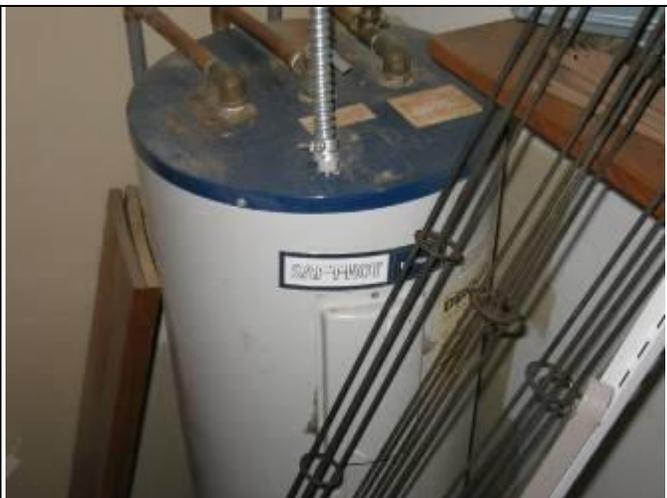
47. Electrically fired hot water heater in unit B – Building 115

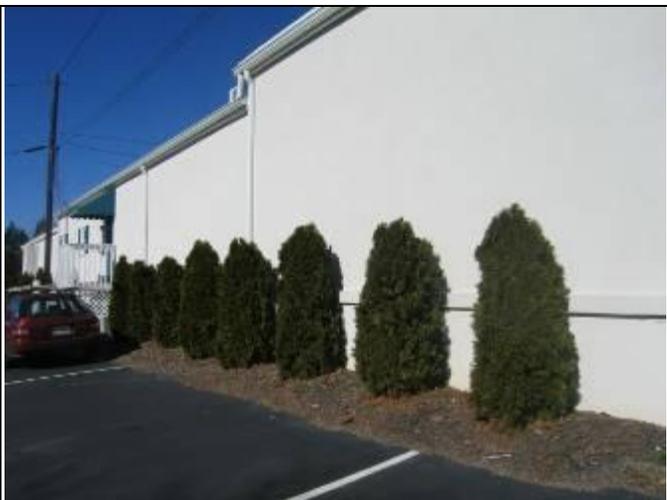
53. Structural view 1: significant cracking in exterior walls not observed at Building 115

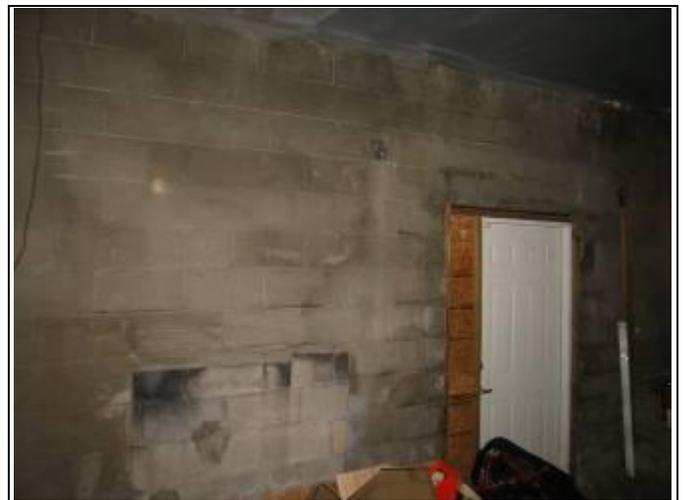
54. Structural view 2: Where observed directly, no cracking noted in exterior concrete block walls

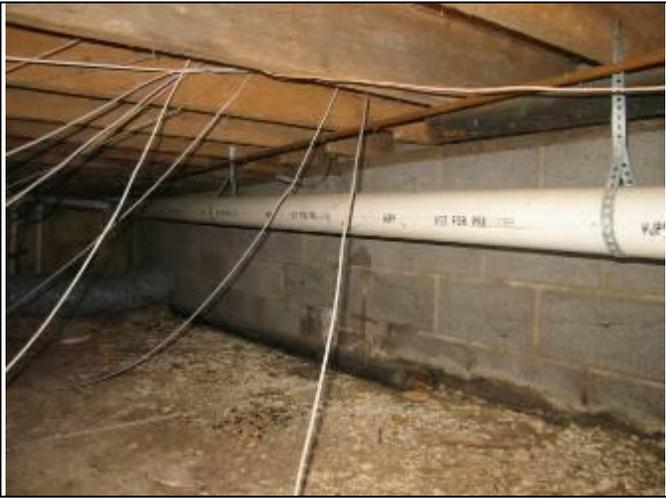
55. Structural view 3: no cracking observed at Building 115 crawlspace

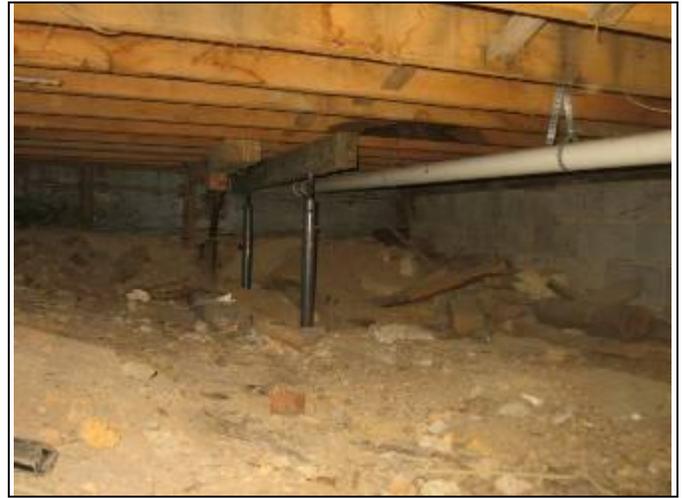
56. Structural view 4: Screw-jacks with drop-girders provide additional floor bracing crawlspace bldg 115

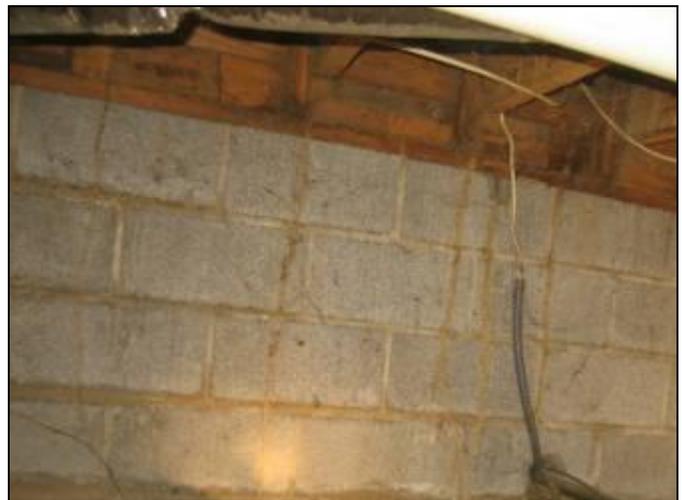
58. Structural view 6: Prior termite activity (tubes) in the 115 Building crawlspace – no cracking noted in foundation walls

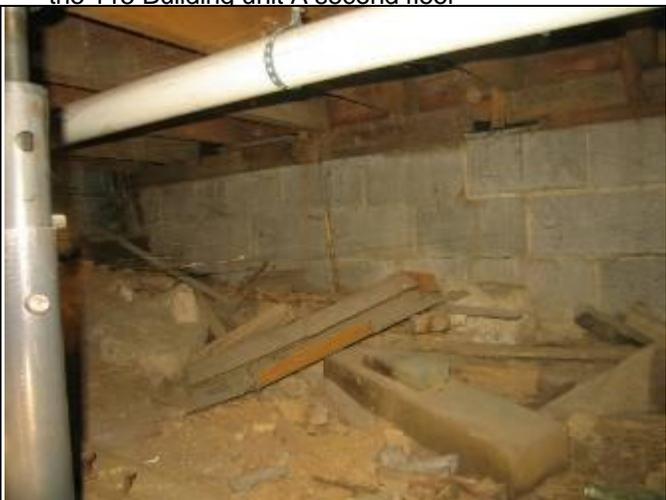
59. Structural view 7: Termite activity continuing down south crawlspace wall in Building 115 – Debris

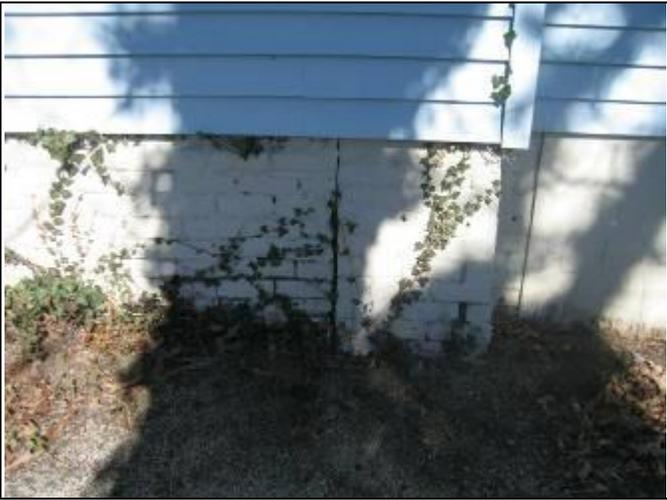
61. Structural view 8: Typical Pier and Curtain Wall construction at Building 113 foundations

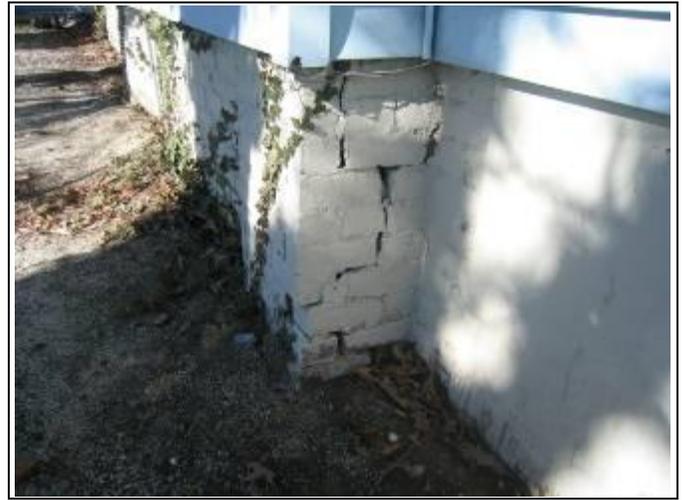
62. Structural view 9: Degradation of 111 year old brick pier at building 113 to be expected

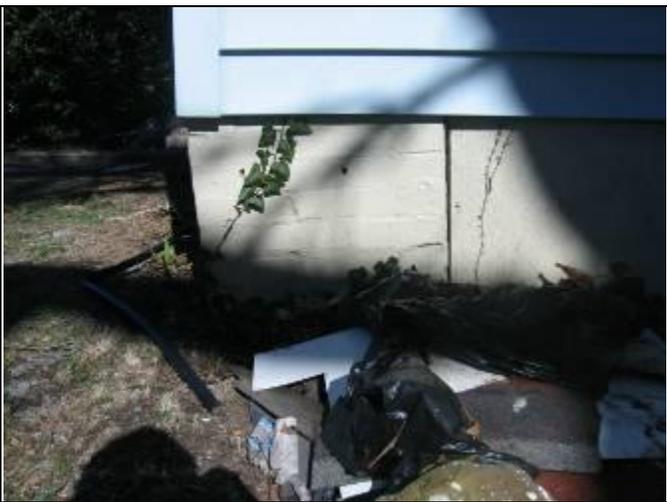
63. Structural view 10: Left rear corner pier rotated outward likely due to moist footings

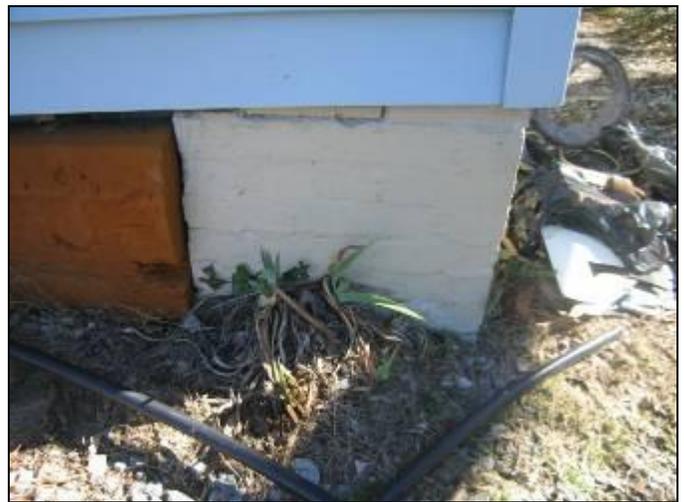
64. Structural view 11: Left rear corner pier rotated – see prior caption

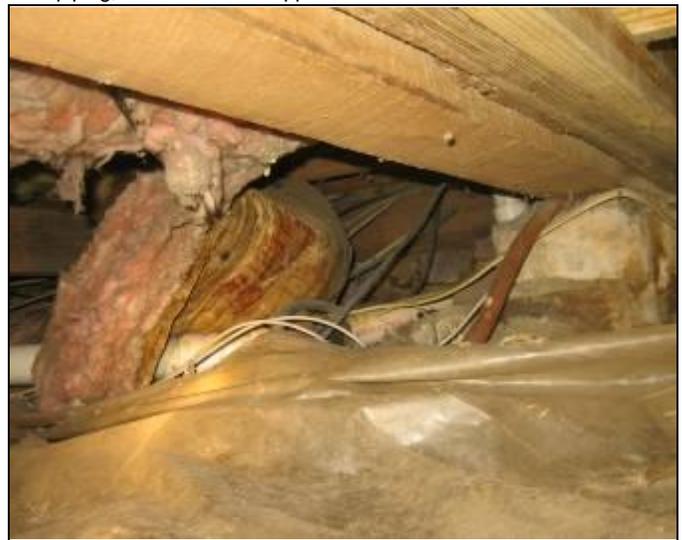
70. Structural view 17: Building 113: Distribution wiring improperly installed, displaced or improperly installed insulation, more debris, etc - safety concern

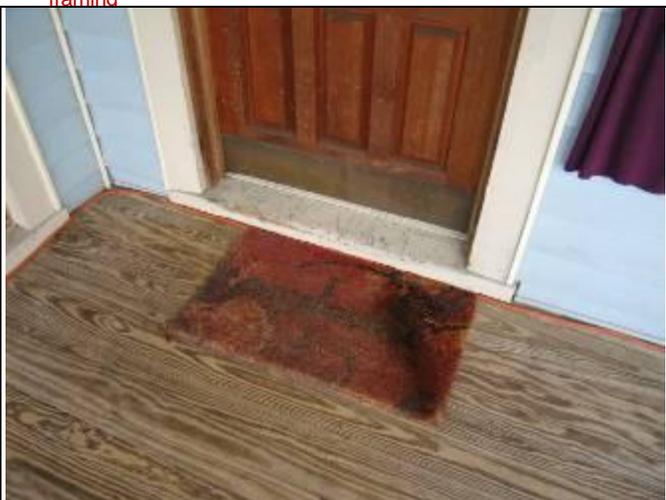
71. ADA accessibility view 1: Front entry threshold at Building 113 in excess of 3/4 inch and generally not negotiable by unassisted wheelchair - additional short ramp needed

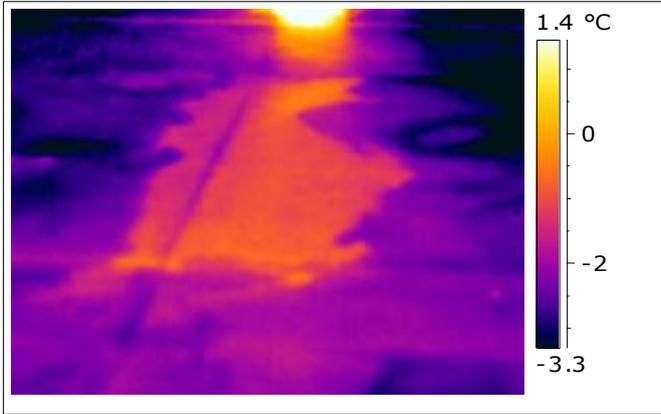
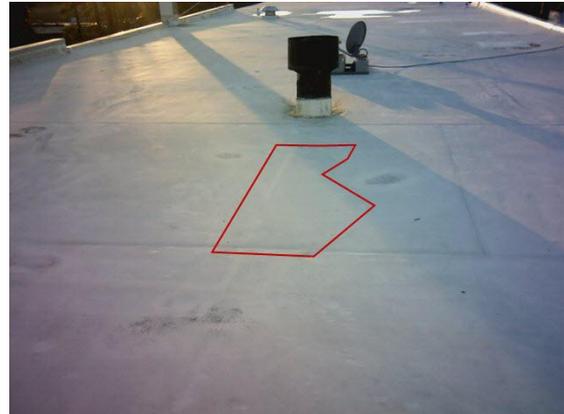
**Comment:** Image east of active roof vent and viewed west – reportedly TPO membrane is overlay with recovery board over existing BUR – TPO reported to be approximately 12 years of age – no indication of moisture/leakage in storage area immediately below on floor or on poly sheet fastened to deck support joists.

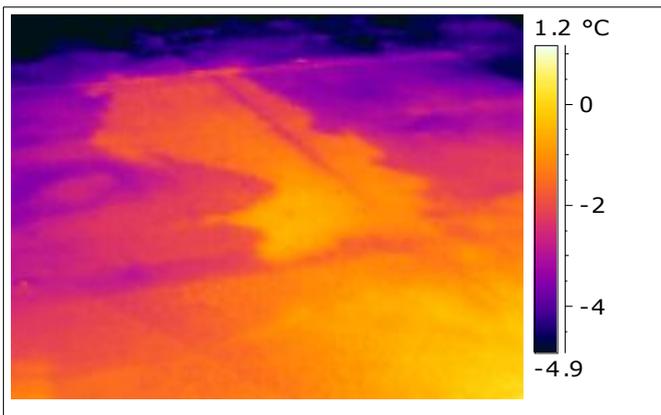
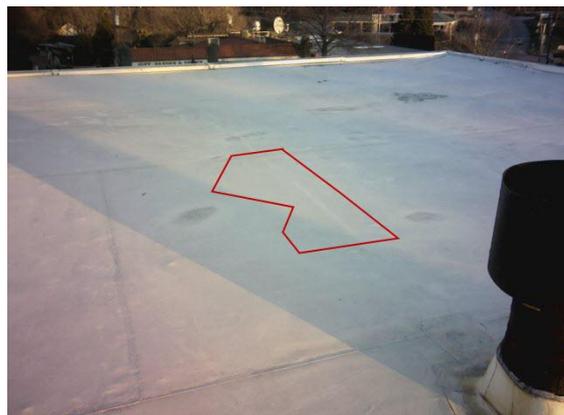
**Comment:** Image east of active roof vent and viewed east-southeast – seams and stains on roof shown in visible light image(s) correspond to same points/landmarks in the IR image and indicate location of warmest and likely highest moisture location

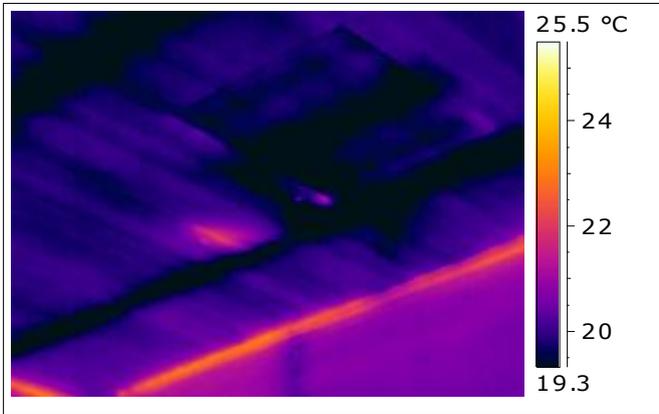
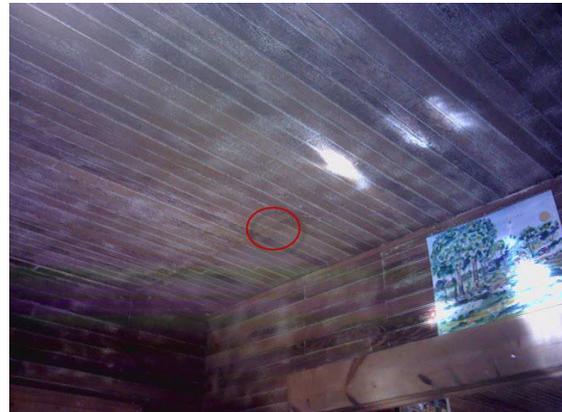
**Comment:** 113 Building front left display room adjacent to square cut in ceiling (access?) boards. Warm spot is due possibly to electrical hot spot at splice or hole in insulation allowing solar heat to back of ceiling boards

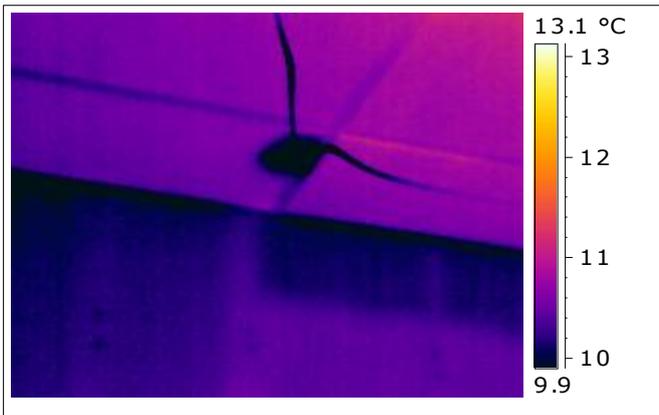
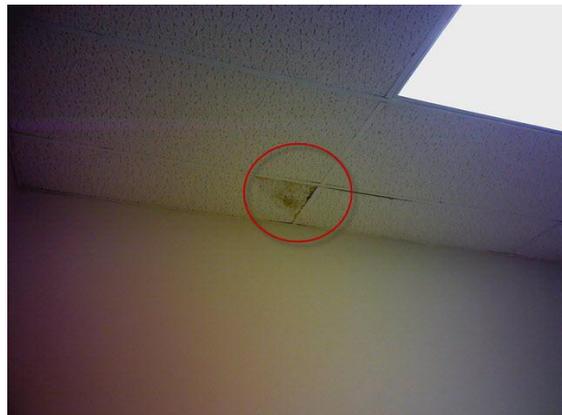
**Comment:** Building 115 tenant Unit E – east side of front room at ceiling – obvious stain indicates point of current active roof leakage – cool spot on IR image shows point of cooling due to water evaporation. This point is directly below the damaged gutter mentioned elsewhere in the report --- the streaks in the IR image are due to accidental pointing of the exposed imager lens to in the direction of the sun
