## Inspection Report

# Bilco Renovations LLC

**Property Address:**  
2000 Anywhere Road  
Podunk ND 22345

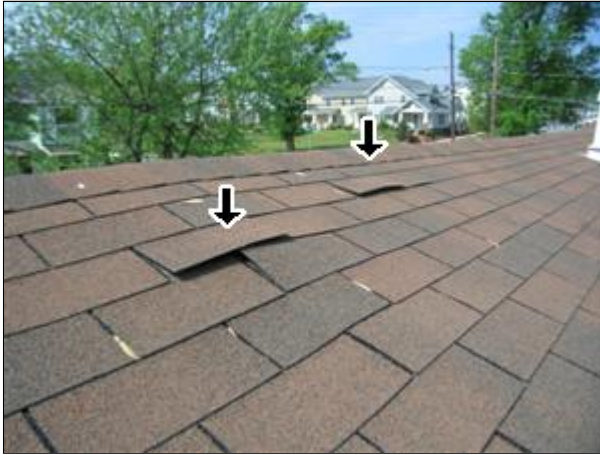
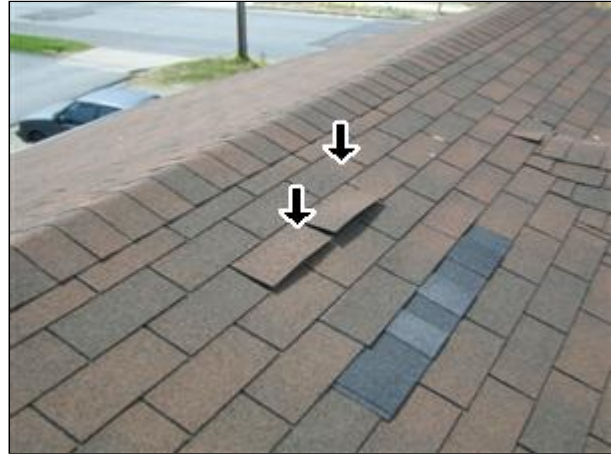
There are at least two areas where shingles are "popped up" due to nail heads or improper installation - Otherwise the roof is in good condition. Photos 3-5 are typical roof views.

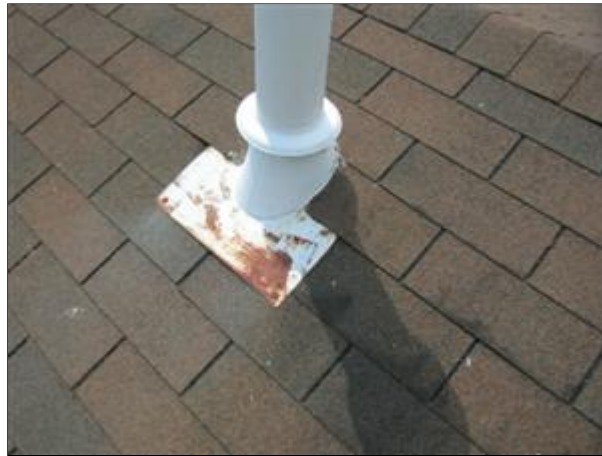
1.2 Picture 1

Representative waste vent pipe flashing in serviceable condition even if corroded.

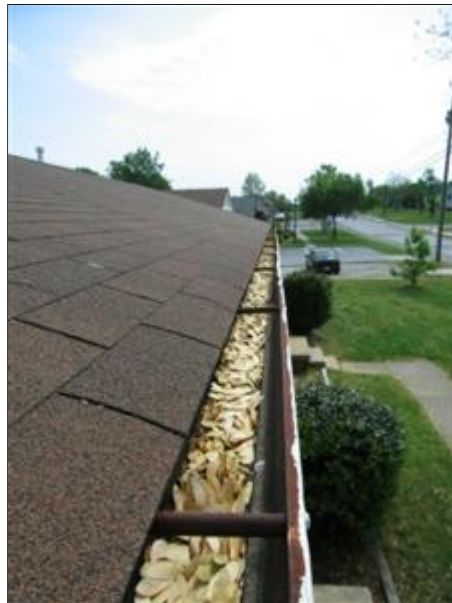
1.3 Picture 1

90% of gutters were clear. The gutter at the front requires cleaning.

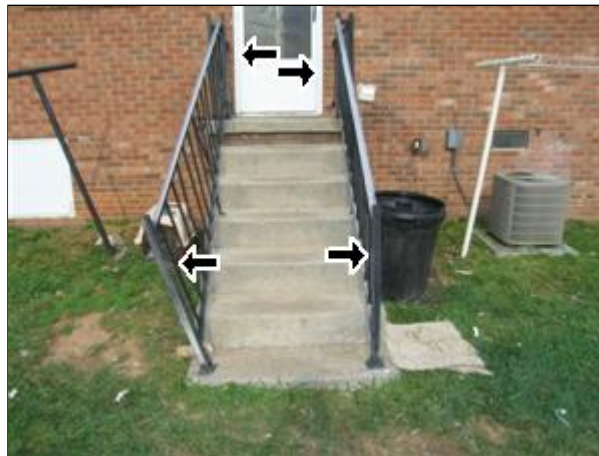
2.3 Picture 1

Many of the rear porch steps metal railings are damaged/loose as this one at apartment unit A rear.

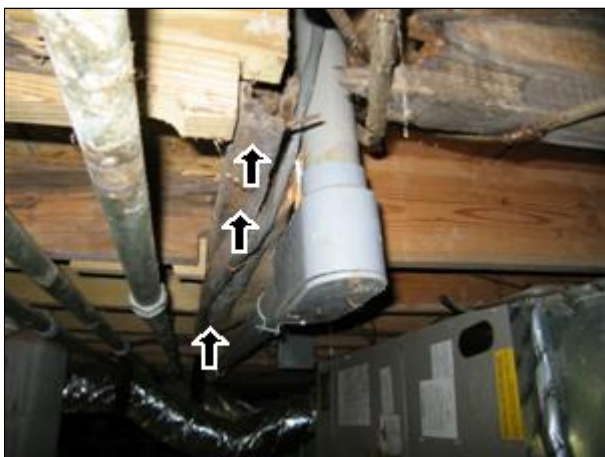
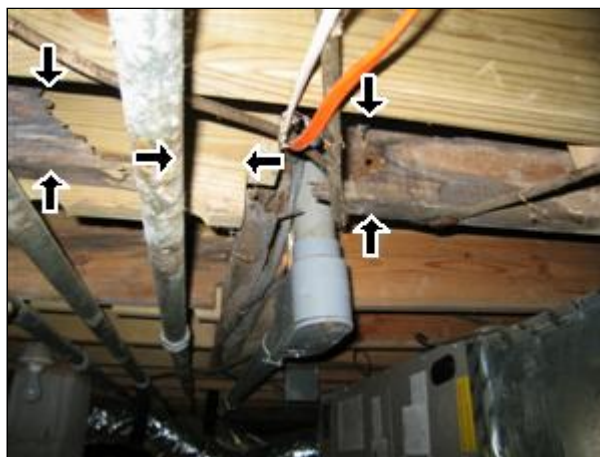
The floor structure beneath the hallway/bathroom partition wall is damaged beneath each apartment viewed. The damage varies from mild to severe and occurs primarily in the area of the partition wall support girder connection to a double-joist that extends from side foundation wall to central pier. In every case, the point of intersection of the girder to the double joist is damaged. In most locations, the damage is complete and there is no support for the girder end except the attached flooring and wall panel above. In every case where the girder end is unsupported, the floor is sagging in the apartment beneath this wall as is visible and sensed (by foot) on both sides of wall (in bathroom and in hallway). In most cases, joist and girder repair attempts beneath this wall have been made that are improper, inadequate or both. (photos 1,2)

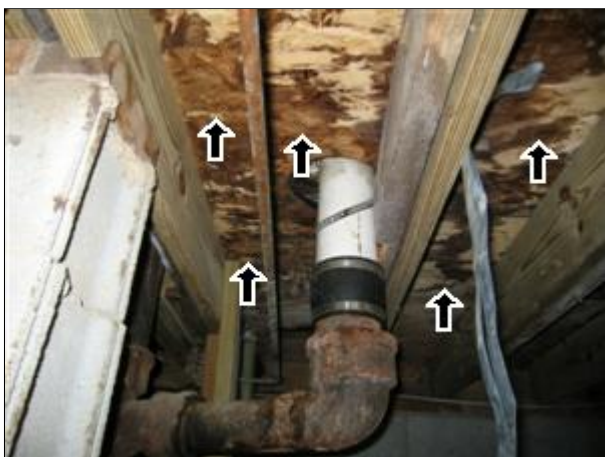
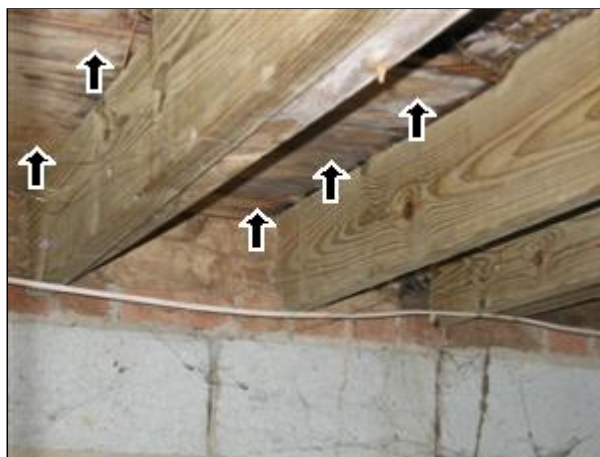
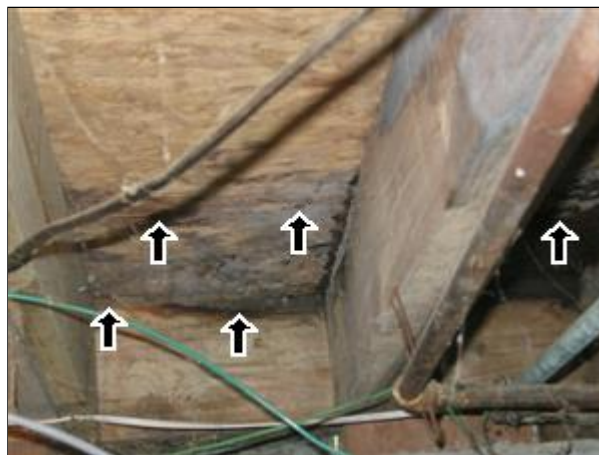
The plywood sub-floor and joist systems beneath the lavatory and bathtub are damaged and settled to some degree under approximately 90% of the apartment units viewed from the crawlspace. The degree of settlement is evident in the

size of the caulk line between the bathtub and the ceramic tile tub surround. In several cases, the plywood in this area (beneath bathtub, toilet and lavatory) as viewed from the crawlspace was wet. (photos 3-5)

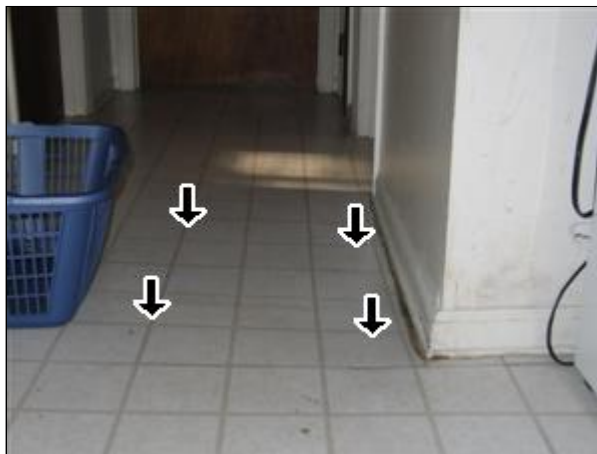
7.2.A Picture 1

The floor around the toilet in the bathroom is soft and the toilet will rock when pressure is applied to the floor on either side.

The hallway floor is settled along with the partition wall between the hall and the bathroom.

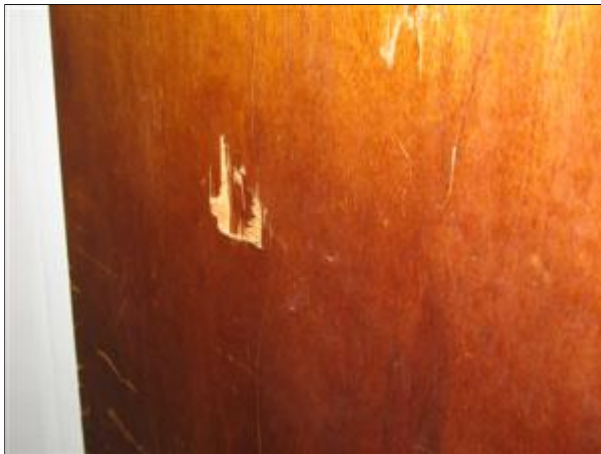
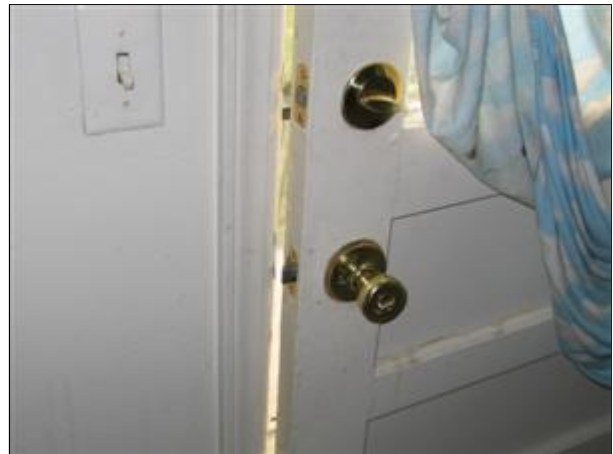
At least two of the interior hollow core doors are damaged from impact.

The rear entry exterior door is damaged and does not close properly.

Many of the interior doors require strike plate adjustment in order to latch properly.

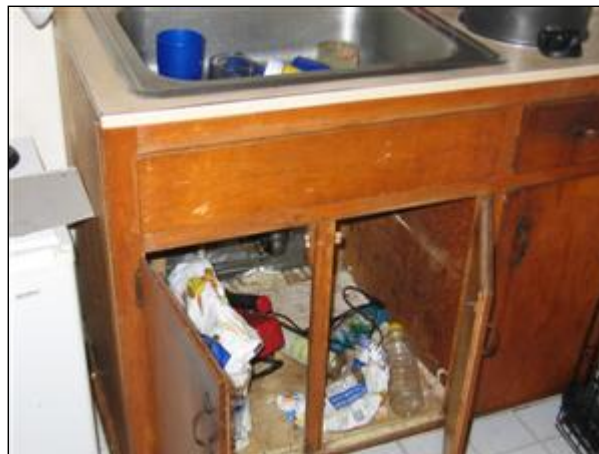
7.5.A Picture 1

The kitchen sink base cabinet is in poor condition.

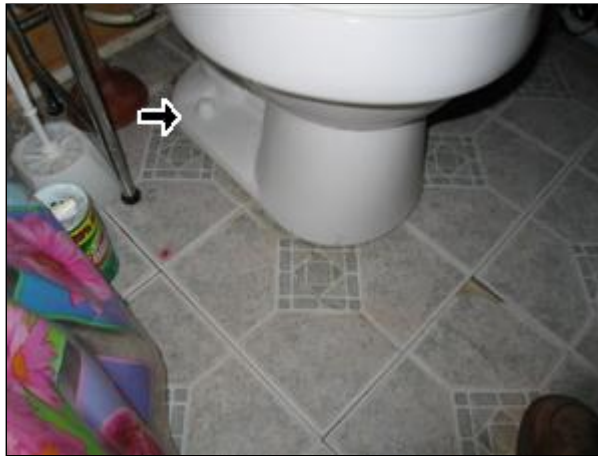
7.7.A Picture 1

The toilet is loose at the floor mounting points.

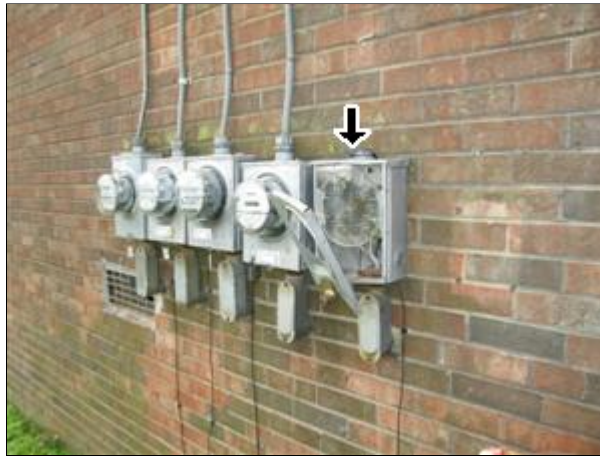
7.16.A Picture 1

Power to this apartment unit was off at the time of inspection-the utility meter was disconnected.

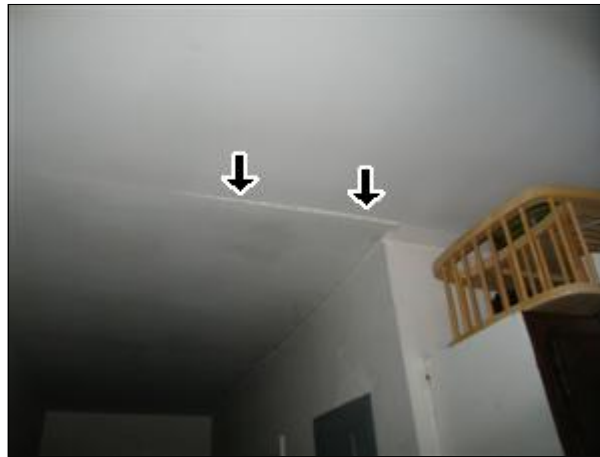
7.0.B Picture 1

The hall ceiling adjacent to the bathroom partition wall has settled slightly along with the wall.

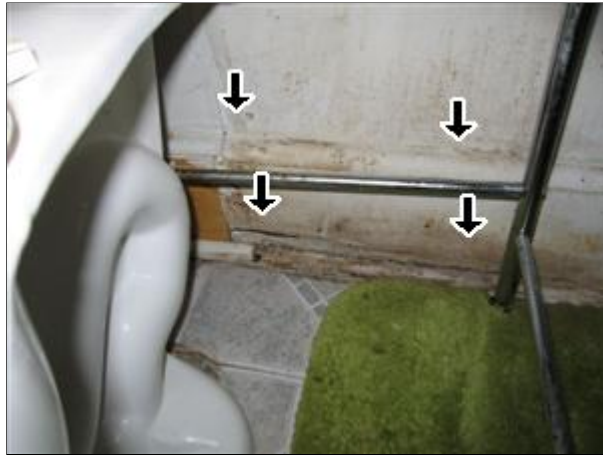
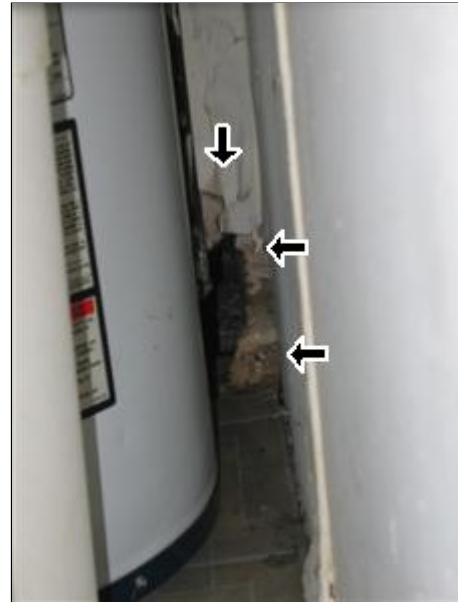
The bathroom wall behind the toilet and beneath the lavatory is damaged from water exposure.

The wall and base trim behind the hot water heater is damaged as shown in the photograph I could not determine the extent of the damage.

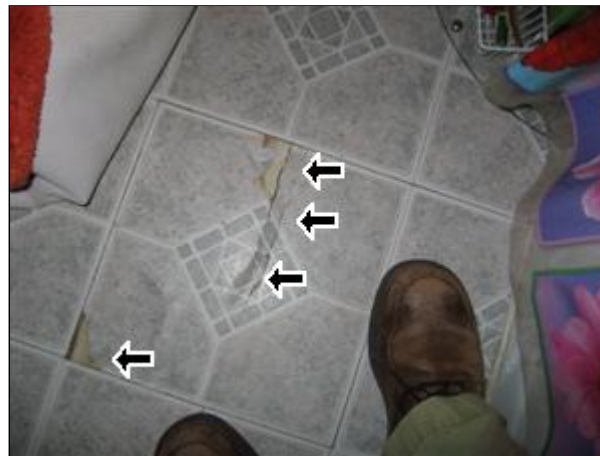
7.2.B Picture 1

The vinyl covered floor in the bathroom has damaged plywood beneath the vinyl.

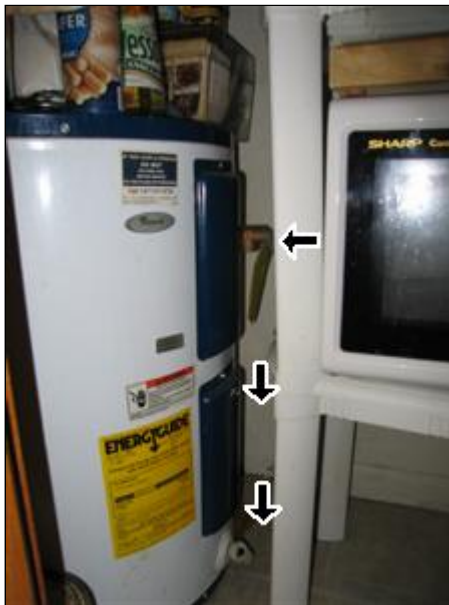
7.6.B Picture 1

The hot water heater temperature and pressure relief valve is missing safety piping to within 6 inches of the floor or extended to the crawl space.

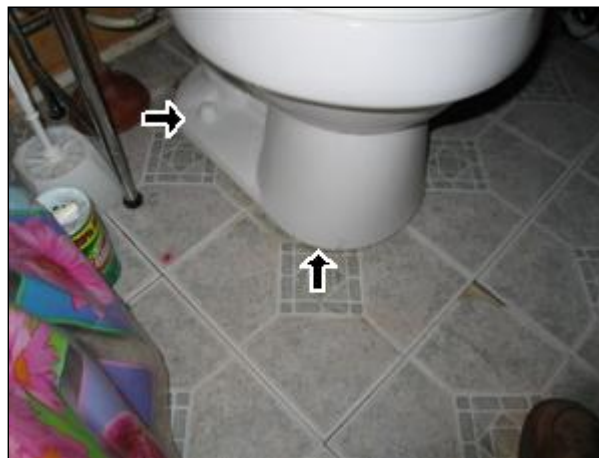
7.7.B Picture 1

The toilet is loose at the floor mounting points.

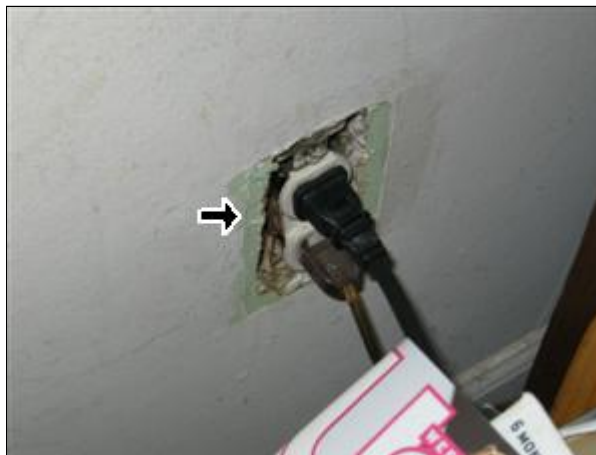
7.17.B Picture 1

One receptacle in the living room is missing a cover plate and reportedly causes the associated circuit breaker to trip.

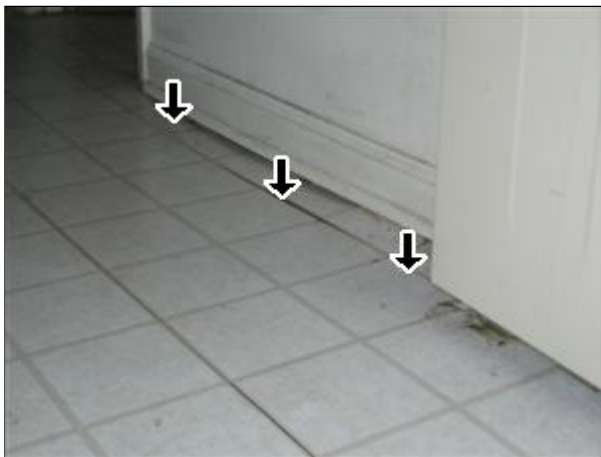
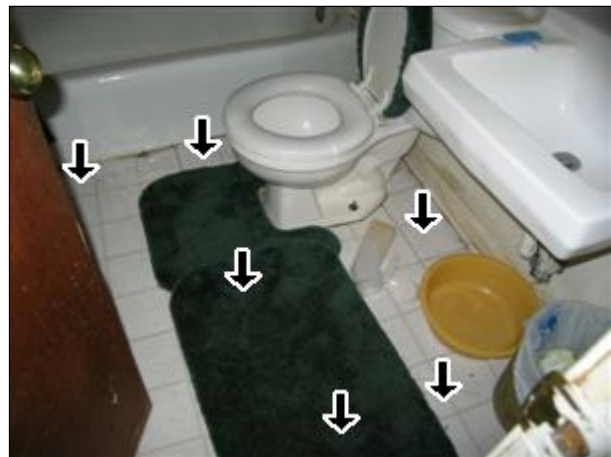
**Comments:** System Repair  
 Typical settlement of hallway floor adjacent to bathroom partition wall due to probable structural failure beneath the wall.

Bathroom floor is soft due to water intrusion damage in almost every area and the bathtub itself has settled.

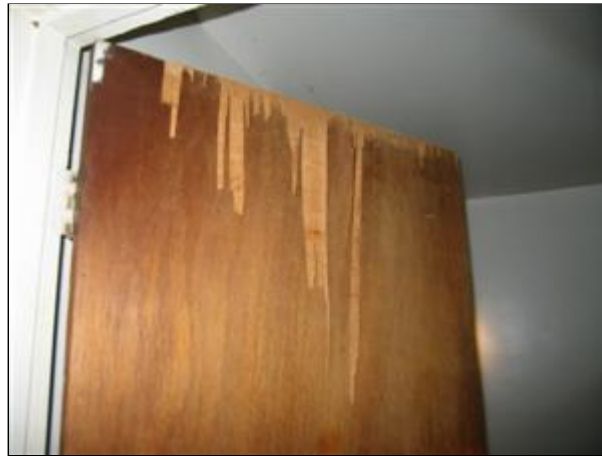
7.3.C Picture 1

The two hollow core luan bedroom entry doors are delaminated and otherwise damaged at the top.

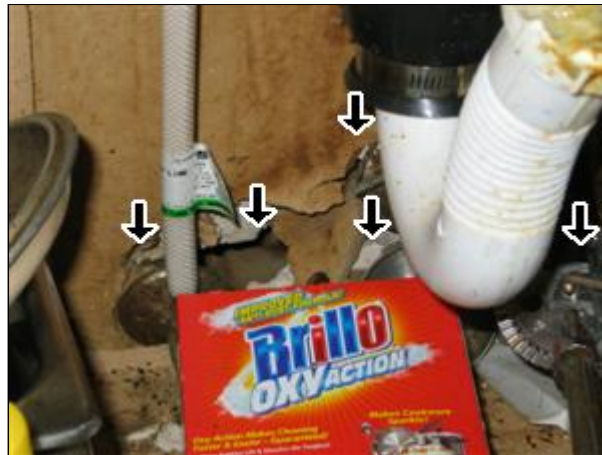
7.5.C Picture 1

There is a large hole at the rear bottom of the kitchen sink base cabinet.

The kitchen base cabinet is heavily contaminated with rodent waste.

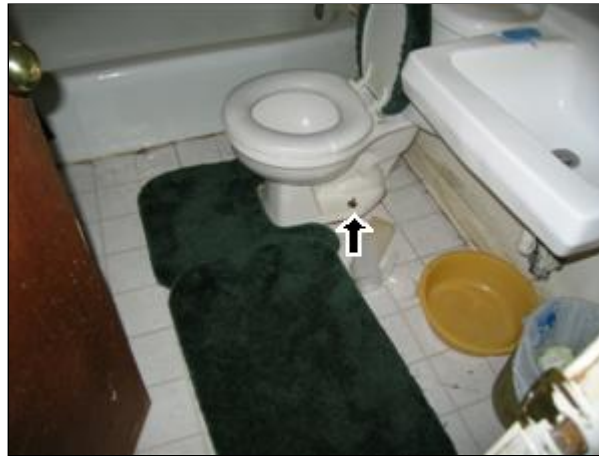
7.7.C Picture 1

The toilet in this apartment unit is extremely loose at the floor mounting points.

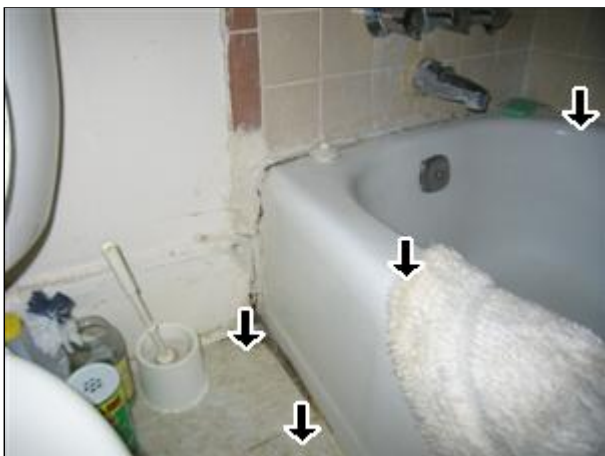
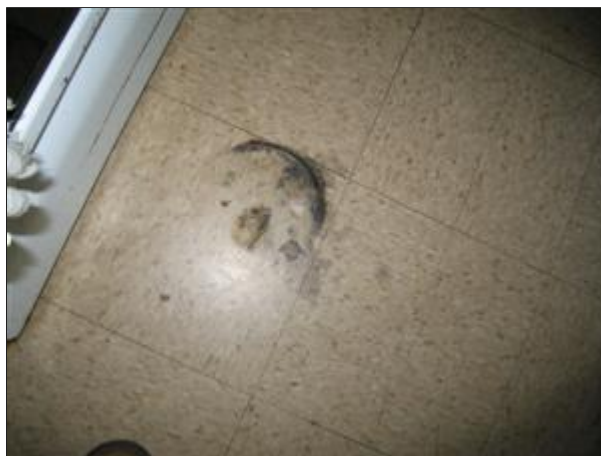
The hallway and bathroom floors in the vicinity of the bathroom hallway partition wall have settled significantly due to structural failure of the supporting girder below.

The supporting floor beneath the bathtub has settled and the bathtub along with it.

The resilient vinyl tile floor in the kitchen is damaged as shown.

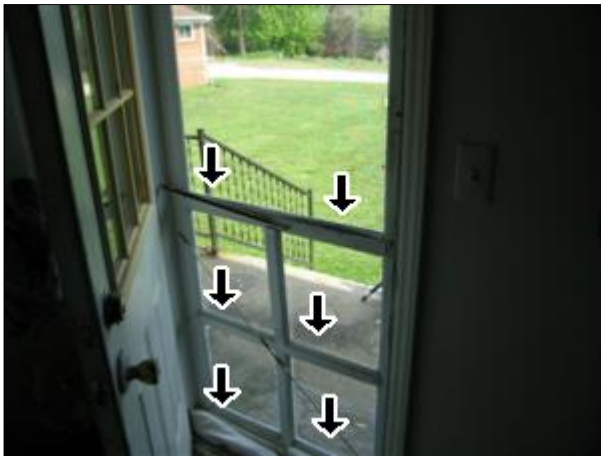
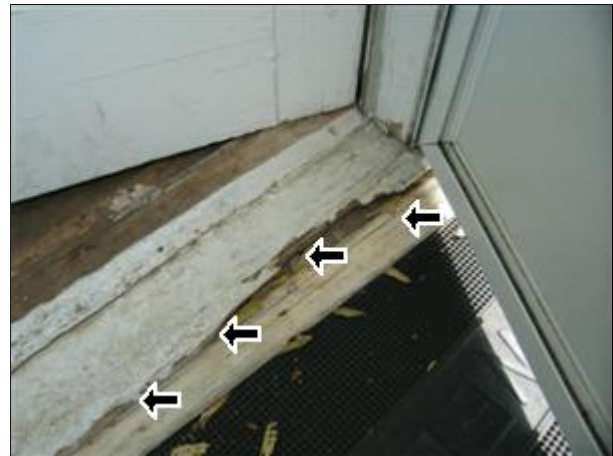
The front entry door threshold is damaged from water intrusion and requires repair or replacement.

The other entry and interior doors are in average condition.

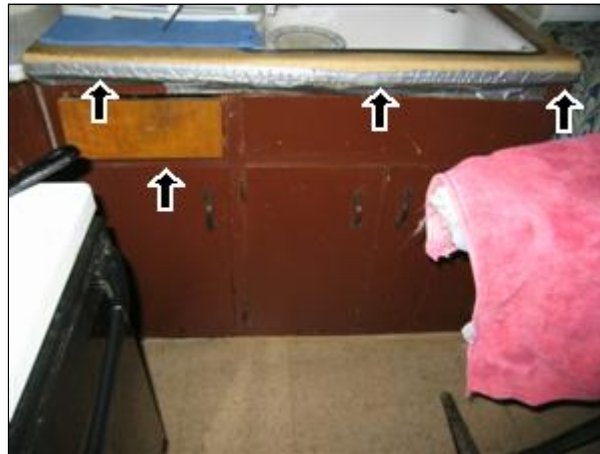
7.5.E Picture 1

The kitchen sink base cabinet and counter top are an extremely poor condition.

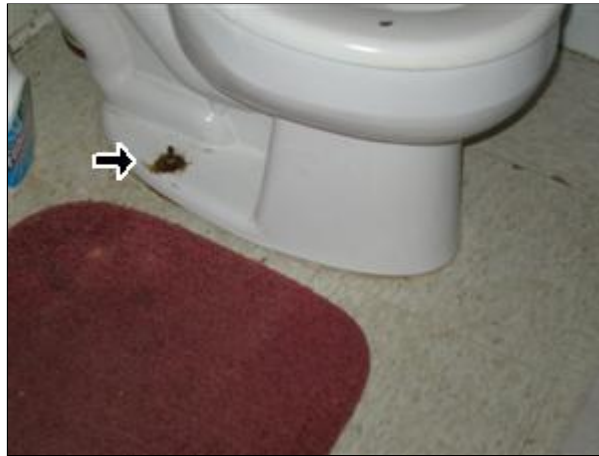
7.7.E Picture 1

The toilet is loose at its mounting points.

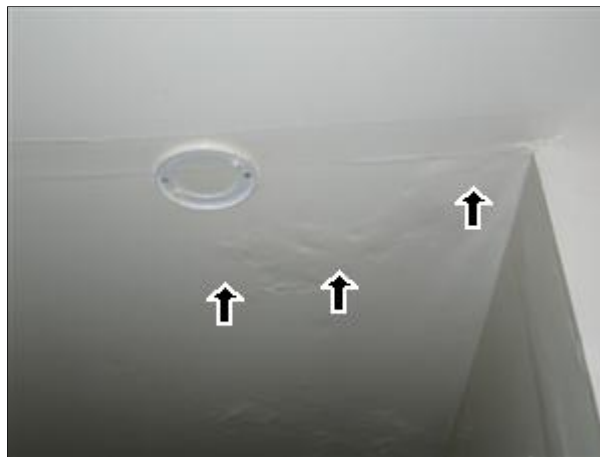
7.0.F Picture 1

The ceiling shows signs of prior repair at the hall entry possibly from a prior roof leak. The area appears to be stable, i.e.: no current leak and the paint secure.

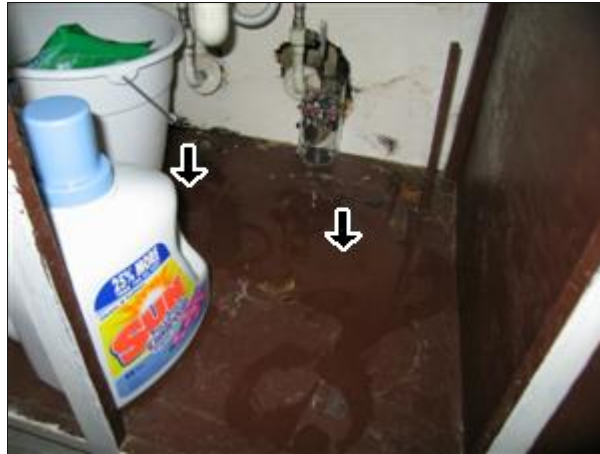
7.6.F Picture 1

The hot water shut-off valve under the kitchen sink is leaking (left side).

The bathtub in this apartment unit has settled little as is evidenced by the small caulk line at the wall-bathtub junction.

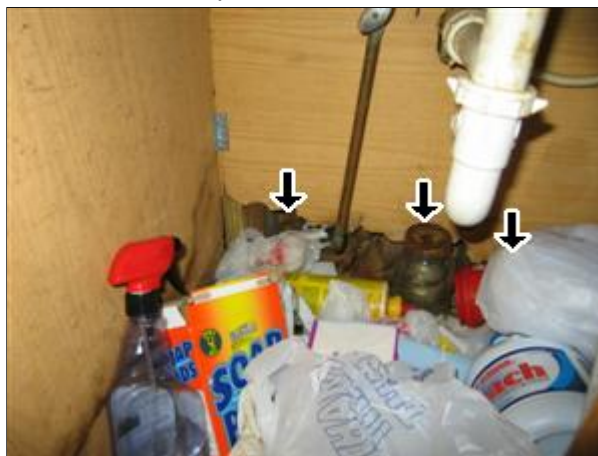
7.5.G Picture 1

The kitchen sink base cabinet rear panel is damaged as is the drywall behind the cabinet. The wall interior is exposed. Reportedly, rodents are common in this apartment. Evidence of rodents was plentiful on this cabinet bottom.

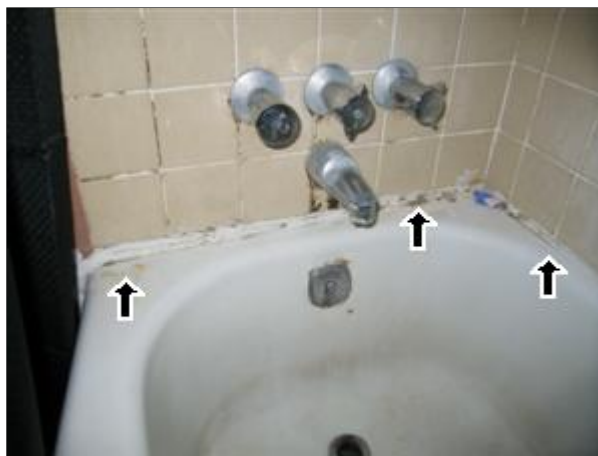
7.6.G Picture 1

Typical large caulked area at the wall tile and tub intersection due to tub settlement. Caulk in poor condition.

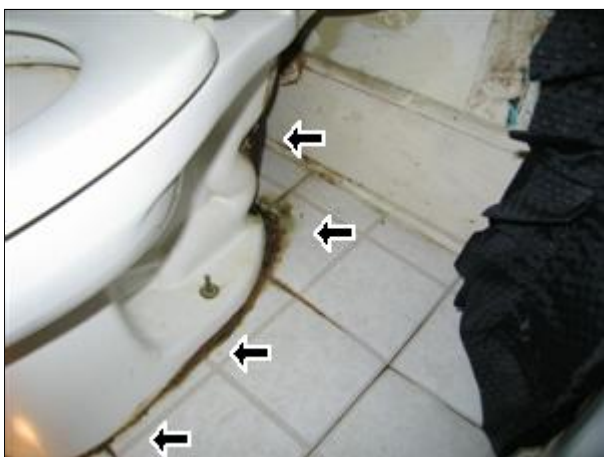
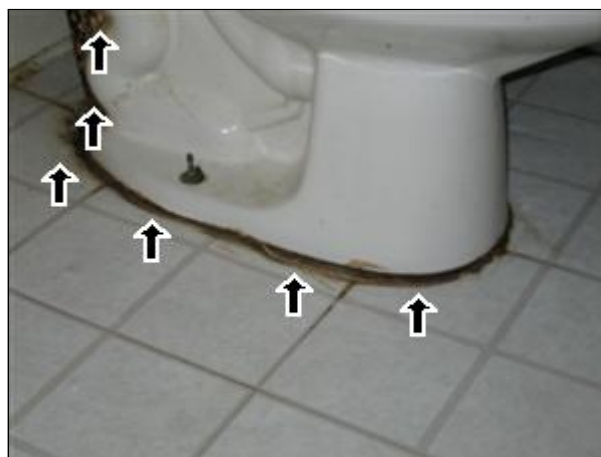
This toilet is extremely loose at the floor mounting points and the toilet bowl may be cracked and leaking waste fluid down the back of a toilet and around the toilet on the floor. This condition requires immediate repair for reasons of sanitation.

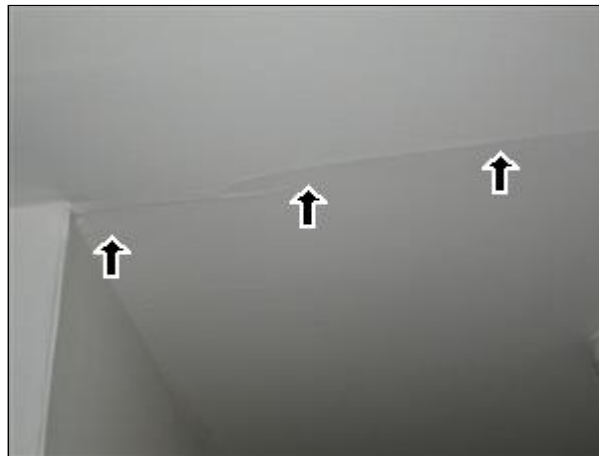
7.0.H Picture 1

Typical damaged ceiling from bathroom partition wall settlement.

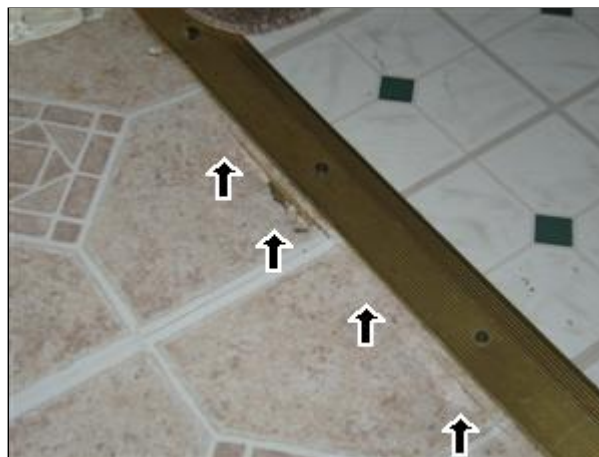
7.2.H Picture 1

Damaged sheet vinyl flooring where it is improperly supported at the bathroom doorway.

The floor in the apartment is settled in the vicinity of the bathroom partition wall on both sides

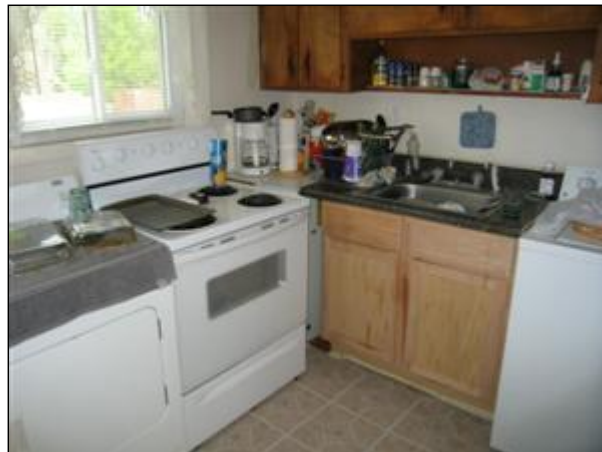
7.5.H Picture 1

Kitchen sink base cabinet and counter top in good condition/recently replaced.

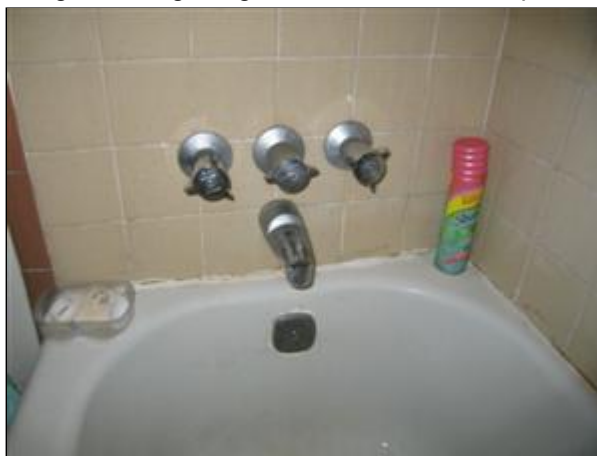
7.6.H Picture 1

Bathtub and tile wall surround caulking in average to good condition for this apartment complex

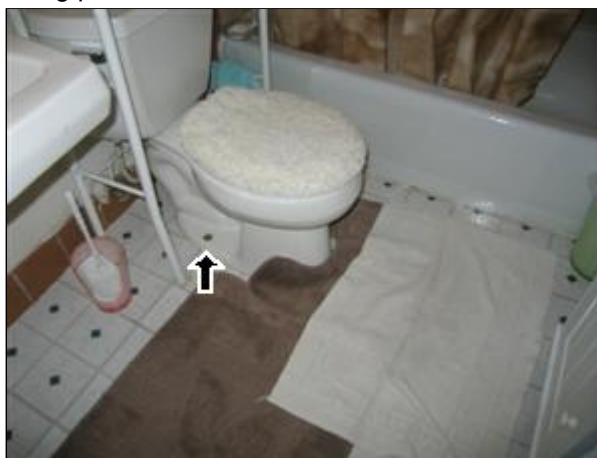
7.7.H Picture 1

The toilet is loose at the floor mounting points
