PROPERTY CONDITION REPORT

McLaurin Building
1234 Business Park Blvd
Charleston, VA 60606

Robert E McCoy Jr., PE
Armco Inspections, LLC

ARMCO Project Number 08-0250.1

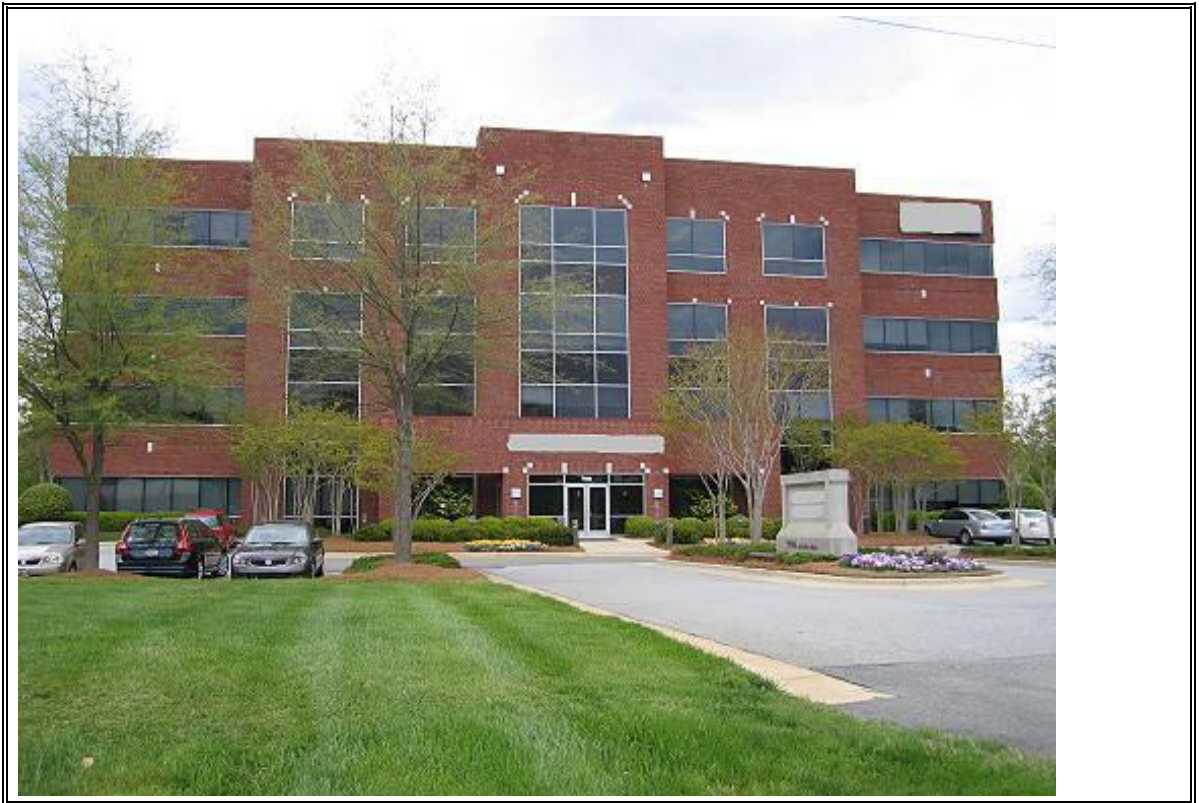
Photograph Number 1: Subject building entry driveway at Business Park Blvd

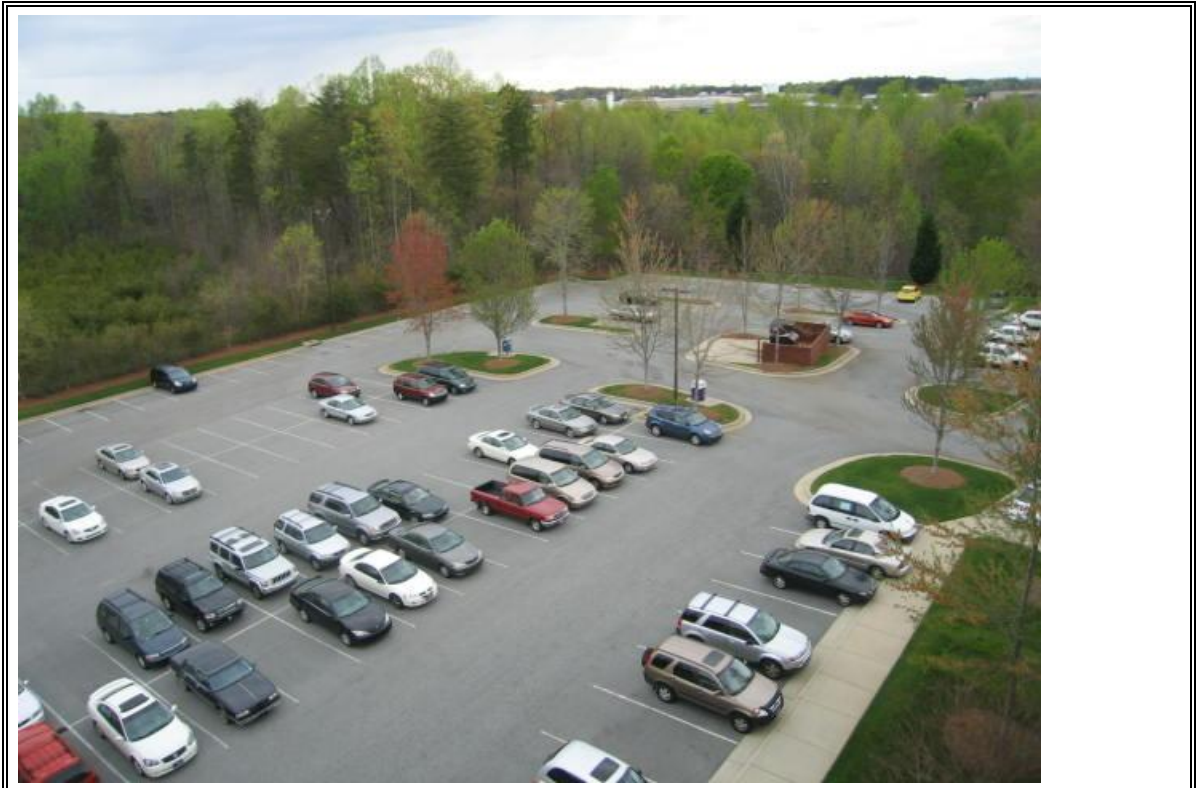
Photograph Number 2: Rooftop view of parking area

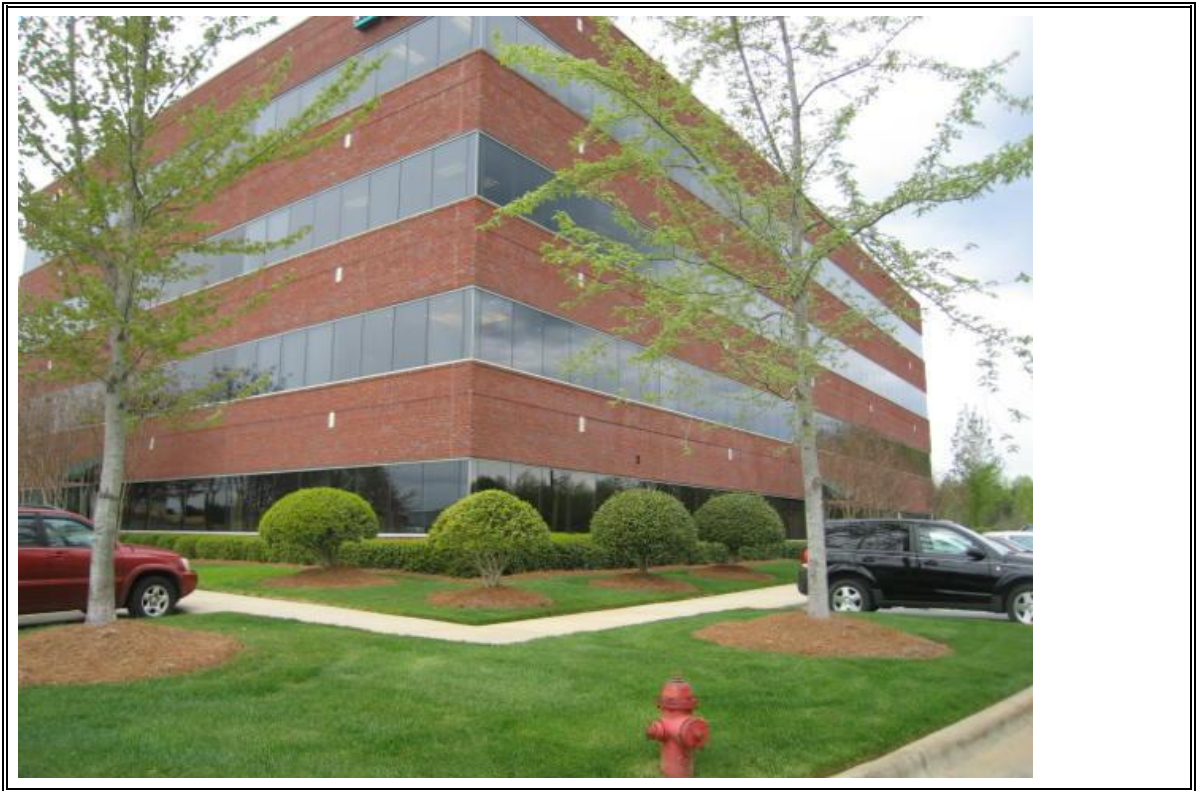
Photograph Number 3: Typical building elevation, landscaping and flatwork

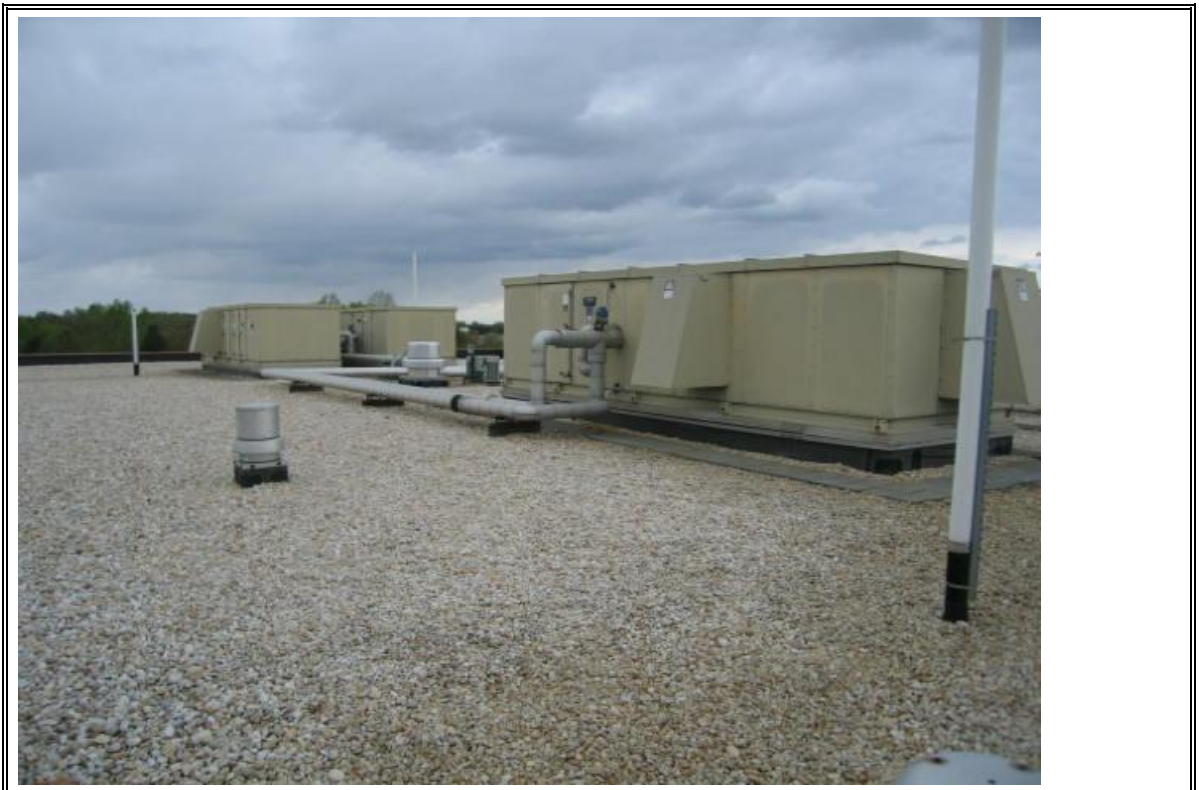
Photograph Number 4: Rooftop view of HVAC systems

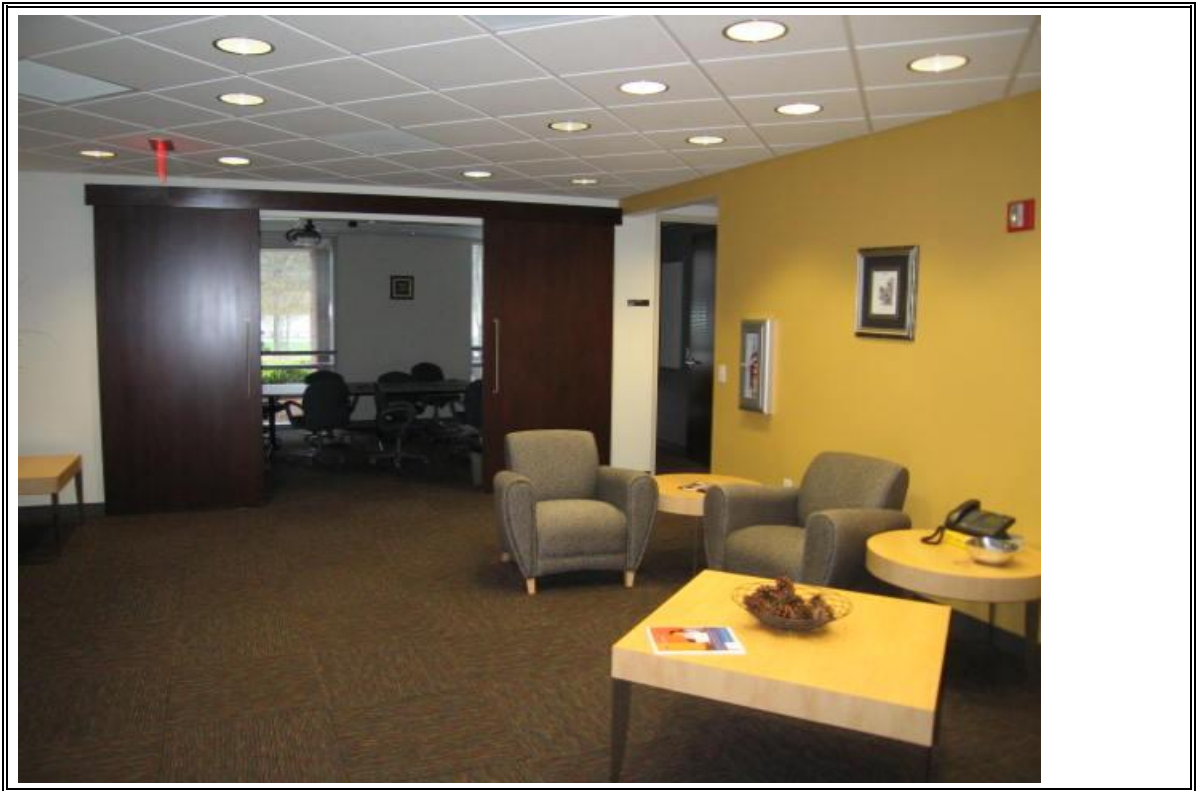
Photograph Number 5: Typical interior office view – note audible/visual fire alarm

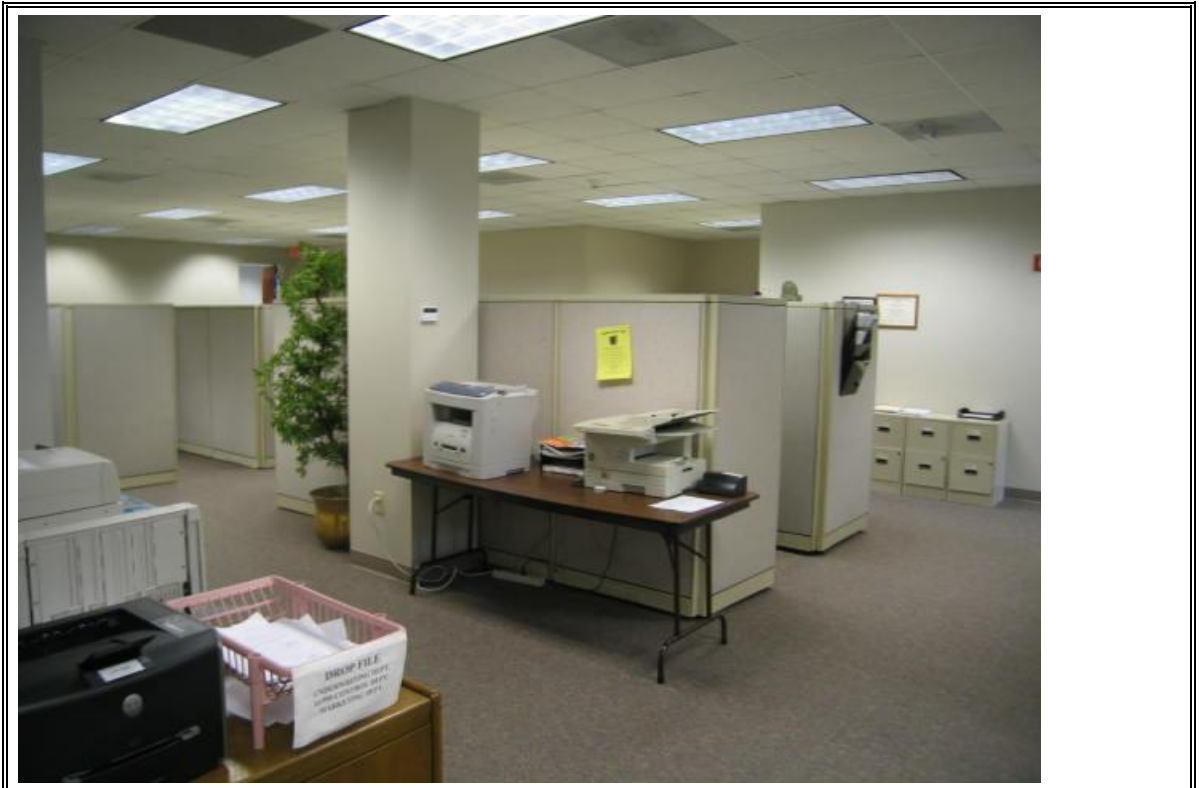
Photograph Number 6: Typical interior office view

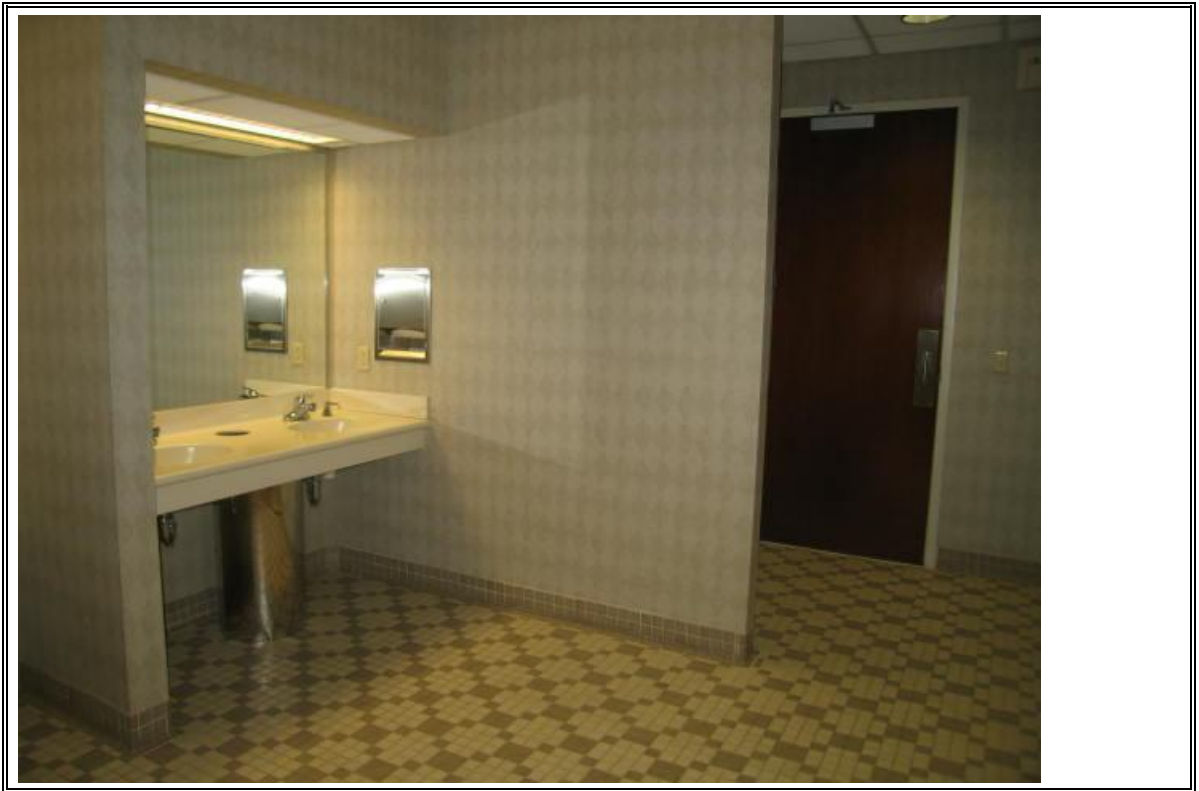
Photograph Number 7: Typical ADA accessible toilet area

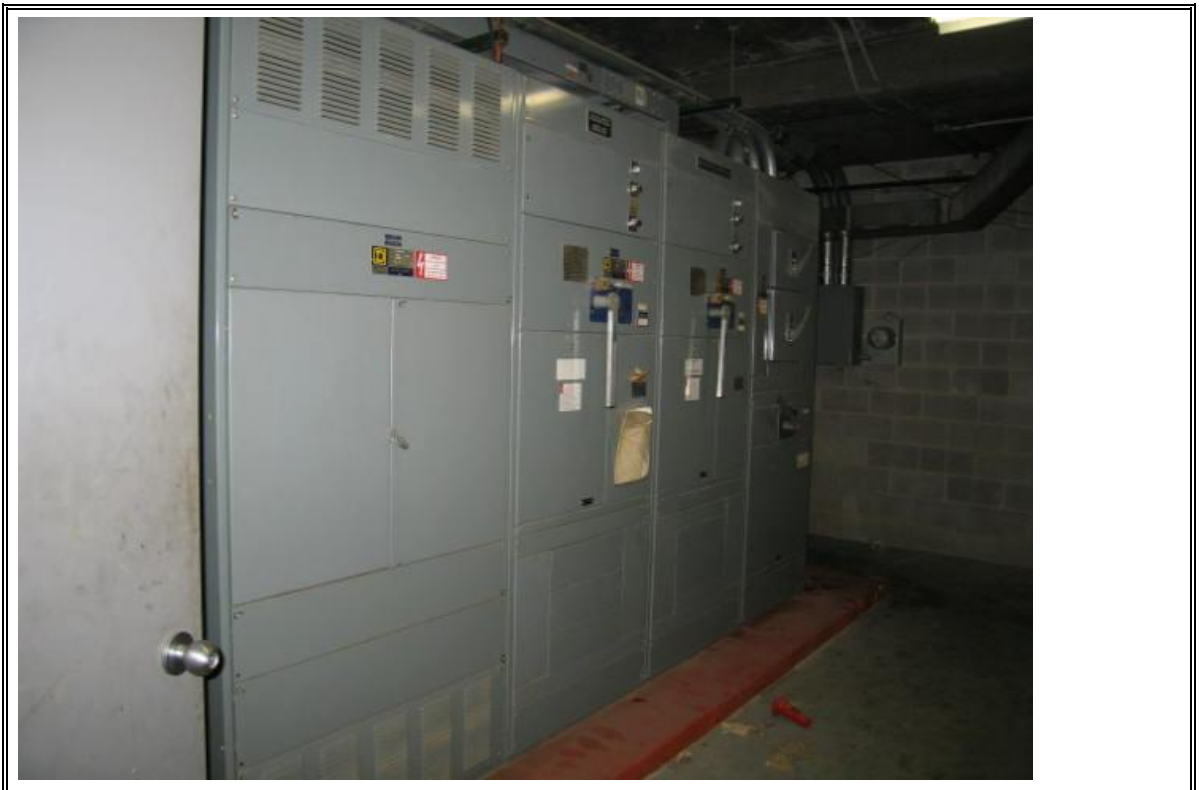
Photograph Number 8: Subject building main switchgear

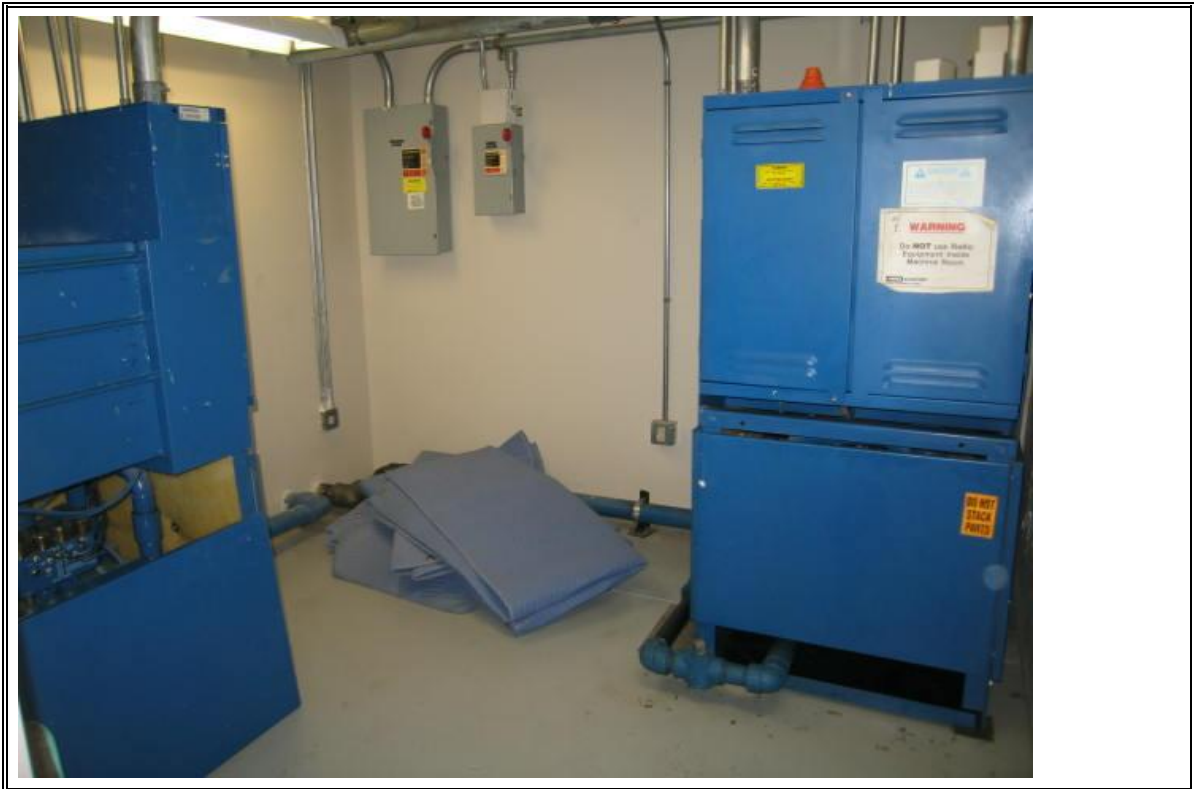
Photograph Number 9: View of dual hydraulic elevator pump/control area

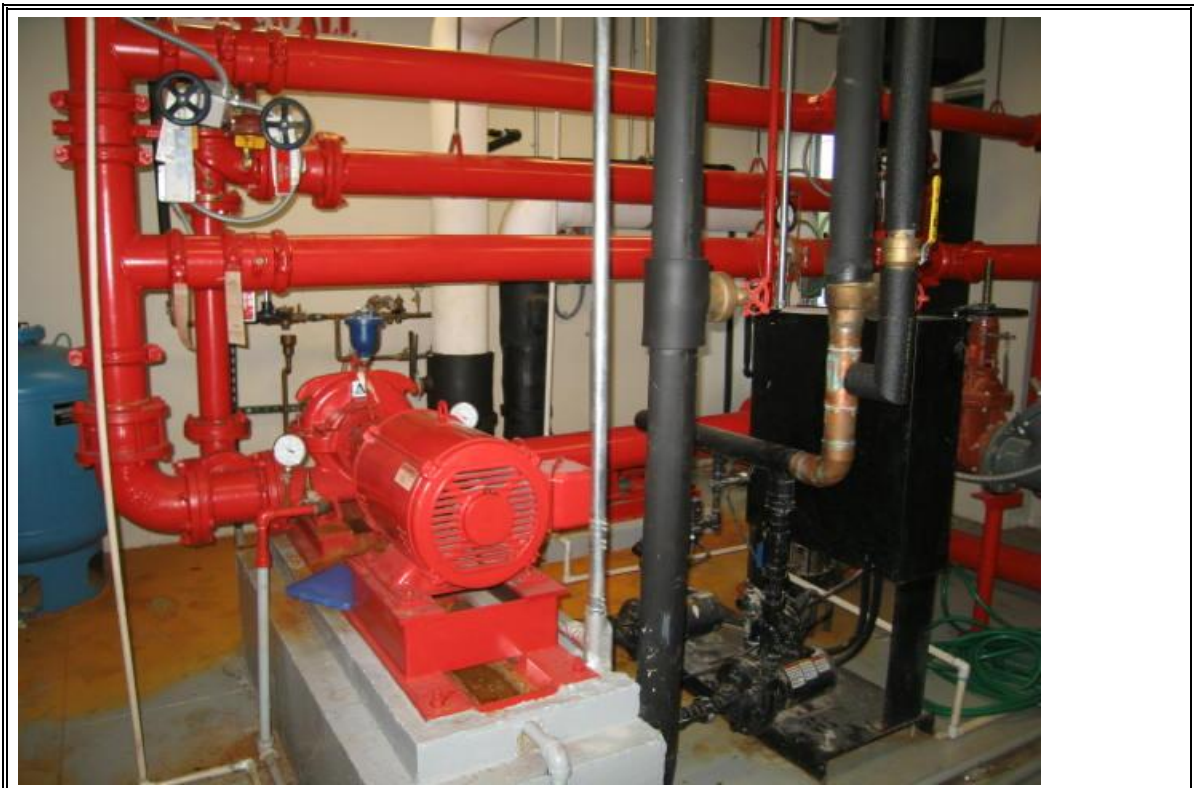
Photograph Number 10: View of typical wet pipe sprinkler system with electric fire pump
