PROPERTY CONDITION REPORT

Wilbur's Widget Distribution, Inc.
3700 Widget Drive
East Hoboken, New Jersey 28222

Date of Site Review: September 3, 2012

ARMCO Project Number 12-0909.1

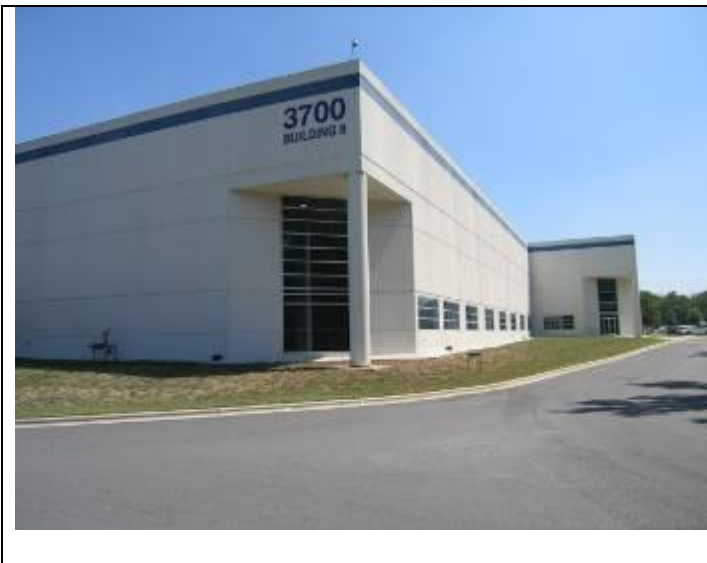
1. Subject Building main entry at Widget Drive –

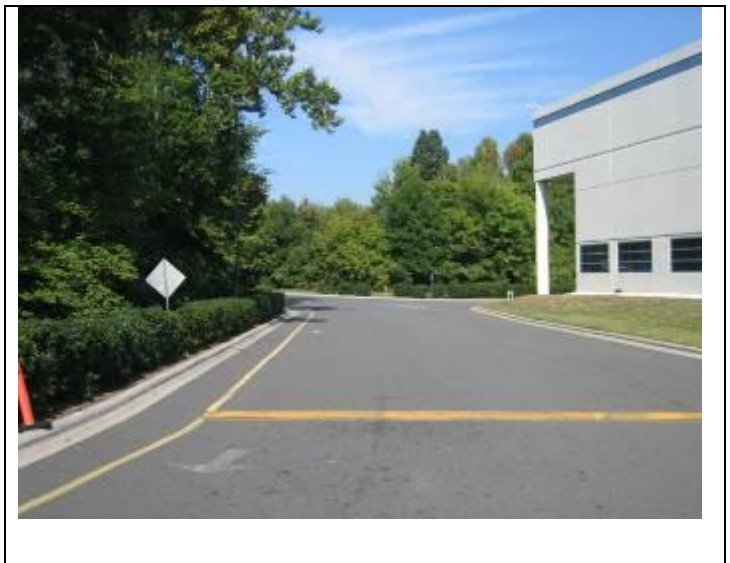
2. Subject Property main entry driveway

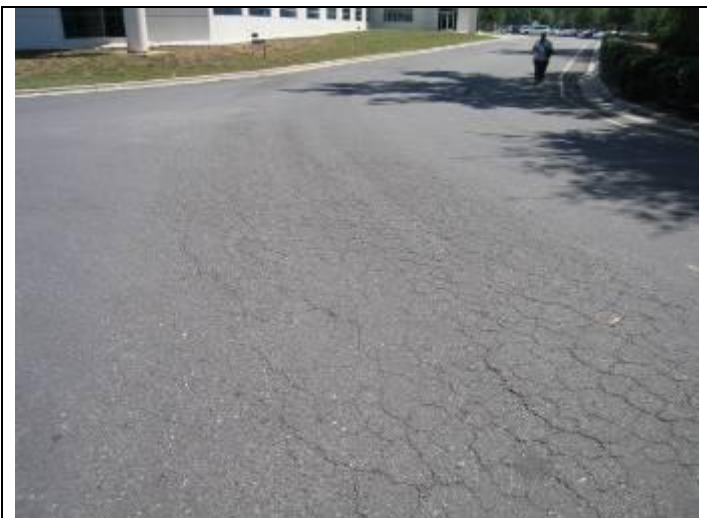
3. Alligatored asphalt at main driveway entry -

- Driveway repairs/replacement to alligatored areas (approximately 1000sf) in the high traffic driveway at the main entrance and elsewhere
- HVAC RTU component replacements.
- Domestic water heater replacement.

The asphalt-paved areas of the Property are in good structural condition. Based on EUL and apparent condition, the asphalt surfaces should be resealed later in the reserve term and periodically thereafter in order to extend the effective useful life of the asphalt pavements. An opinion of cost is included in Table 2. Costs are also included in the reserve term for the repair of deteriorated asphalt areas estimated at 1000sf.

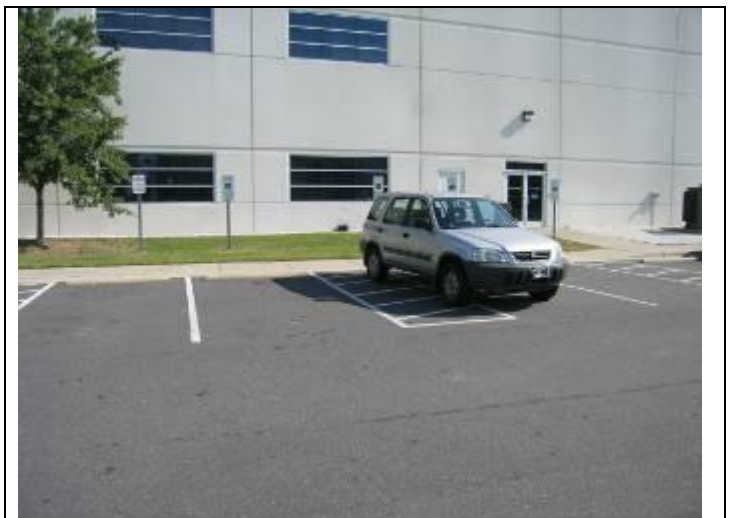
4. ADA parking spaces (five total) - van accessible

- Armco noted that the ADA parking provided is less than the BOMA guidelines: nine (9) required for 460 total spaces and five (5) are currently provided. As an immediate need, the number of designated ADA spaces should be increased by a total of four (4).

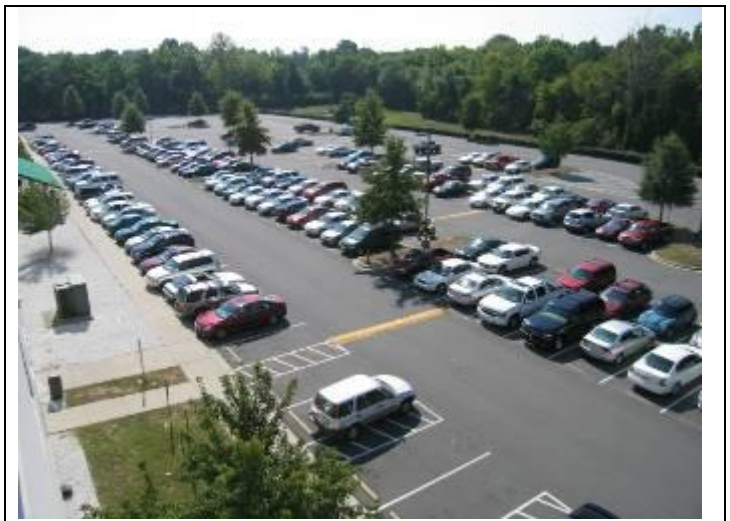
6. Employee and visitor parking area - ADA parking

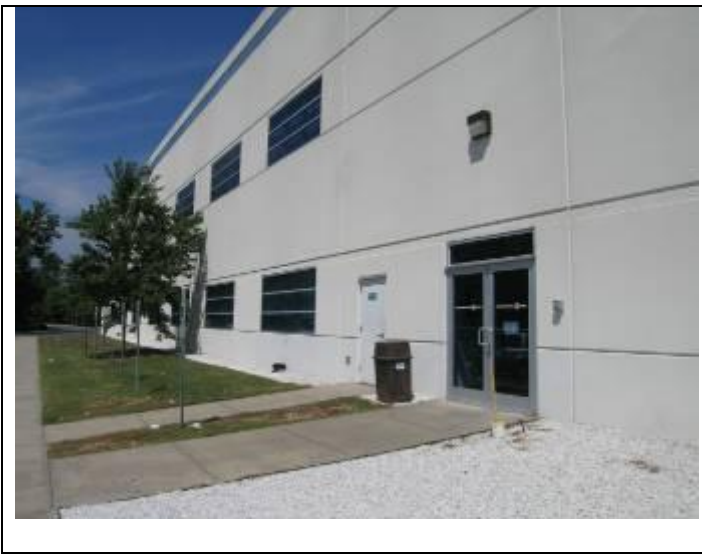
7. Employee entrance - typical tilt-up-wall construction

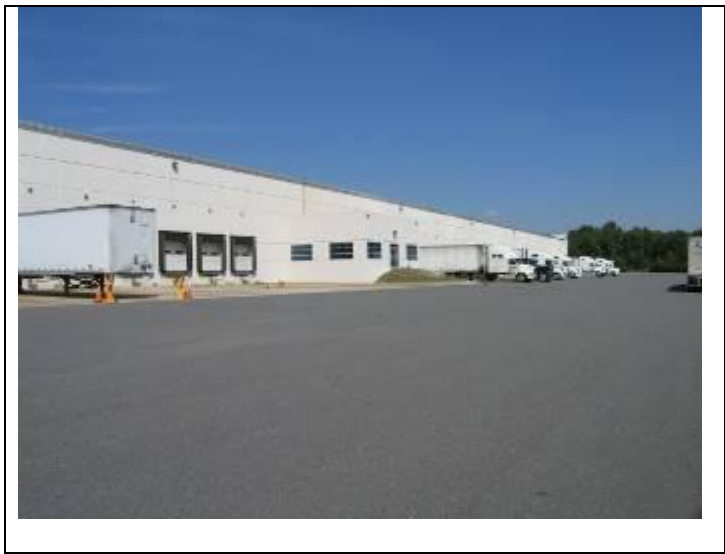
8. East elevation loading areas and asphalt condition

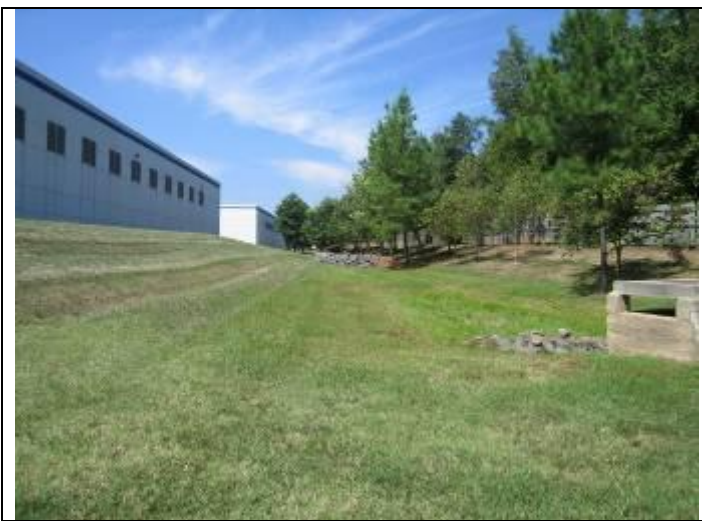
9. Building North elevation and run-off/retention area

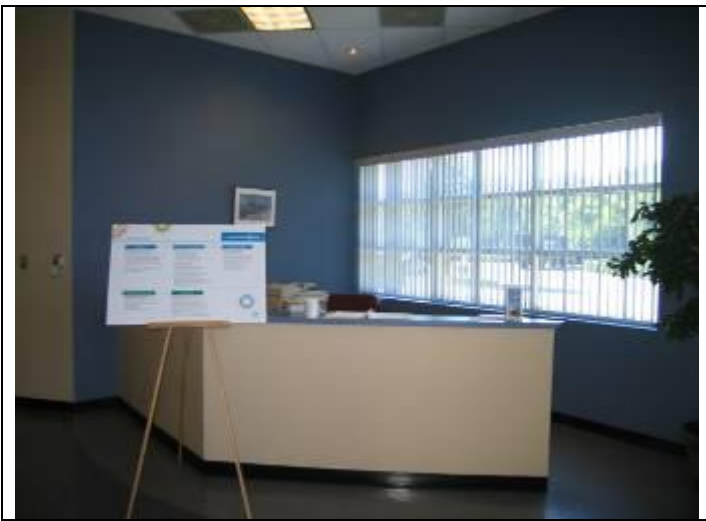
13. Main lobby area section - finish condition typical

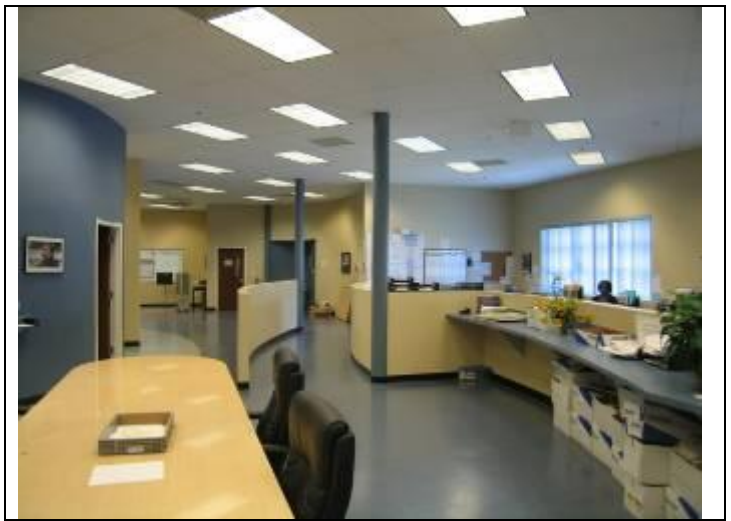
14. Typical office space - no carpet all good condition

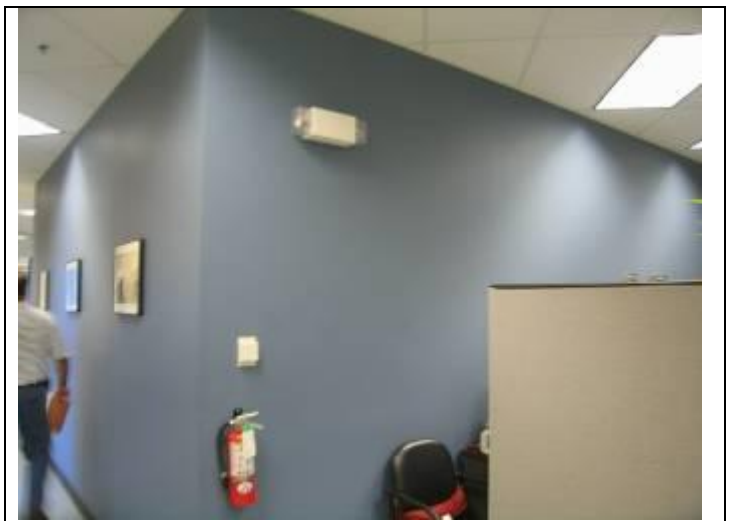
18. Current fire extinguisher, emergency lighting

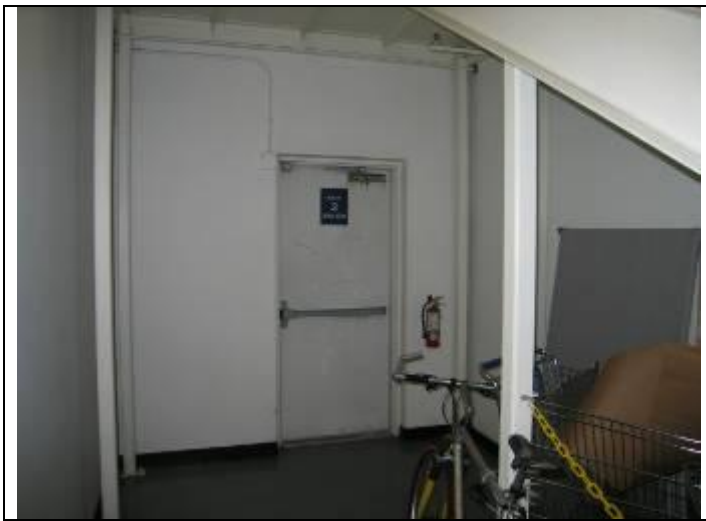
19. Stairwell and exterior door, current fire extinguisher

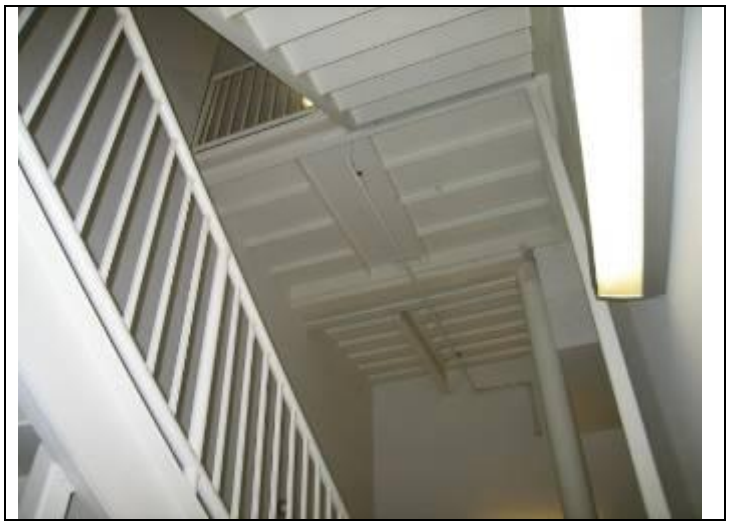
20. Metal framed interior stairwell in good condition

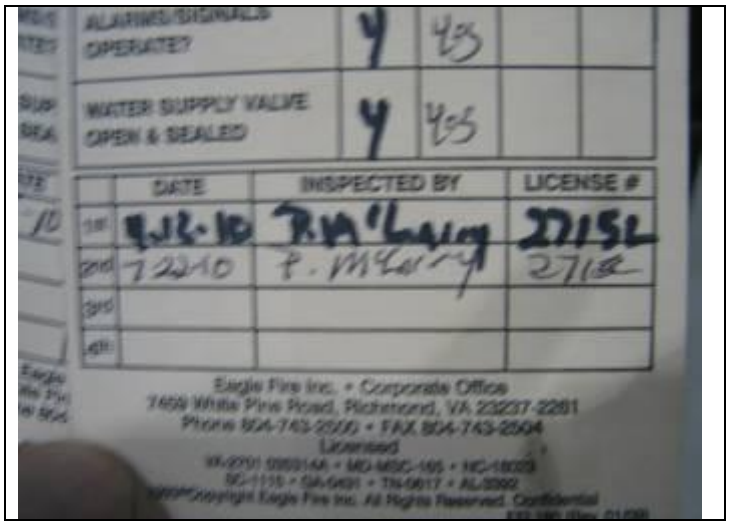
32. Current sprinkler riser inspection tag

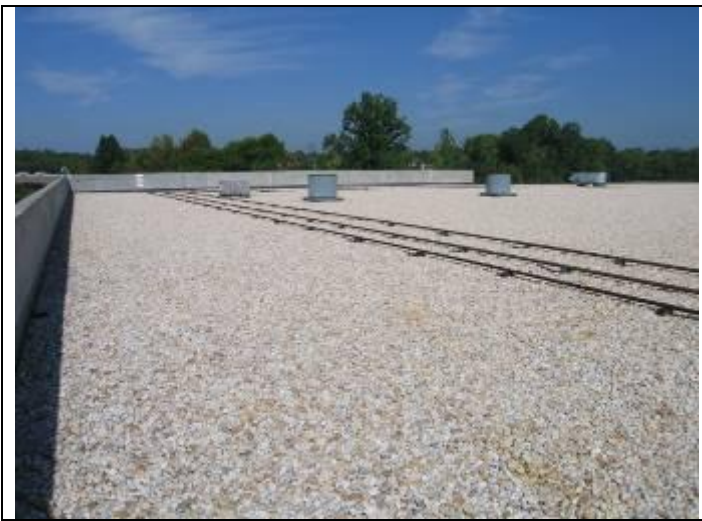
37. Natural gas distribution piping, typical ventilation fans, Gravel ballasted EPDM roof membrane

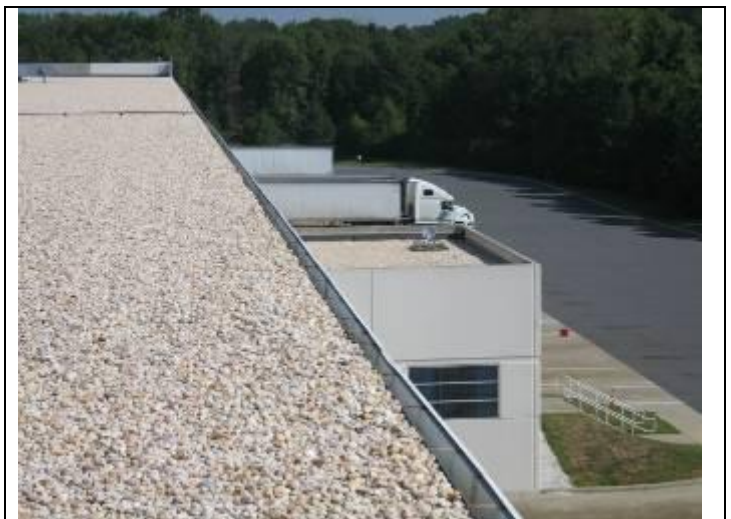
40. Ancillary rooftop over shipping/receiving office – ballasted membrane

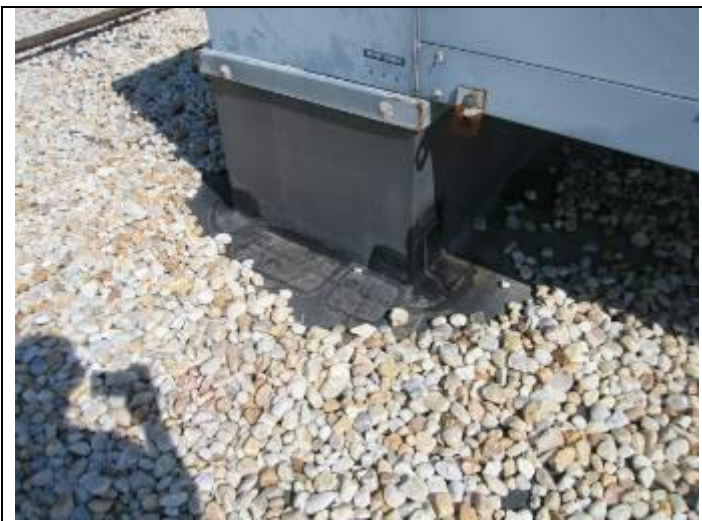
The roofing appears to be in good overall condition and is reportedly the originally installed systems. Isolated areas of patching were noted. Based on the EUL (20 years), replacement of the flat roof membranes is anticipated beyond the end of the term with normal maintenance. Some evidence of leakage was noted and recorded. The roof system is currently estimated at 8 years of age and is under active warranty by the Firestone company.

41. Flashing repair to single membrane rubber at RTU

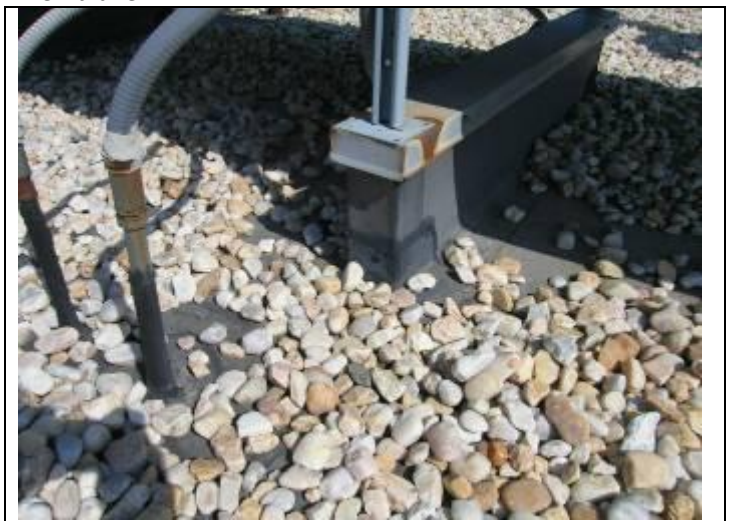
42. Flashing detail - prior repair evident
