## PROPERTY CONDITION REPORT

**Wilbur's Widget Manufacturing Building**  
1234 Doobiewood Drive  
Asheville, North Carolina 27909

ARMCO Project Number 12-14211.1

**RE:** Property Condition Assessment  
Wilbur's Widget Manufacturing Building  
1234 Doobiewood Drive  
Asheville, North Carolina 27909

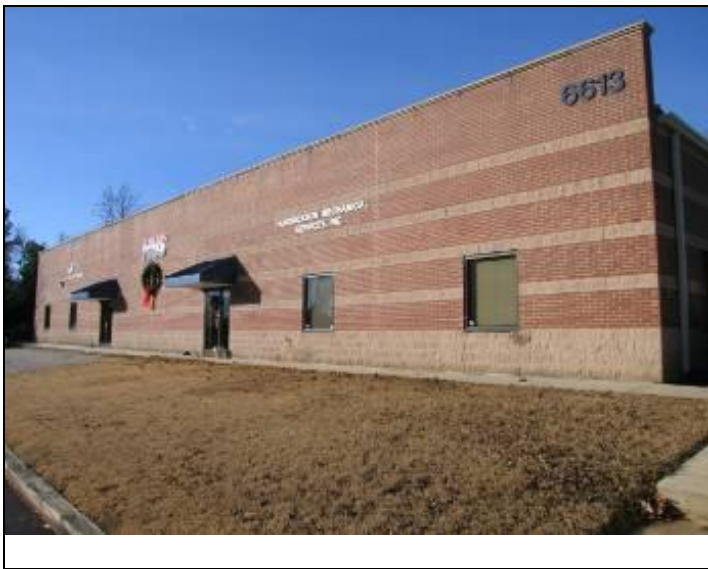
1. Front (east) elevation

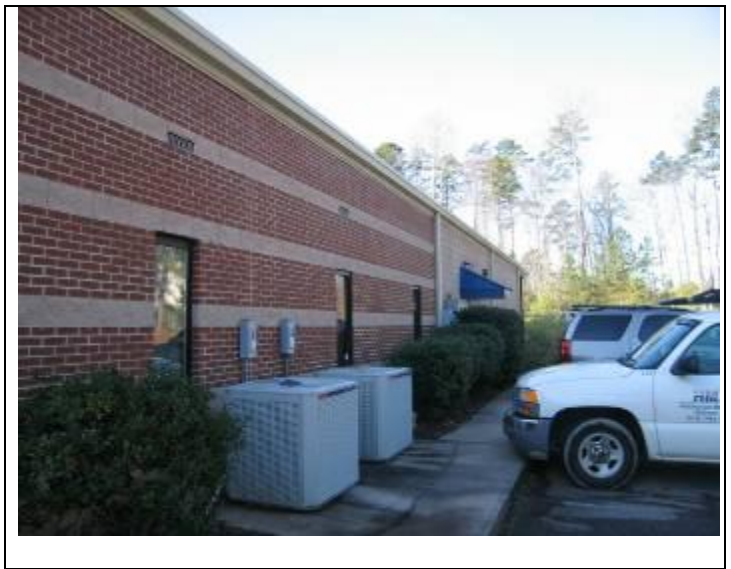
2. Right side (north) elevation – twin split heat pumps and utilities

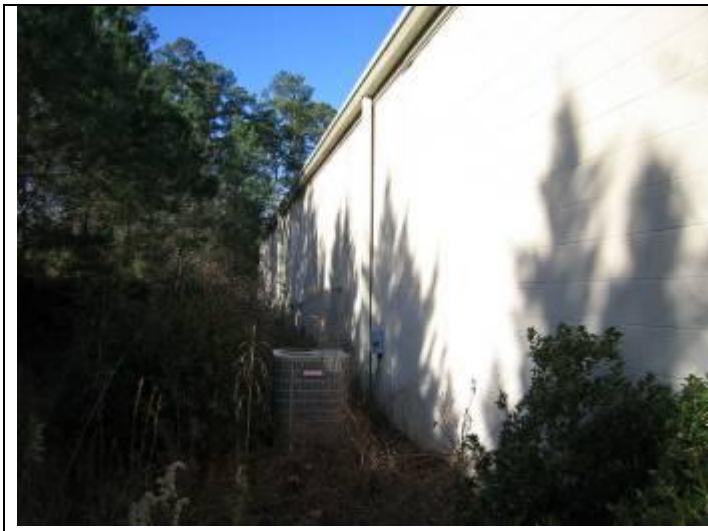
3. Left (south) elevation – parallel to drainage ditch – tenant HVAC

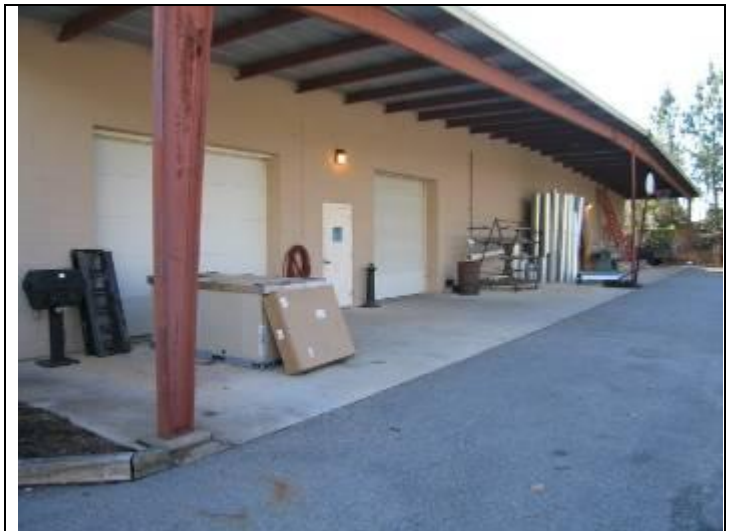
4. Rear (west) elevation and loading/service areas

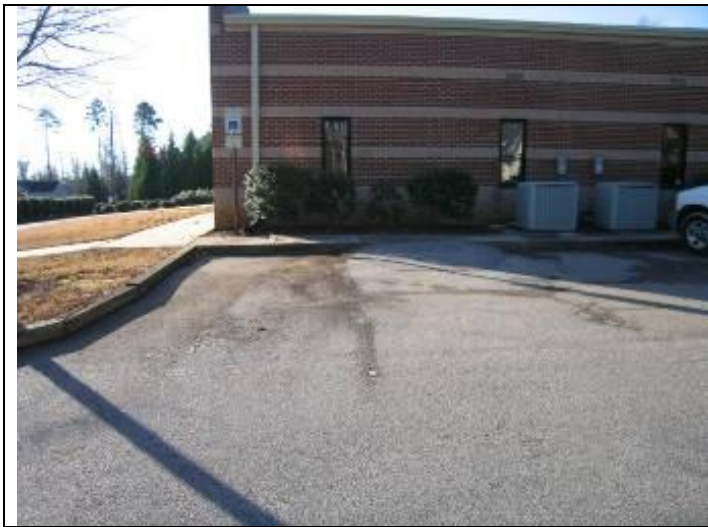
5. ADA parking at north parking lot

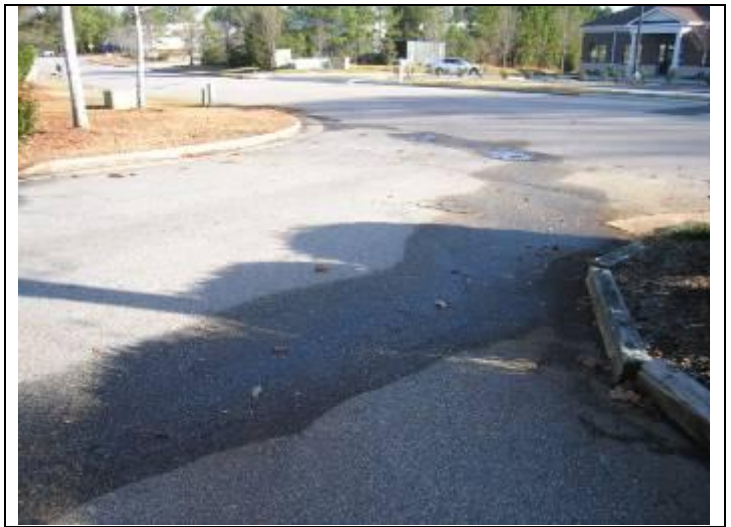
6. Asphalt driveway at Fleetwood Drive

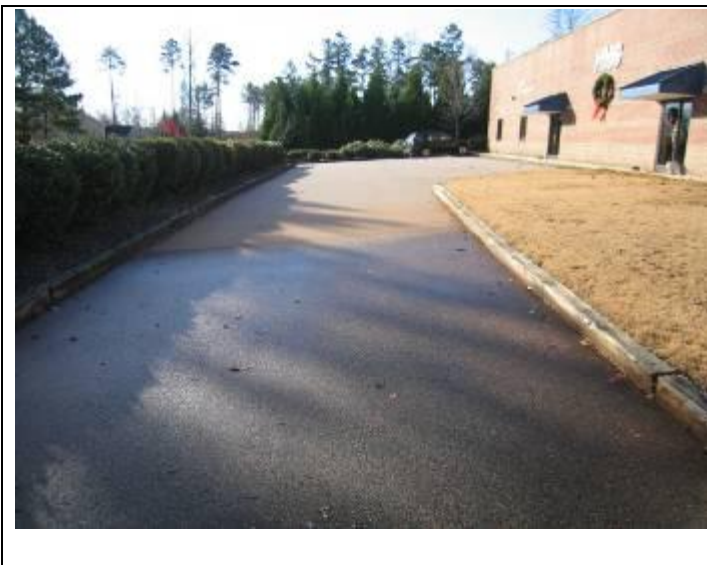
7. Asphalt front drive lane and parking – wood curbing

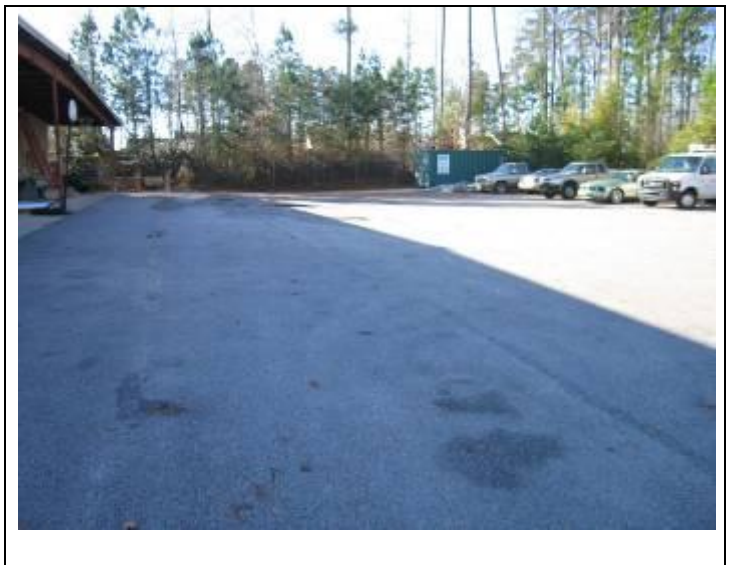
8. Rear service/staging area with asphalt paving in typical good to fair condition

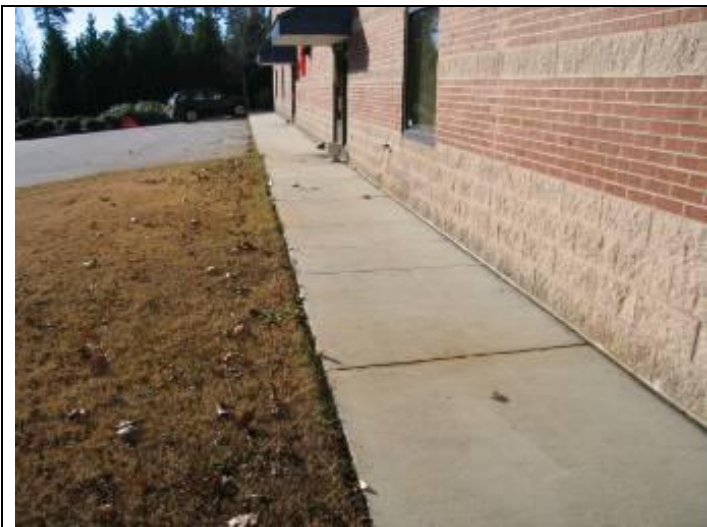
9. Front walkway typical of good flatwork condition

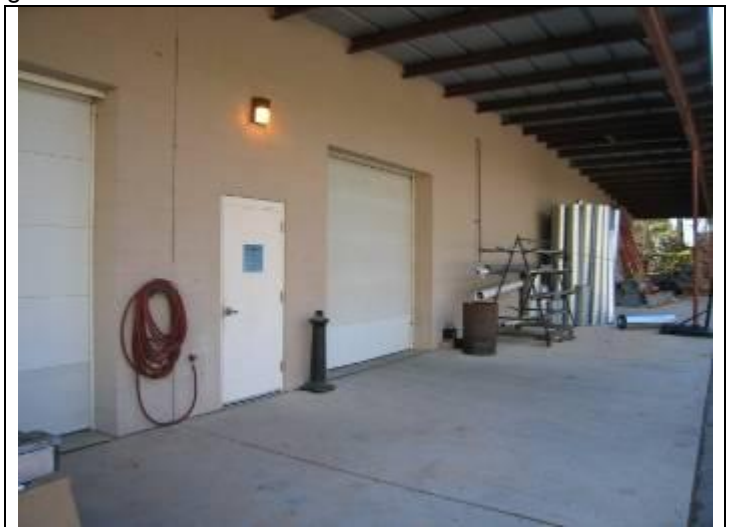
10. Rear service doors in good condition – typical exterior lighting

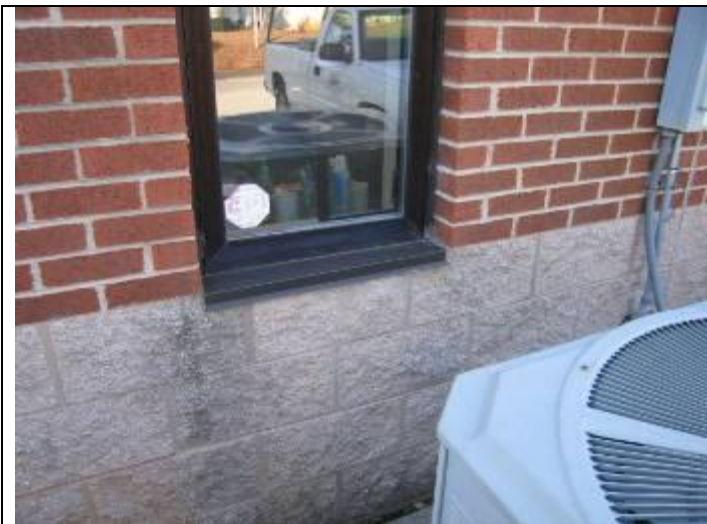
11. North elevation fixed aluminum framed window with deteriorated caulk

1. Seal-coating to maximize the asphalt life to the expected useful limit of 25 years along with re-striping of parking area stalls including ADA parking
2. Replace window frame caulk as a matter of immediate need to inhibit water entry
3. Further examination by a structural specialist (PE) with soils experience to provide remedies and/or repair specifications as may be necessary for the wall and general area with respect to effective drainage.
4. Further examination of the breaker/panel sizing by an independent electrical contractor to assure proper future performance.
5. Secure building warranty documentation as is available (roof, HVAC, envelope, etc)

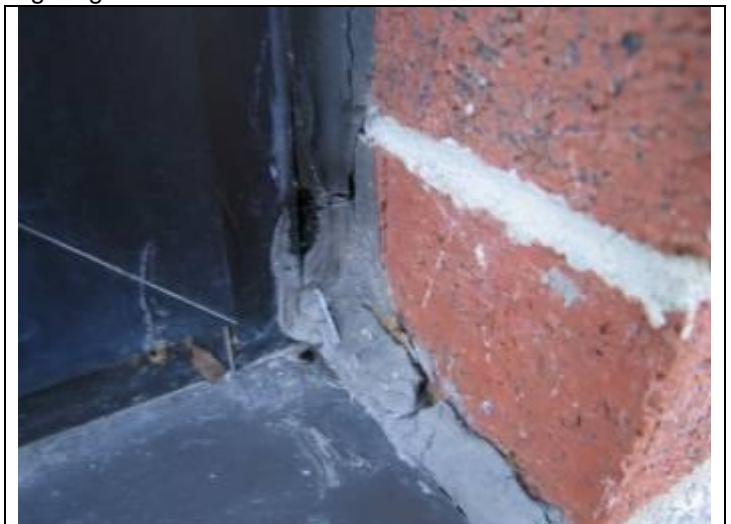
12. Damaged caulk will permit stormwater to wall interior cavity

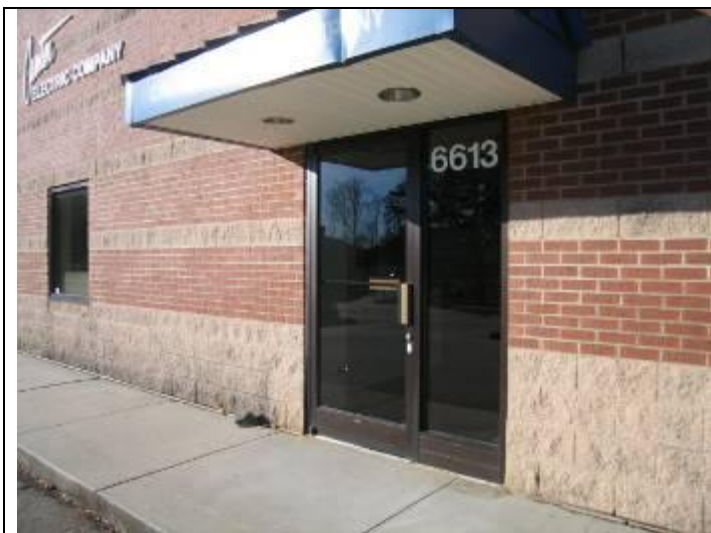
13. Front entry with storefront style doorframes with full height glass insulating panels (one of two)

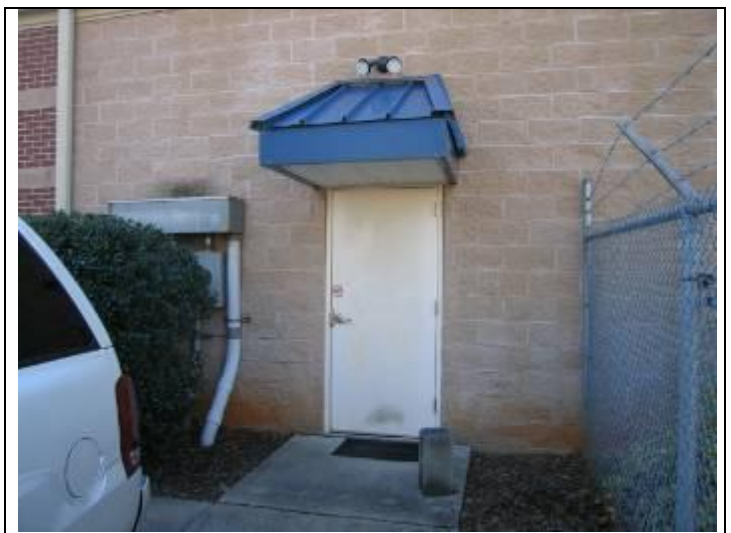
14. North side service entrance adjacent to utility meters (electric and gas)

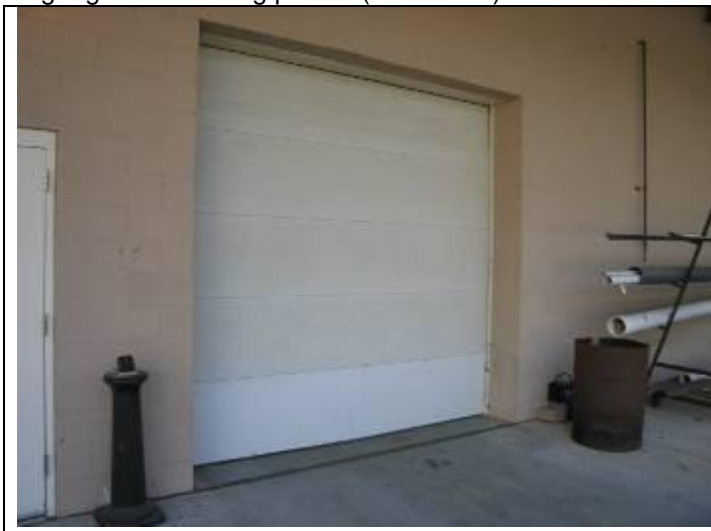
15. Rear loading area sectional door in good condition

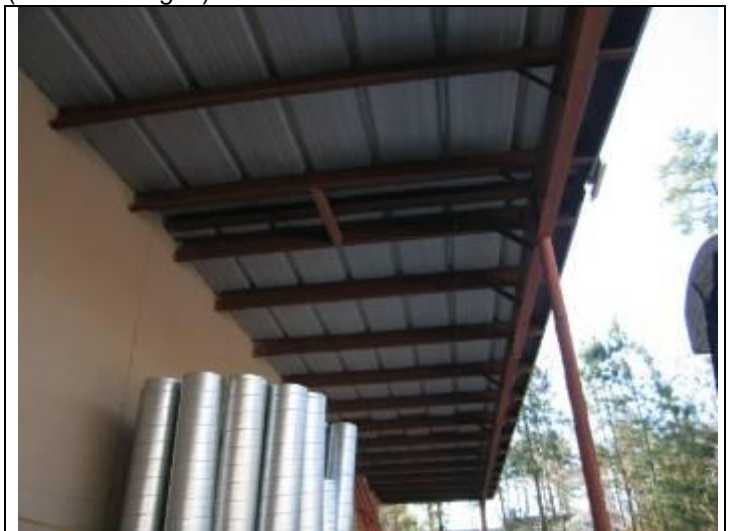
16. Canopy framing in good condition – some loose metal trim at upper right

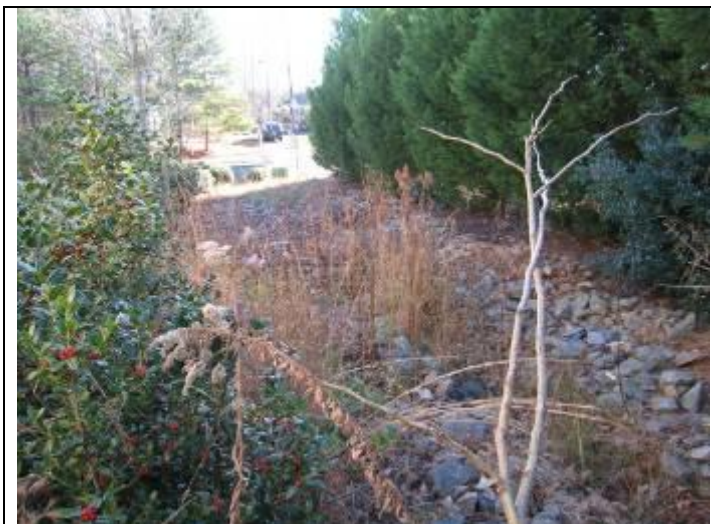
17. Rip-rap lined drainage ditch at south parcel border and parallel to south building elevation

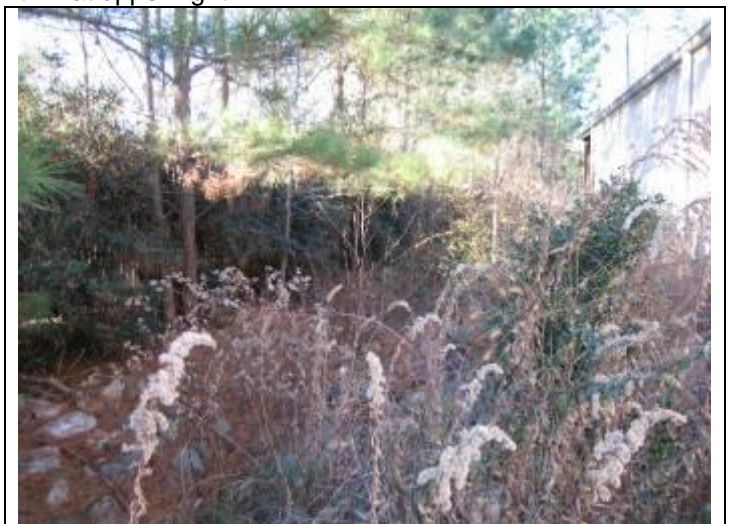
Landscaping	Landscaping is provided along the site and building perimeter areas. Landscaping consists of grass-surfaced lawn sections, trees, and shrubs in planter areas. The level of landscaping appears to be appropriate for an industrial building. The area at the south parcel border adjacent to the drainage ditch is overgrown – see Site Drainage for	Good to Fair

18. Overgrown conditions between building in drainage ditch

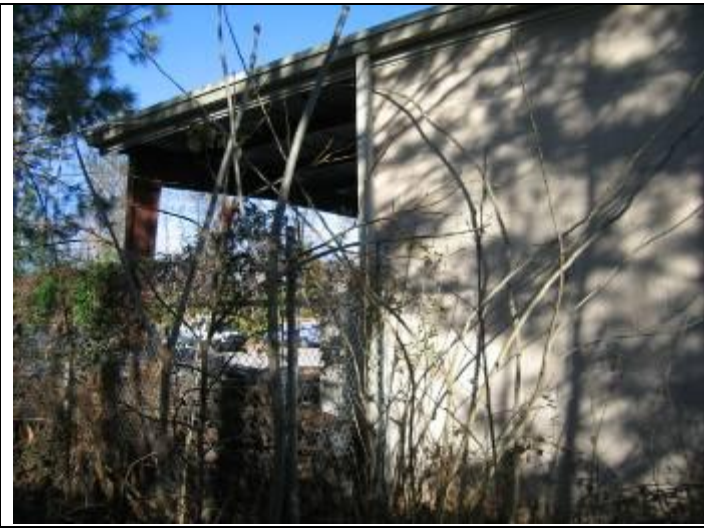
19. Additional view of vegetation at south elevation

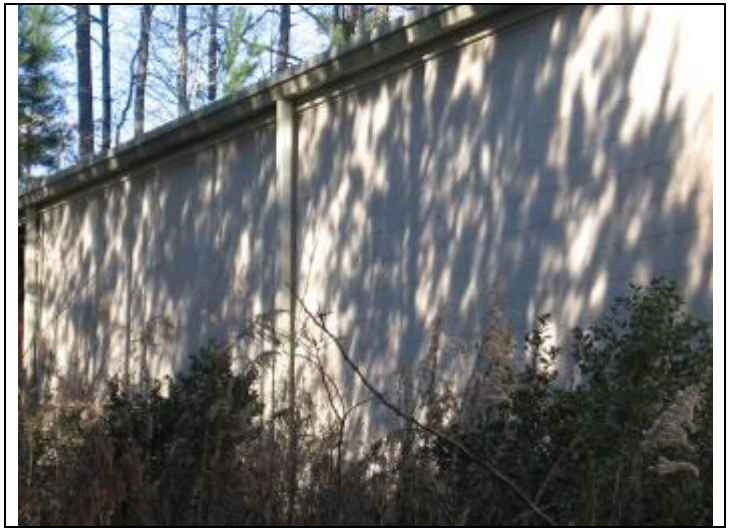
20. Area of wall separation/settlement

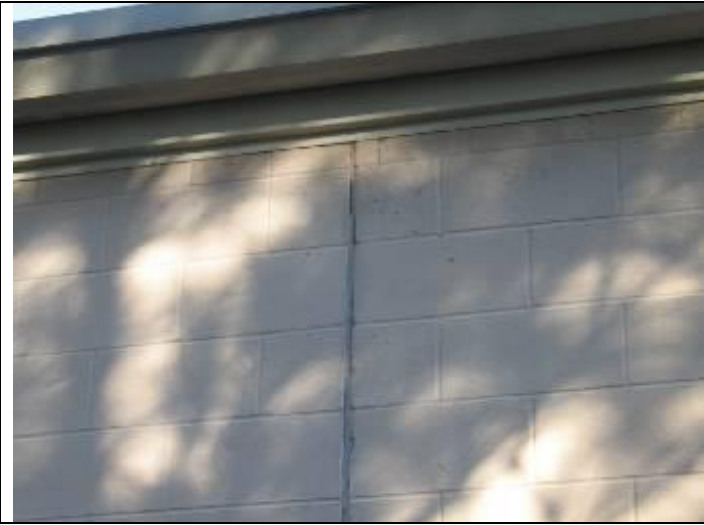
<b>Wilbur's Widget Manufacturing Building</b>		
Decks & Balconies	None present.	N/A
Expansion Joints	Expansion joints noted in the CMU exterior walls was noted in good condition at all but the south elevation where it requires replacement due to separation and cracking	Good to Poor
Stair Structure	None present.	N/A
Railing & Guard Rails	None present.	N/A
Parking Structure	None present.	N/A
Carport Structure	None present.	N/A
Equipment Supports	None present.	N/A
<b>3.4 Building Exterior – ROOF</b>		
Roof Access	None Provided	N/A
Roofing System	The roof membrane assembly consists of Standing-seam metal – no leakage evidence noted or reported.	Good
Insulation	The roof insulation beneath the roof assembly appears to be vinyl covered sheet that is supported by the “z” channel	Good
Active Leaks	No active leaks were reported and none were known to exist.	N/A
Parapets	A single parapet wall is installed along the front or east elevation.	Good

Control & Expansion Joints	Caulked joints between CMU panels were generally in good condition. Some separated/cracked joints were observed at the south elevation. These should be addressed as part of	Fair to Good

21. Separation of south elevation expansion joint

<b>Wilbur's Widget Manufacturing Building</b>		
	<b>suggested repairs, if any, stemming from a possible additional review by a structural/soils professional.</b>	
Trim & Details	None present.	N/A
Sealants	Information was not provided regarding whether the paint finish included a sealant application.	N/A
Thermal Insulation	According to the supplied drawings, wall insulation consists of fiberglass batts installed between metal studs	N/A
Glazing Systems/Windows	Front office areas have fixed windows with dual insulated glazing.	Good
Doors & Frames	Exterior doors include glass storefront type entrance doors with dual-glazed tempered glazing in aluminum frames. Other exterior doors are painted metal doors in metal frames. Loading docks have overhead roll-up metal doors.	Good
Window and Door frame caulk	<b>Caulk at several window frames at the north elevation was noted deteriorated or damaged and should be replaced immediately to inhibit stormwater entry to the wall cavities adjacent.</b>	<b>Good to Poor</b>

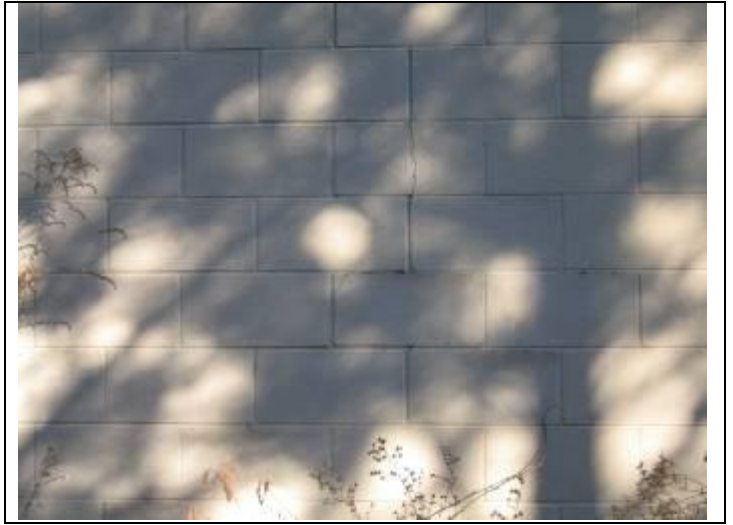
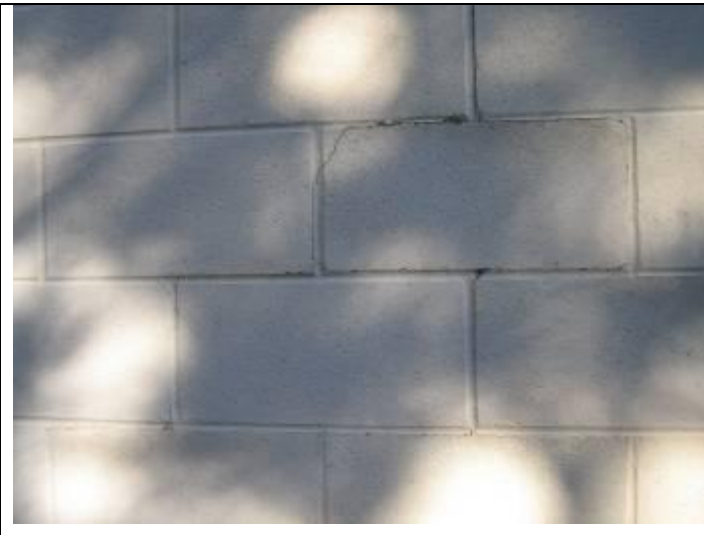
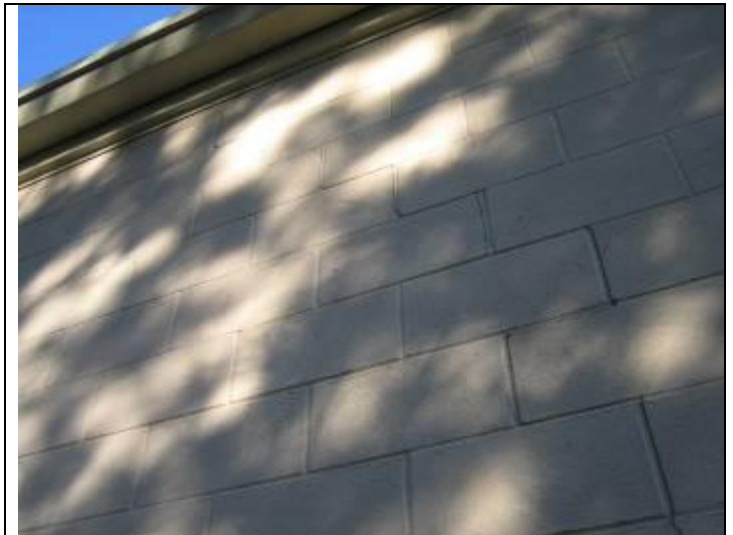
22. Through-block and stair-step cracking at south elevation

23. Through-block and stair-step cracking at south elevation

24. Through-block and stair-step cracking at south elevation

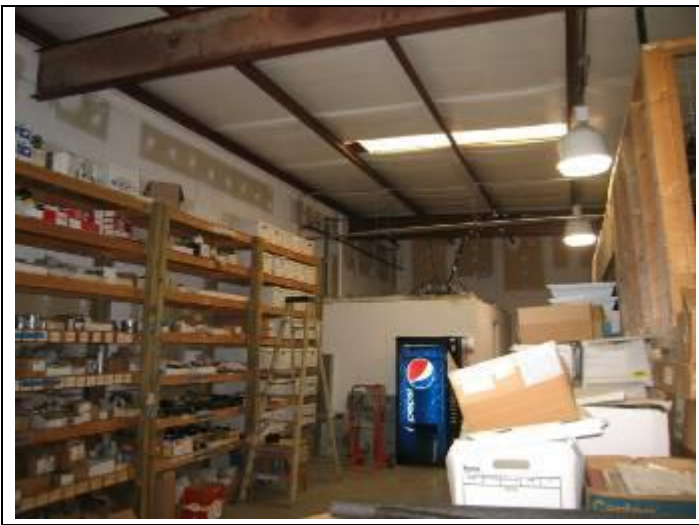
25. Canter Electric storage area adjacent to south elevation wall

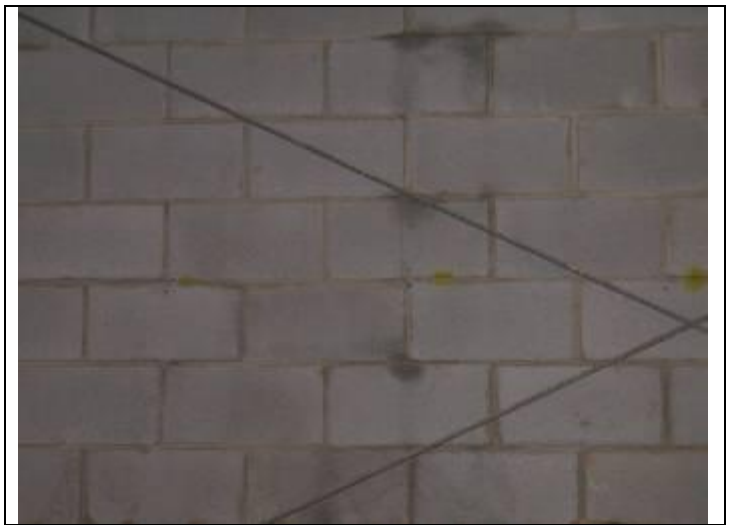
26. South elevation wall interior view with cracking through block at upper center and continuing in stair-step

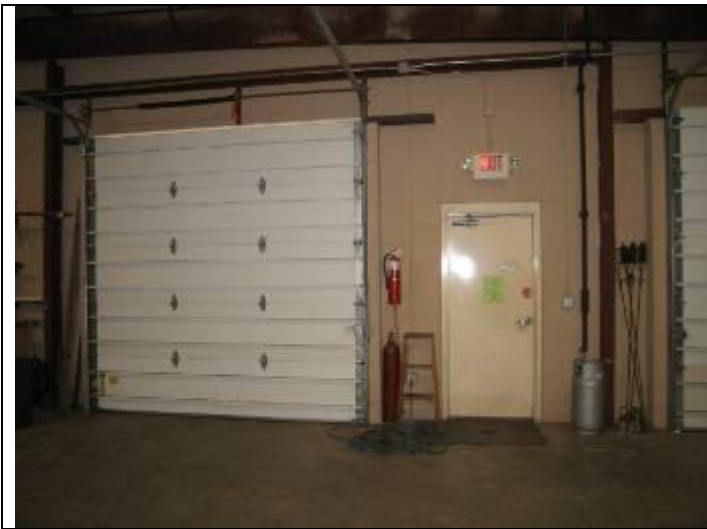
33. Warehouse/loading bay and rear service doors – fire extinguisher current

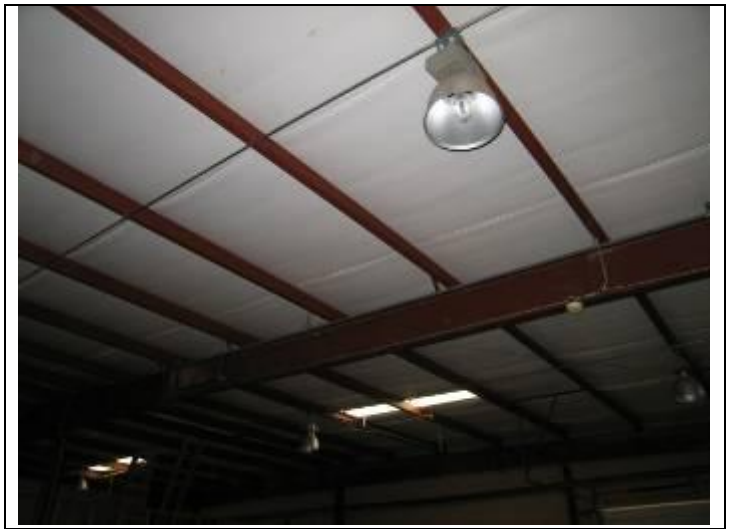
34. Warehouse area steel framing and HID lighting – insulated roof deck

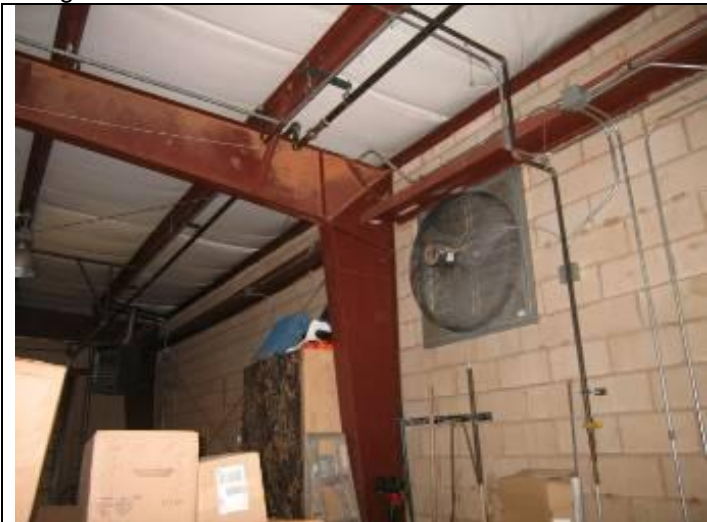
35. Warehouse area steel framing detail and exhaust fan at north wall

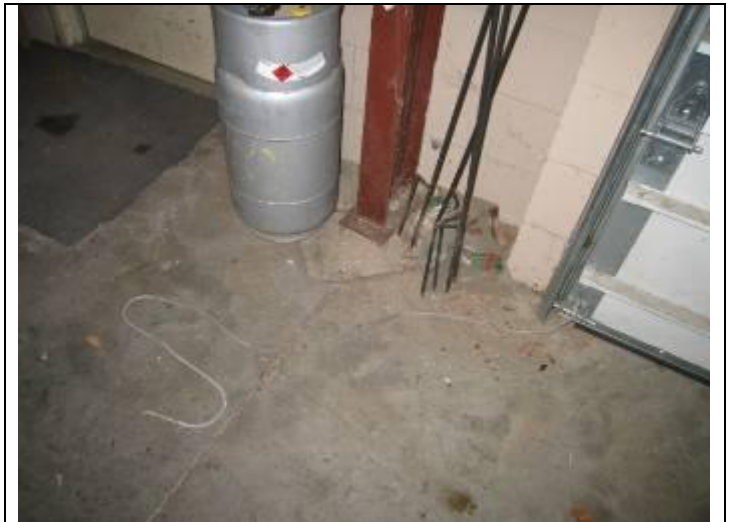
36. Structural columns with isolated foundations

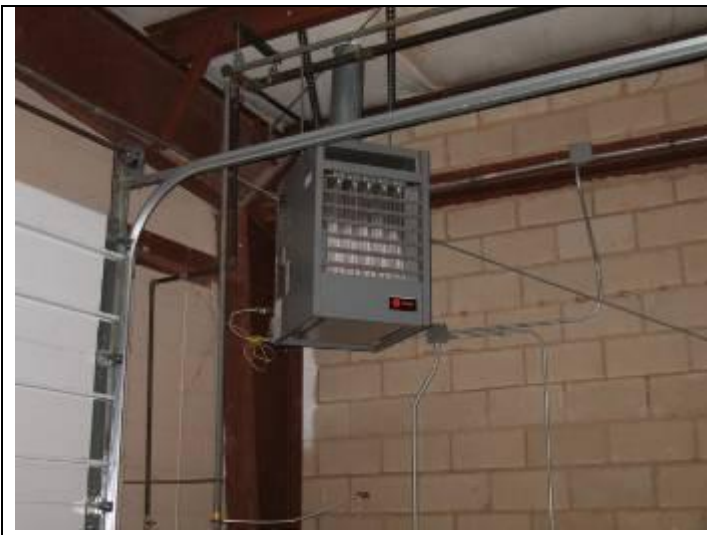
37. Natural gas fired space heater (gas supply design capacity is for two heaters per construction drawings)

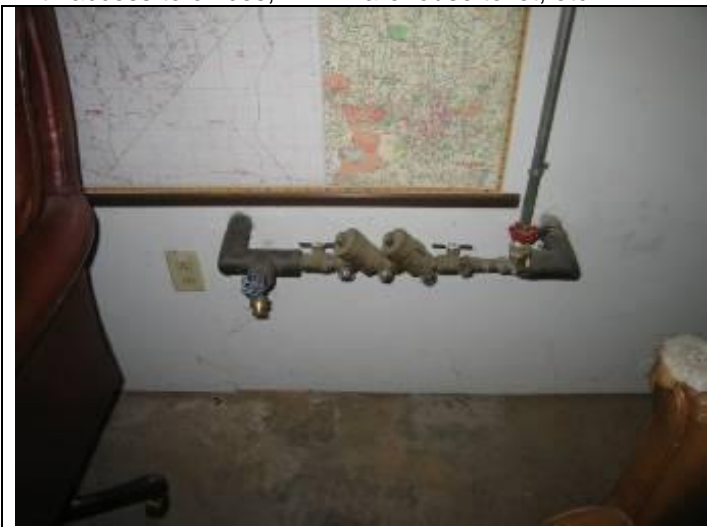
41. Water supply shut-off with back flow prevention

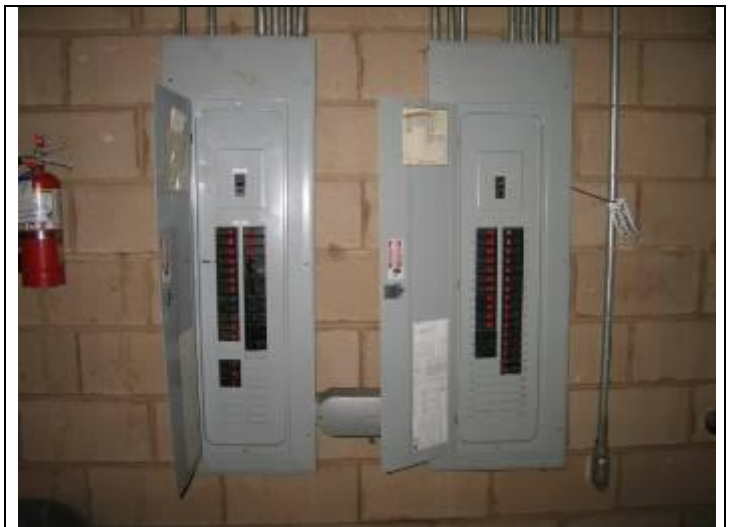
42. Twin main service panels at Wilbur's Widget Mfg. with 200 ampere maximum buss ratings per panel and 225 ampere main breakers installed.

<b>Wilbur's Widget Manufacturing Building</b>		
	breakers installed as specified in the construction plans. Armco recommends examination of this installation by an independent electrical contractor to assure proper matching of the main breakers specified and installed with the panel design maximums.	
Wire Type	The wiring in the facility was not directly observed. The construction plans indicate that copper branch wiring (120vac) should be installed.	Good
Exterior Lighting	The site lighting was accomplished through building mounted metal halide lights. The site lighting levels were observed and appeared to be adequate.	Good
Interior Lighting	The office areas were illuminated with fluorescent light fixtures. The warehouse areas were provided with high bay HID light fixtures. The lighting levels were observed and appear to be adequate.	Good
Emergency Power Service	An emergency power system is not present.	N/A
