## Inspection Report

# Bilco Renovations LLC

**Property Address:**  
2001 Widget Central Drive  
Walnut Cove ND 27499

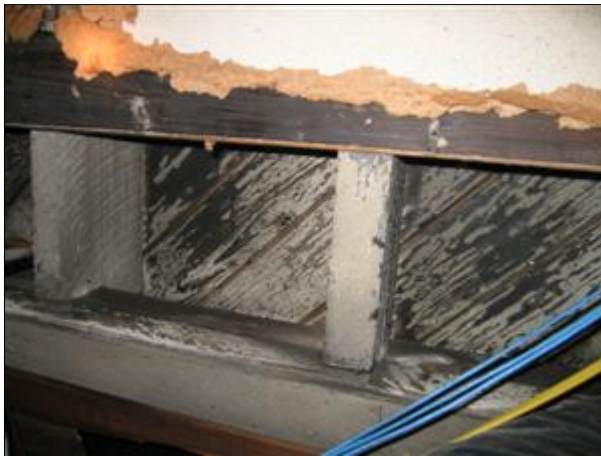
1.0 Picture 1

Photograph number one shows framing and subfloor above one basement closet that appears to be covered with organic growth. In this case the growth (if existing) is a result of high levels of moisture and poor ventilation in the closet.

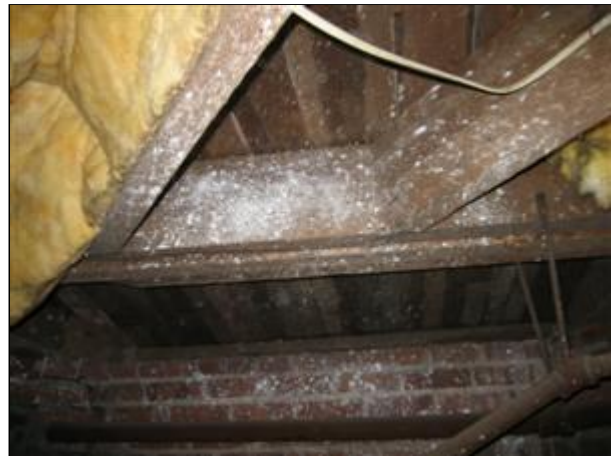
1.0 Picture 2

Photos 2,3 show areas of the main crawlspace that are similarly discolored and may contain organic growth of significant levels. Recommend additional evaluation to determine the composition of the discoloration with remedies as may be required.

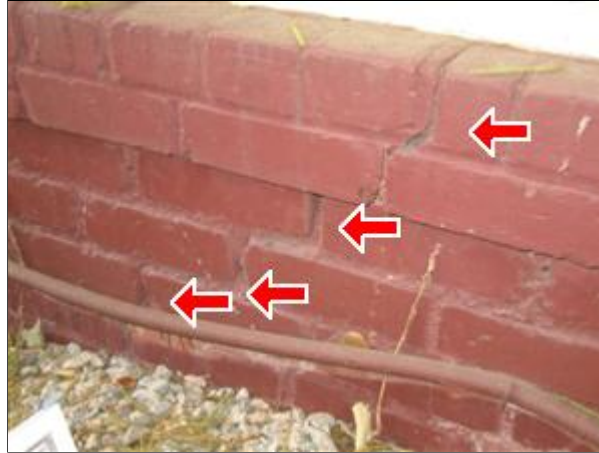
1.1 Picture 1

Stairstep cracking was noted in several locations especially at the left side elevation. These cracks appear to be old in that paint was noted inside the crack. Recommend observation over time of these cracks for possible widening which I consider to be unlikely. In the event of significant wall shifting I recommend consultation with a structural engineer for corrective or preventive action. See section 2.6 for comment regarding soil grade and storm water control.

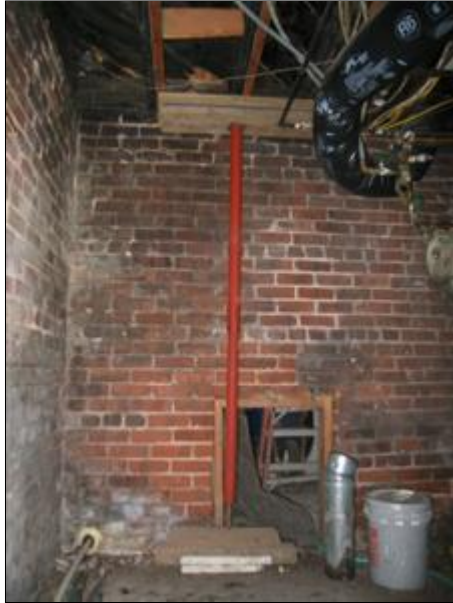
1.2 Picture 1

Some of the fire damaged floor joists have been provided "sisters" for reinforcement. In addition, screw jacks have been provided to support the ends and middle sections of some of the floor joists. If the screw jacks are structurally necessary, they are improperly installed. I cannot determine if the supporting girder at the opposite end of the joists supported (photo 1) contains the necessary strength to adequately support the floor and what may be load bearing walls directly above (girder shown in photographs 2-4). I recommend evaluation of this area by a North Dakota registered engineer with a structural specialty to determine if the girder and associated floor system is adequate for the building load and if not, repaired as as will be necessary to restore the original design intent.

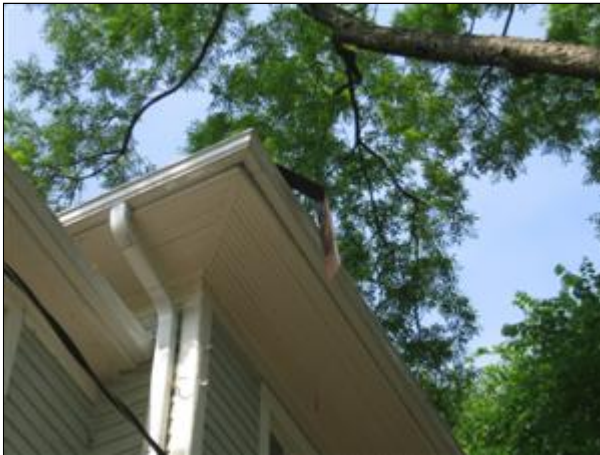
2.0 Picture 1

The tongue and groove bead board soffit material appeared to be in good condition all around the house. One possible area affected by roof leakage was noted at the left side (as viewed from the rear lot) of the left side rear chimney (as viewed from the street). I could not determine if active leakage is occurring. I saw no evidence of leakage from within the attic or from within the room located at the second floor left rear (ceiling).

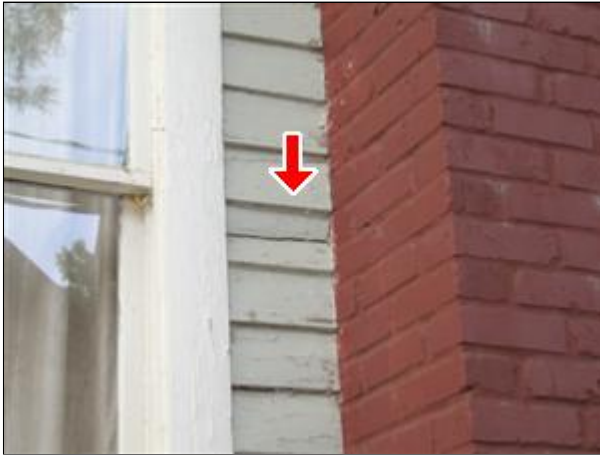
2.1 Picture 1

(1) Deterioration of the exterior wood lap cladding finish was noted at the left side elevation more so than anywhere else. This condition is assumed to be due to increased exposure to storm conditions as well as shading. One or two areas of cracked plank were noted as well as peeling paint that has exposed the underlying wood. If these conditions are not corrected and ongoing pro-active maintenance provided, additional deterioration will occur.

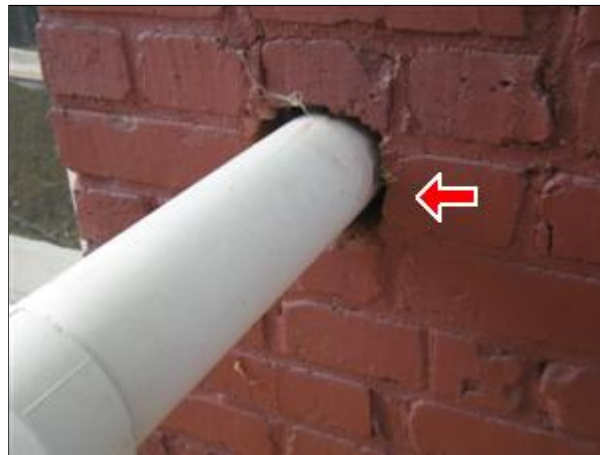
2.1 Picture 3

(2) Points of entry of exterior air and insects should be sealed - this includes wall cracks in areas around windows and doors.

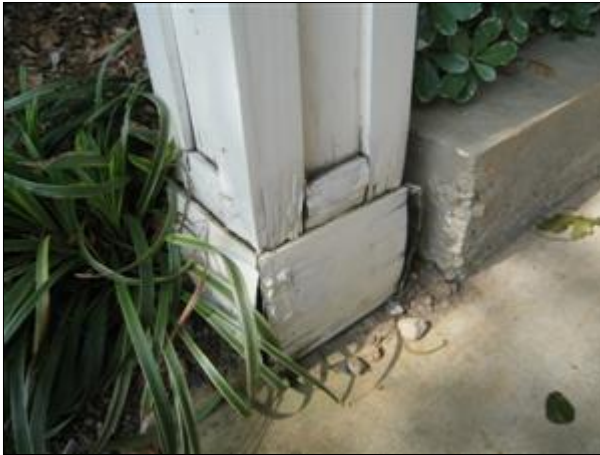
2.1 Picture 4

(3) Column trim damage was noted at the extreme right rear of the house as shown in the photograph. This damage is a direct result of moisture absorption from the adjacent mulched area which is in direct contact. None of the other columns in this area exhibited trim damage of this type. Recommend complete separation of soil from wood construction of any type (unless the wood has been treated for ground contact). Also recommend sealing of the wood trim at all exterior columns on front and rear porches and decks (photos 2,3)

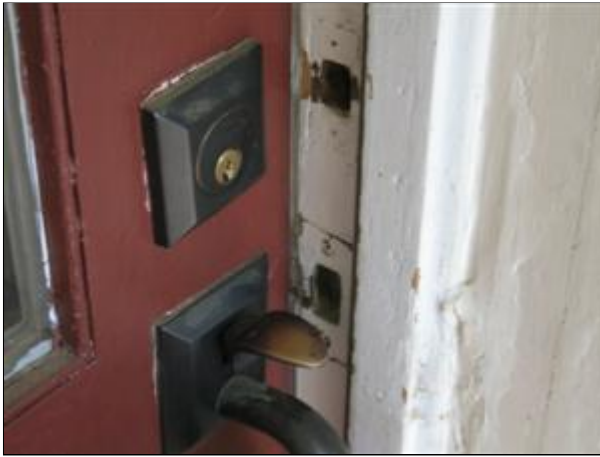
2.2 Picture 1

Weather strip provided on this door is improperly installed or missing. Weather strip on the front entry door from the front porch is missing weather strip altogether.

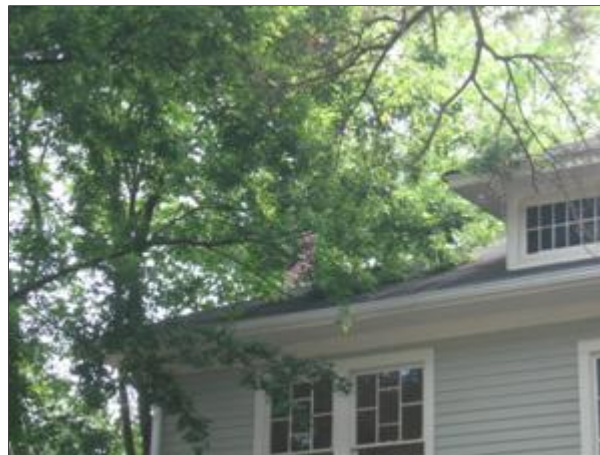
2.6 Picture 1

(1) Tree limbs that are in contact with roof or hanging near roof should be trimmed to decrease the chance of shingle damage during storm conditions. The photograph is typical.

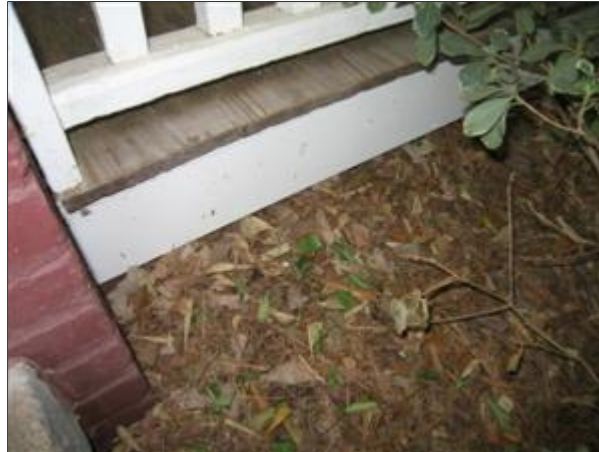
2.6 Picture 2

(2) The soil/mulch and/or vegetation at the front of the building is near the porch floor framing. This condition can lead to water intrusion and damage to the wall framing and siding (if wood). It can also lead to insect intrusion and subsequent framing damage. Recommend keeping the leaves, grass and soil at least six inches below the siding where possible.

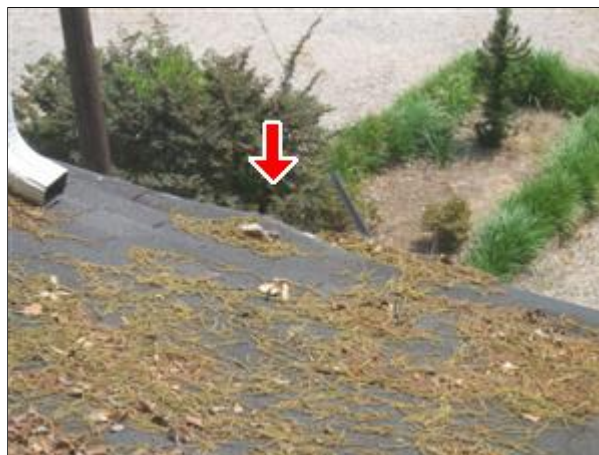
3.0 Picture 1

One small section of asphalt shingle appears to be out of position adjacent to the gutter above the second floor rear deck.

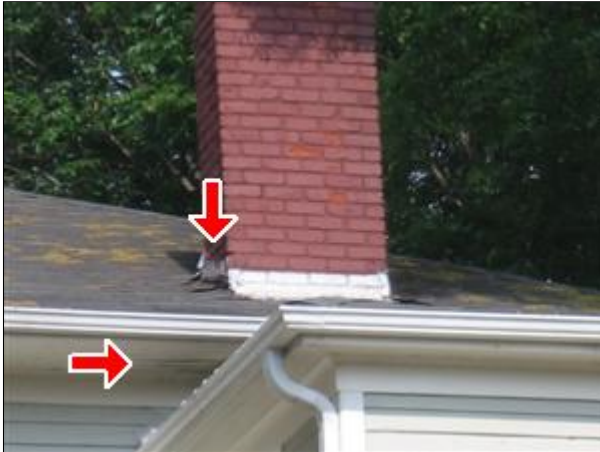
3.1 Picture 1

The flashing may be improperly installed at this chimney located at the left rear of the house. Moisture stained soffit material appears to exist immediately below the area of concern. Recommend additional examination by a roof professional to ensure flashing integrity.

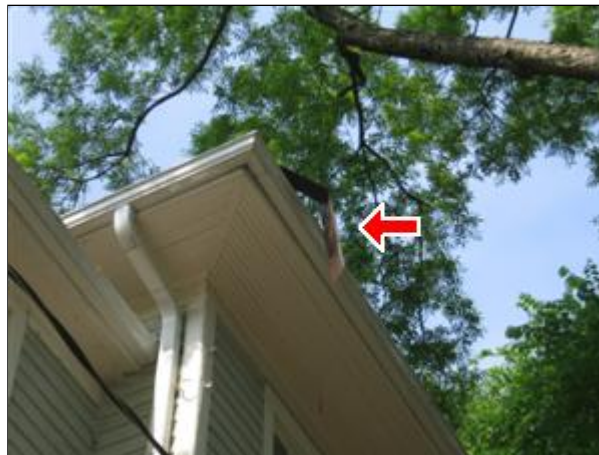
3.3 Picture 1

One section of gutter guard appears to be out of position at the left rear corner of the building.

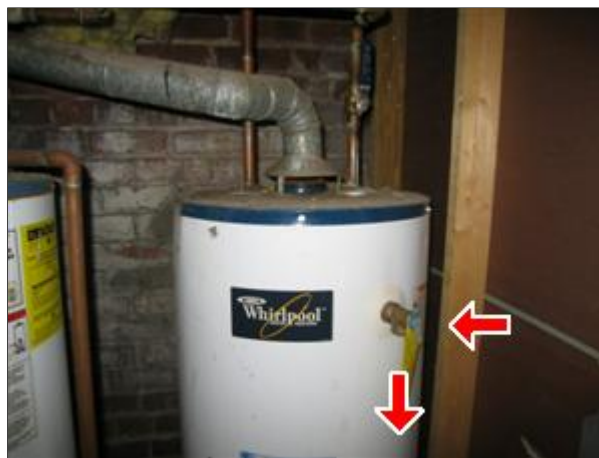
4.2 Picture 1

- (1) The hot water heater located in the basement utility area was off at the time of inspection (known natural gas supply) and could not be tested for fully proper operation.
- (2) The temperature/pressure relief valve on the water heater needs a 3/4inch pipe to extend within 6 inches of floor for safety.

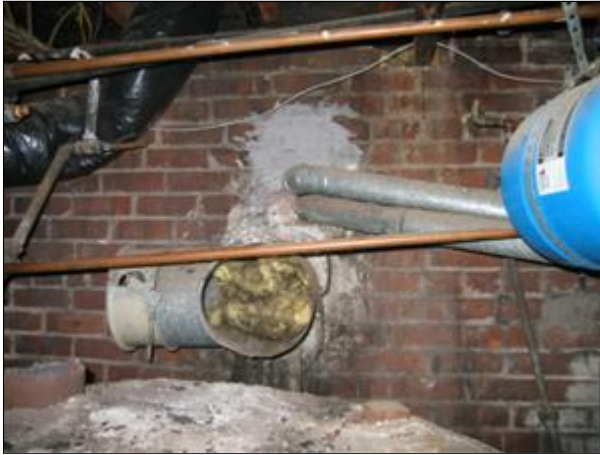
4.2 Picture 2

(3) The water heater discharge flue is connected to a chimney system that originally served natural gas or coal fired boiler or furnace which has been removed. The original flue in the chimney was sized to accommodate both the water heater and the furnace or boiler and as such may be significantly oversized for the water heater alone. This condition is called and "orphaned" water heater and may result in inadequate draft for the water heater to operate properly. I saw no evidence of flame rollout (stained or burned finish) on the water heater shell or products of combustion (corrosion, etc.) at the exterior of the flue. In any event, I recommend examination of this water heater for proper operation by the same HVAC professional that corrects the deficiencies with the furnace located in the attic.

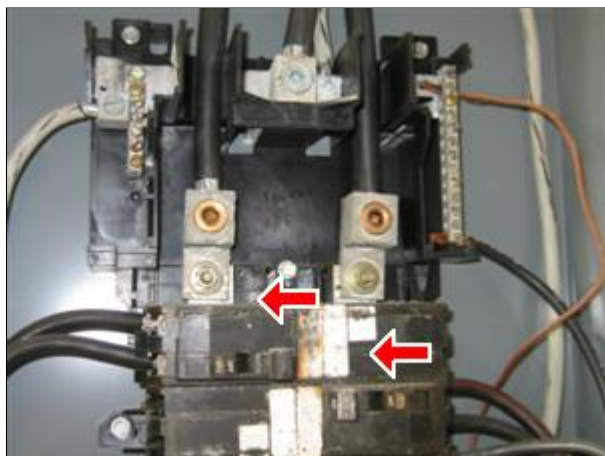
5.1 Picture 1

- (1) Some evidence of elevated moisture levels was noted at the main service panel at the left side elevation utility meter. Recommend examination of the enclosure for points of entry of moisture with repairs as may be necessary.

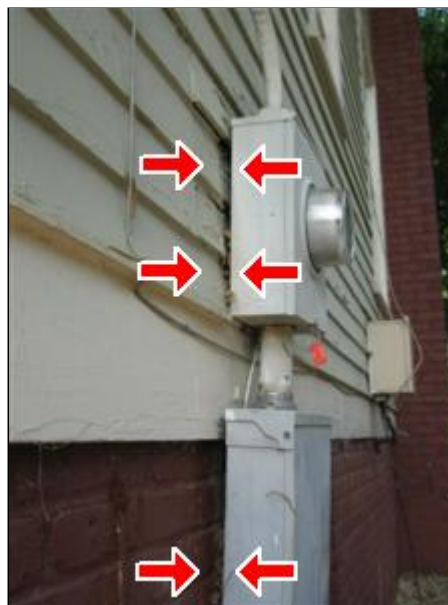
5.1 Picture 2

The meter base and service panel assembly is loose at the wall mounting points as indicated in the second photograph. It is possible that service panel moisture intrusion is occurring through the rear mounting holes.

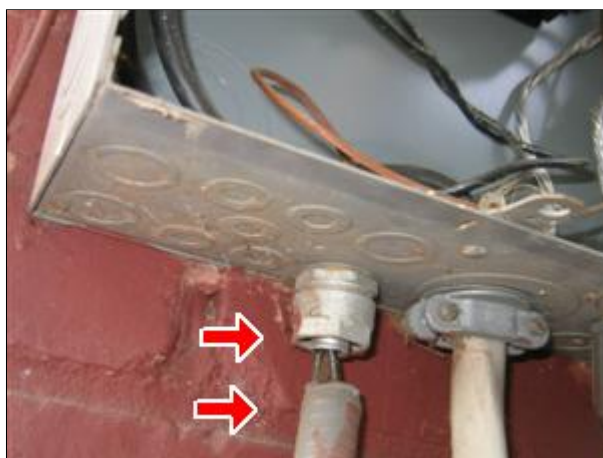
5.1 Picture 3

(2) A waterproof flexible conduit was noted loose at the bottom surface of the main service panel at the utility meter. The conduit should be reconnected to the fitting to protect the internal conductors from stress and possible disconnection.

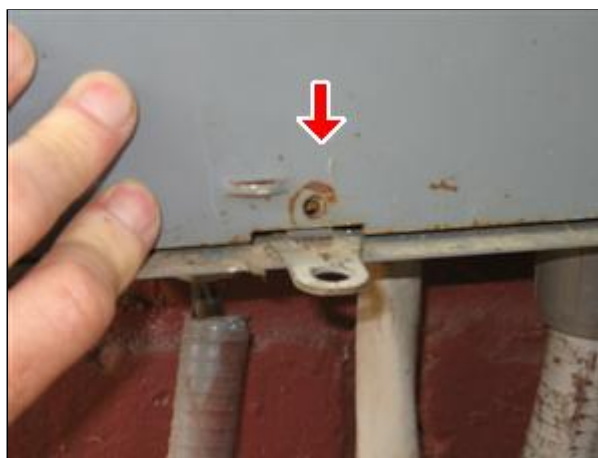
5.1 Picture 4

All three of the main service panel dead front panel mounting screws are missing and should be replaced for safety - photo 2

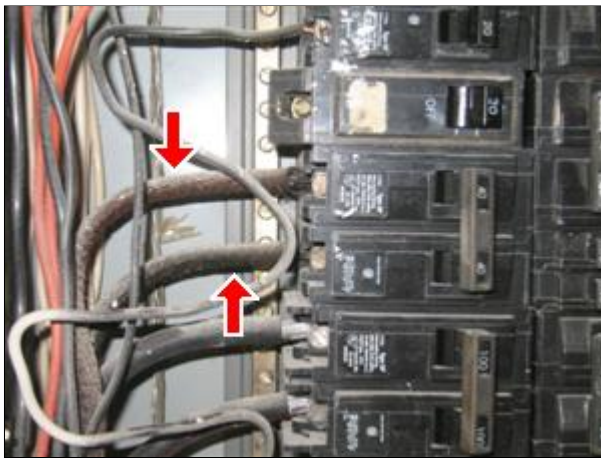
5.1 Picture 5

(3) The grounding conductor for the two pole circuit shown in photos 1-2 is improperly connected to the neutral bar in the sub panel located at the first floor left side rear kitchen utility room. This conductor should be relocated to the enclosure bonded grounding bar at the right side of the enclosure

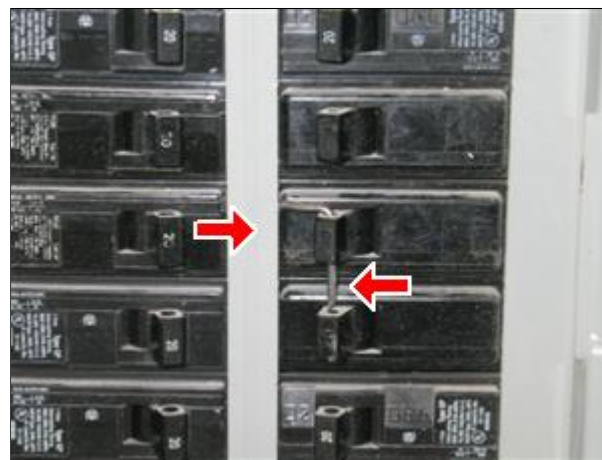
5.1 Picture 7

The third photograph shows a circuit breaker handle sporting a staple. **This staple was effectively preventing tripping or proper action of the circuit breaker** affected as it was trapped beneath the center section of the dead plate (when first observed). Recommend examination by a qualified electrician to determine the possible reason for the presence of this device and removal if none can be found.

observed). Recommend examination by a qualified electrician to determine the possible reason for the presence of this device and removal if none can be found.

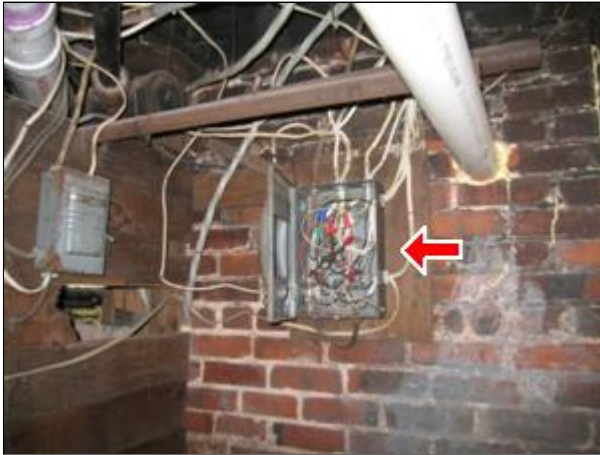
5.2 Picture 1

Splices for branch circuit wiring were noted exposed at this old circuit breaker or fuse panel in the basement utility room as well as a number of open junction boxes in the basement utility area in hallway as well as the second-floor attic area (at least five locations). Cover plates should be provided to protect the wiring and splices in every case according to current commercial standard.

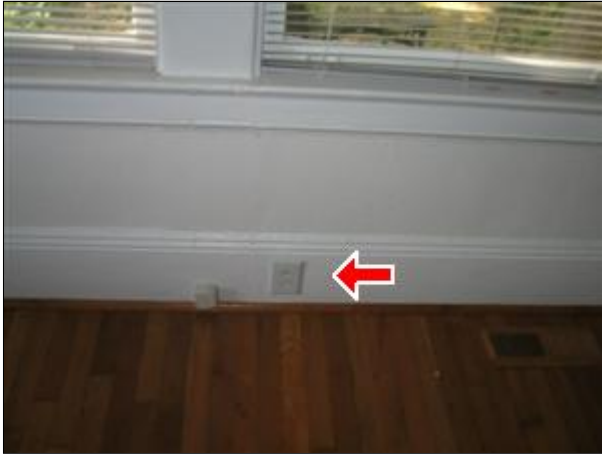
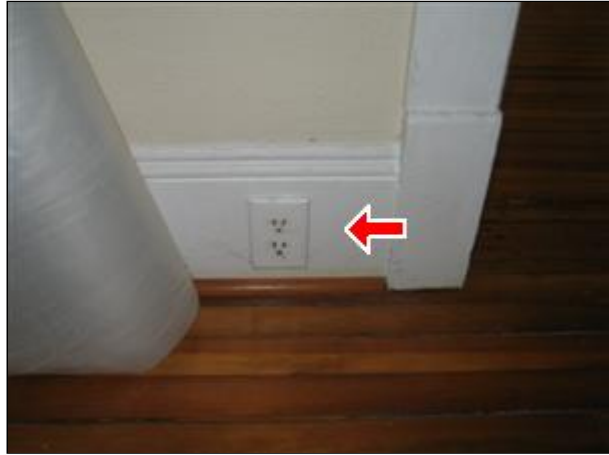
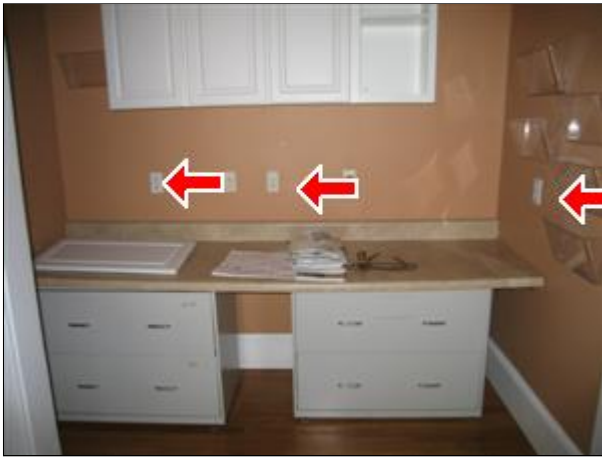
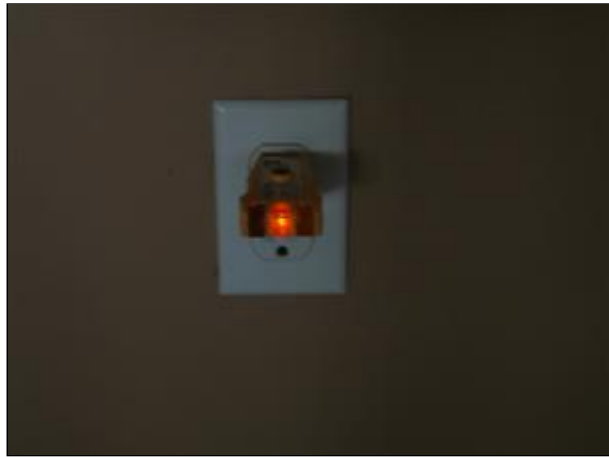
(1) Many three prong (grounding) receptacles are wired without a ground throughout the building. The outlets need to be grounded or replaced with two-prong (non-grounding) receptacles for safety.

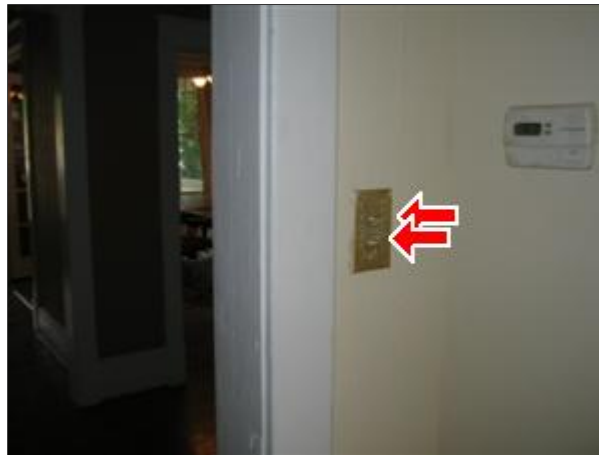
5.3 Picture 5

(2) The purpose of some wall switches want not determined - recommend asking the seller for clarification.

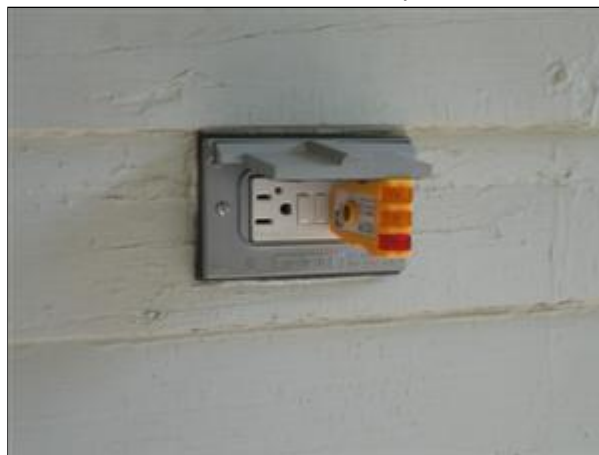
5.5 Picture 1

This GFCI receptacle located at the rear second-floor deck did not operate when tested (no power).

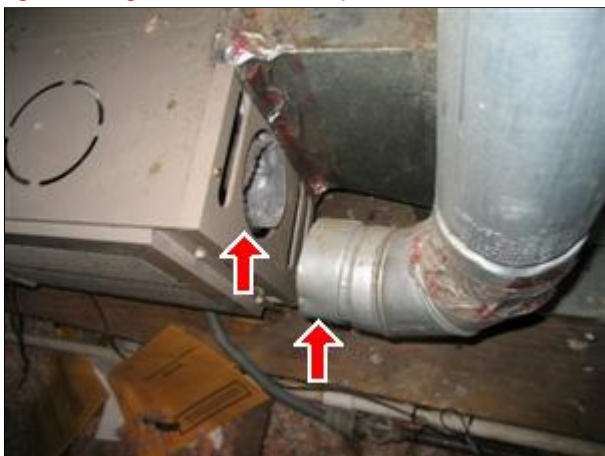
6.3 Picture 1

The discharge flue for the second floor attic natural gas fired furnace is disconnected at the furnace enclosure. Repairs are required prior to furnace operation to prevent products of combustion including carbon monoxide and water vapor from being discharged into the attic space. This condition is also possible fire hazard.

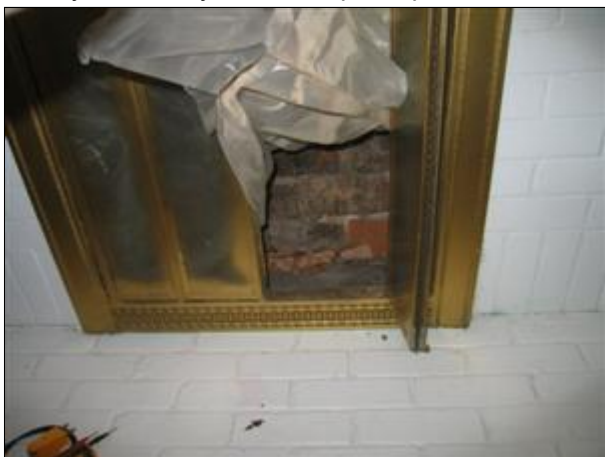
6.6 Picture 1

View of typical coal burning fireplace (4 total). These units appear to have been decommissioned as the flues are plugged with newspaper or the equivalent. "Chimney balloons" or the equivalent are available commercially for this purpose and can be installed by a nonprofessional person. Prior to to operation of any of these fireplaces I recommend examination by a chimney and/or fireplace professional.

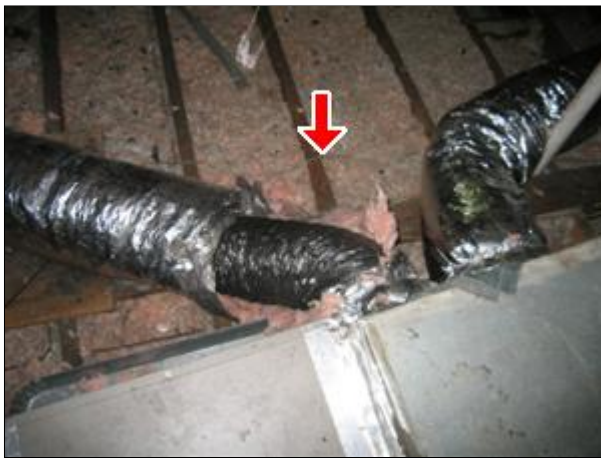
7.2 Picture 1

Significant conditioned air distribution duct damage was noted in the second floor attic space as shown in the photographs. In some cases the outer insulation jacket is compromised, and in other cases the duct is open to the attic and conditioned air is being lost in significant quantities (photos 2-3).

The above conditions cause significant energy loss to the attic well as possible condensation formation in the attic during the winter.

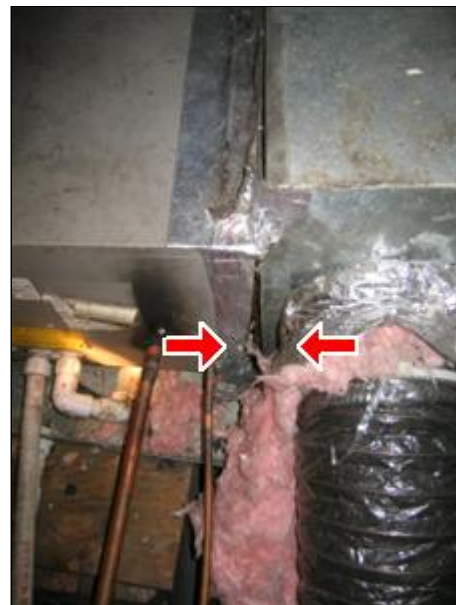
7.2 Picture 4

In addition to the above, separation was noted between the evaporative coil housing and the discharge duct plenum chamber - photo 4

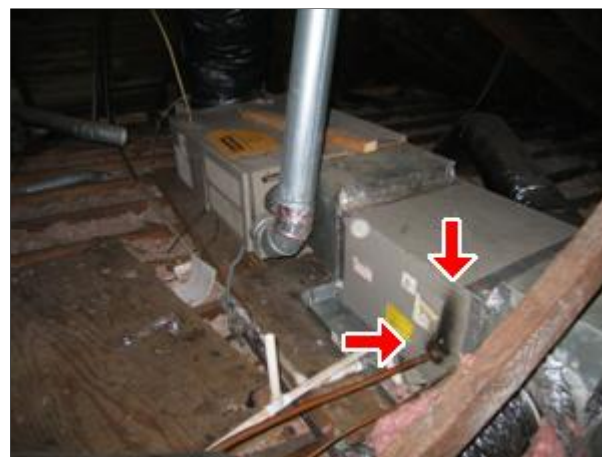
7.2 Picture 5

Photo # 5 shows air patterns on the side of the evaporator coil housing to indicate air leakage at the point of entry of the refrigerant lines.

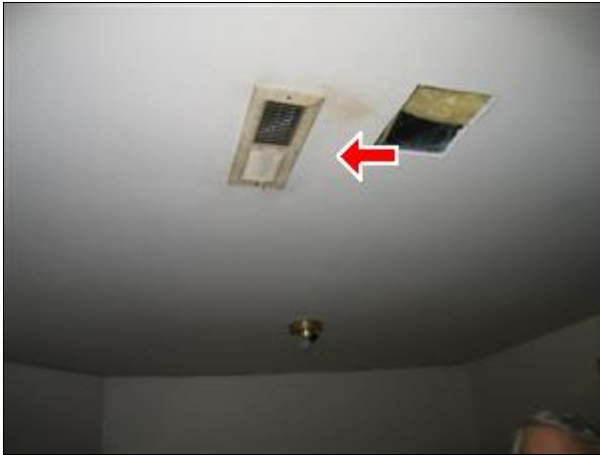
7.3 Picture 1

No airflow was noted from the ceiling register at the right side rear basement "storage room." No airflow was also noted at the right side rear office - activity room rear floor register on the first floor. It is possible that these two issues are related.

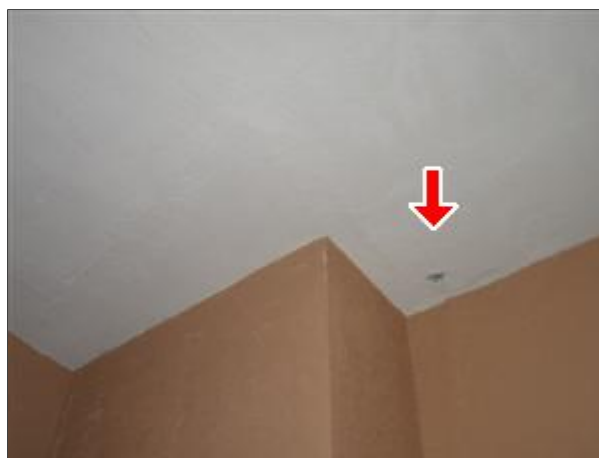
8.0 Picture 1

(1) Minor ceiling damage was noted adjacent to the chimney chase at the first floor left side rear utility area. This damage may be due to prior flashing storm water leakage as indicated may be possible in section 3.1 (see section 3.1 for recommendation)

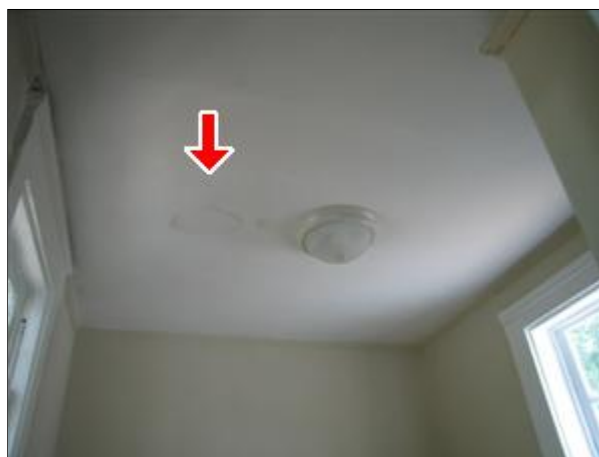
8.0 Picture 2

(2) Ceiling stains were noted at the second floor left side rear storage room adjacent to the light fixture. It is possible that the chimney flashing for the chimney noted in section 3.1 is also responsible for this stain (see section 3.1 for recommendation).

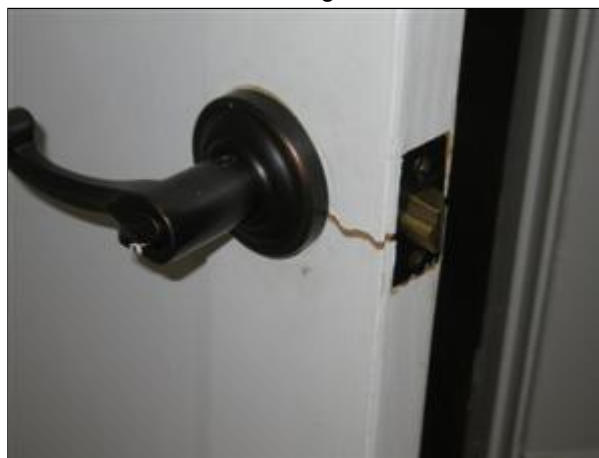
8.5 Picture 1

This second floor bathroom access door is split in the area shown. The door appears to rub the door frame during operation resulting in excessive force in the area of the damage.

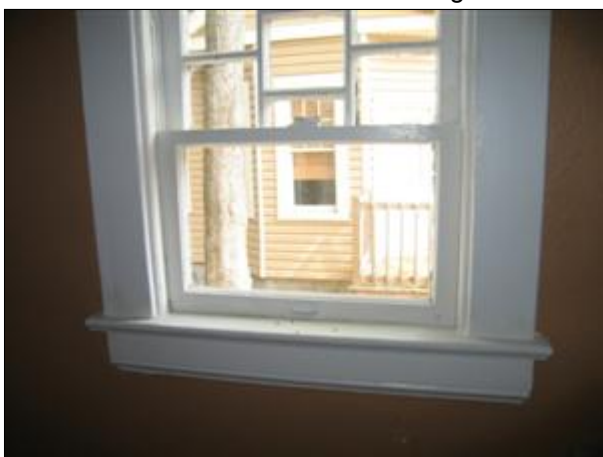
8.6 Picture 1

Some of the windows are painted shut and not movable and some could be satisfactorily tested. Many of the windows or original and utilize sash cords and window weights for ballast or balance.

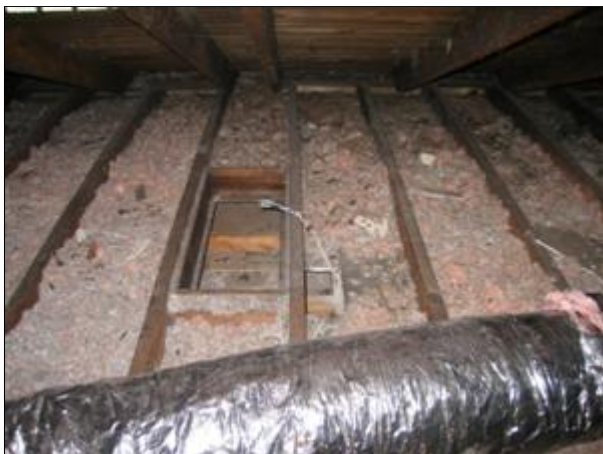
9.0 Picture 1

(1) On the second floor there are two areas where the ceilings are at lower levels than the balance of the floor. In these two areas insulation levels are approximately 0. This condition seriously compromises the R-value of the entire second floor ceiling. Recommend review and recommendation by a qualified insulation professional for adequate second-floor insulation and air sealing.

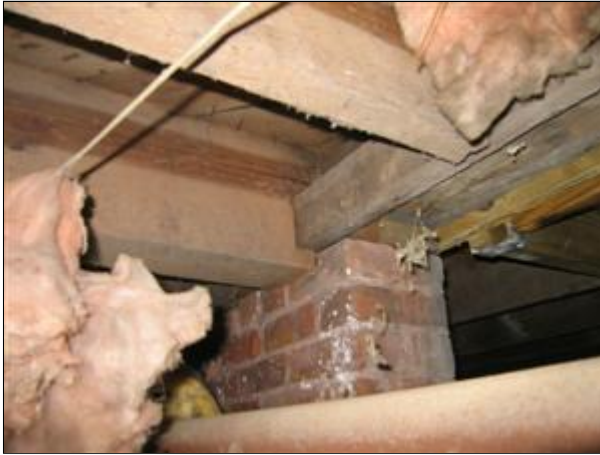
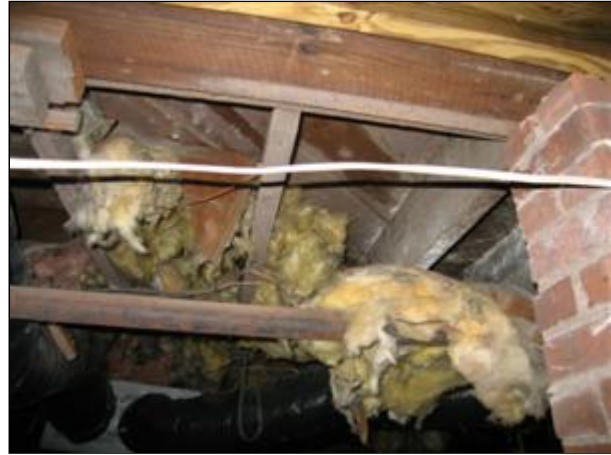
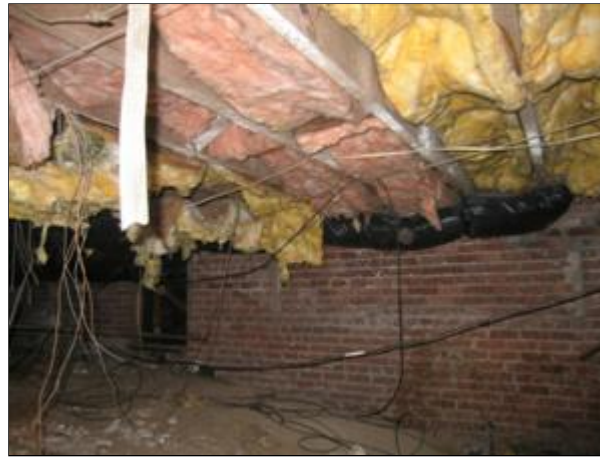
(2) Missing, down and otherwise damaged insulation was noted above the crawlspace across the front of the building. The images are typical.

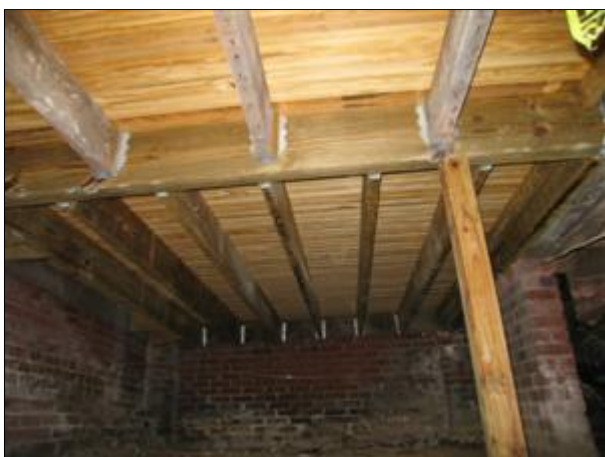
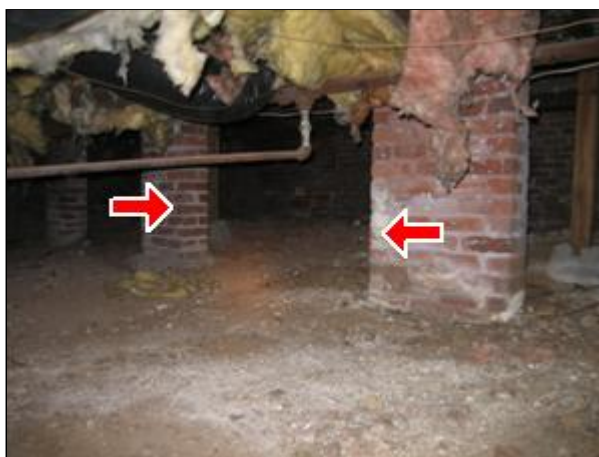
(3) Vapor barrier plastic is installed in approximately 0% of the crawl space. Properly installed vapor barrier inhibits moisture entry into the crawl space air from the soil and possible subsequent framing damage. I saw no evidence of moisture induced framing damage in this crawl space. I also recommend some type of effective sealing or separation of the front porch crawlspace area from the crawlspace area beneath the "living space" of the building. At the present time, brick piers with large open gaps serve as the separator between the porch area and main crawlspaces. The area beneath the front porch will always have elevated levels of moisture even if the soil is covered due to moisture migration through the porch floor boards and around the porch perimeter framing.

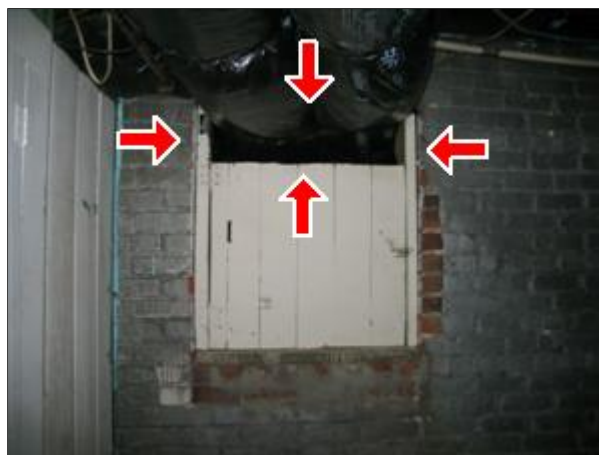
9.1 Picture 1

(1) The interior of this house or building is very effectively coupled to the atmosphere of the crawlspace through the opening shown in this photograph even if all other floor or wall penetrations at access this crawlspace area have been completely sealed. As such any "stack effect" or other natural phenomenon or event that results in depressurization of the house will cause air from this crawlspace to be drawn into the occupied areas of the building. In addition to effective sealing of the upper levels of the second floor, I recommend some method of effective sealing in this area (shown in photo) as a first priority. Treating the first floor basement access door as in exterior door with proper fit and weather strip, etc. is also strongly suggested.

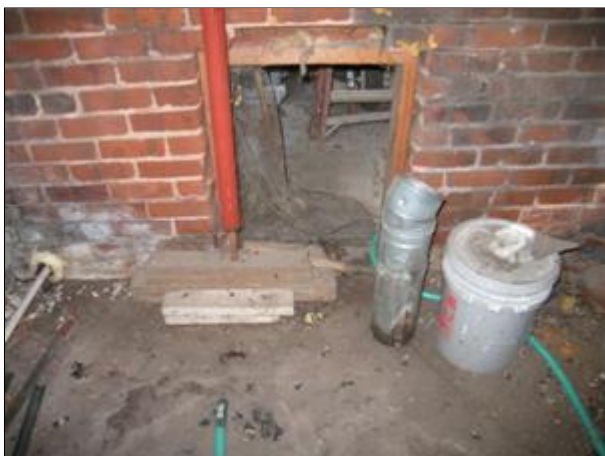
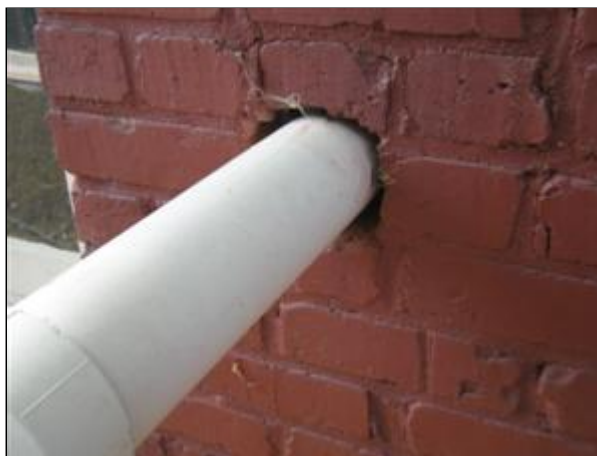
(2) In a fashion and with consequences similar to that suggested in tab 1 of this section, the interior of this building is also effectively coupled to the exterior through this hole in the exterior wall that leads to the rear storage shed. Recommend completely sealing the hole to prevent air passage into the basement area. If insulation of the sealed area is to be considered, it should be extruded polystyrene or the equivalent due to the proximity of ground moisture.

Likewise, and for the same reasons, I suggest sealing all wall penetrations in the lower floors that allow air leakage (at furnace flue, etc.).

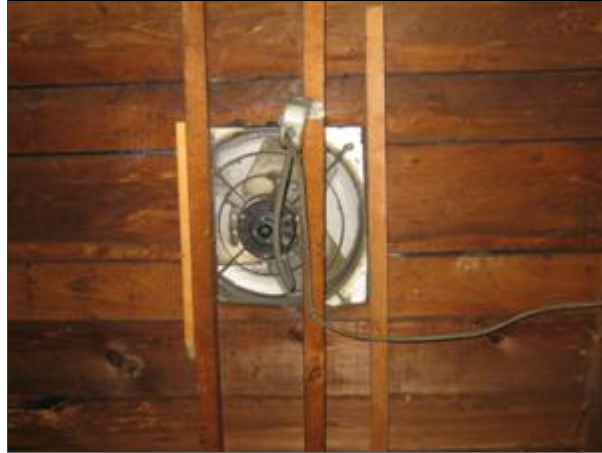
9.3 Picture 1

The thermostatically controlled fan was too high to reach and test in the attic. Given the geometry and original ventilation style of this attic (no soffit vents other than leakage between the boards), it is unlikely that this fan, if operable, is particularly effective. Recommend eventual evaluation of the attic space by an HVAC or insulation professional or recommendations regarding effective ventilation.
