PROPERTY CONDITION REPORT

Wilbur's Most Excellent Mall

2456, 2460, 2465 Nevada Beach Drive
Phoenix, Nevada 29887

ARMCO Project Number 12-0909.1

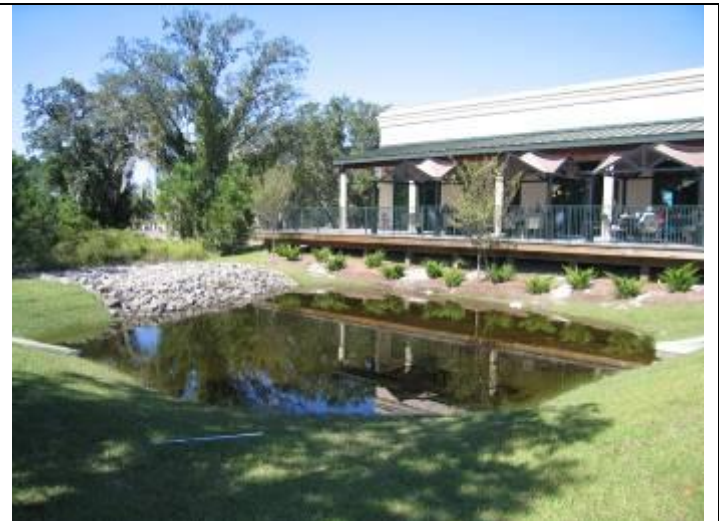
Drainage for the site appears to be adequate with one exception. Armco noted that the retention pond construction at the north parcel boundary behind building 2465 is not complete and is not functional. Water flow into the pond area has been intentionally diverted as can be seen in one photograph (see photos 20 and 21). In addition, the current construction site poses a safety hazard to persons (kids, elderly, derelicts, etc) that could accidentally fall over the wall into the excavated area (there is no fence or other restraining device). This issue is included in the immediate needs table.

6. Building 5954 rear area view / retention pond system

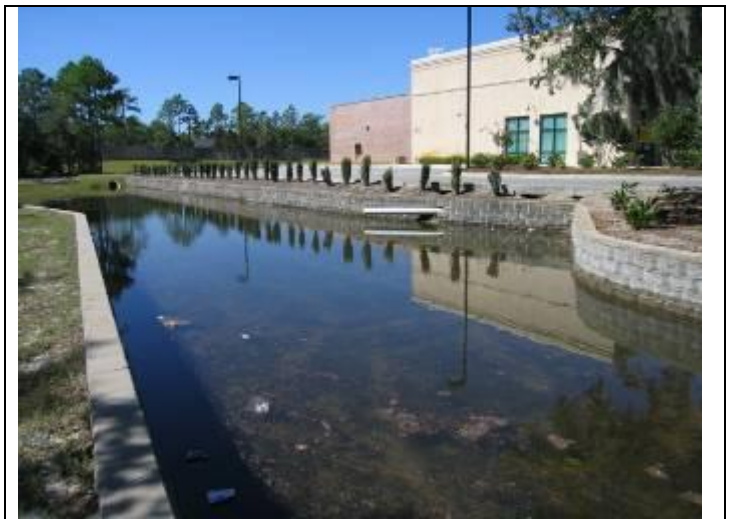
10. Retention pond system continues west of Building 5954

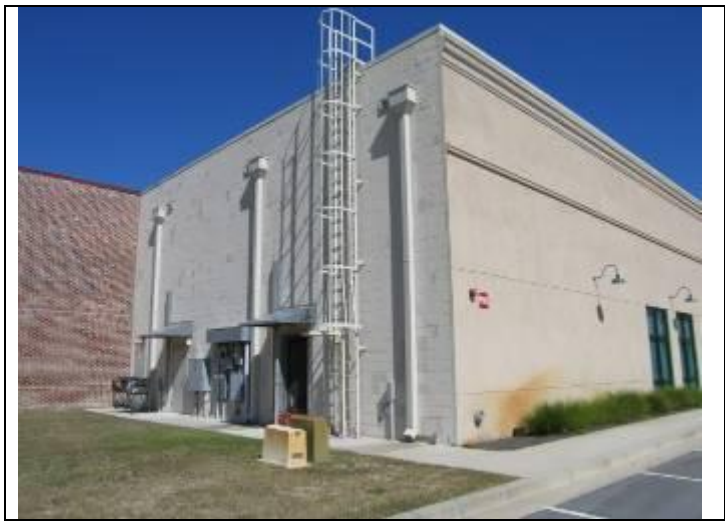
The exterior access doors to the two sprinkler riser rooms in building 2456 “wings” were locked. Armco could not verify the last inspection date or visual appearance of the equipment. Estimated costs are included in the immediate needs table for inspection and repairs as may be necessary.

14. Bldg 5920 units 110,120 – Sprinkler riser room inaccessible

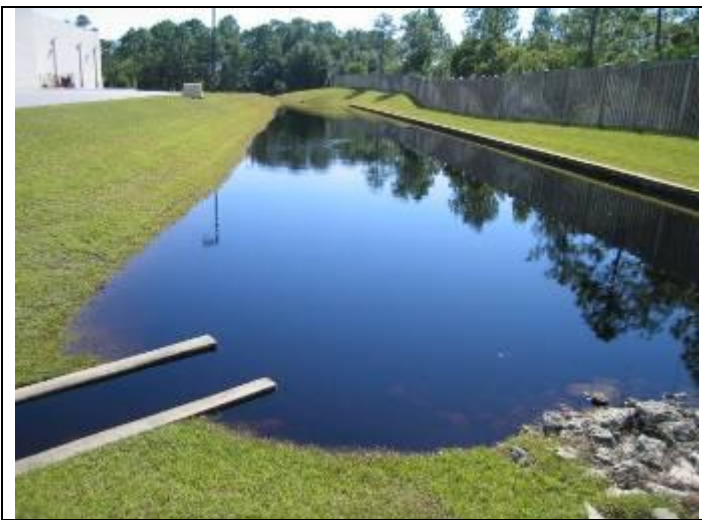
15. Retention pond system continues west/behind building 5920

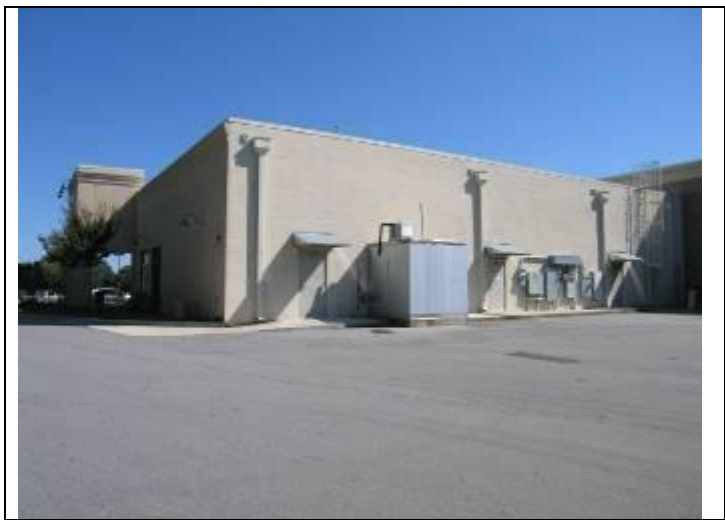
16. Bldg 5920 units 140,160,170 – Sprinkler riser inaccessible

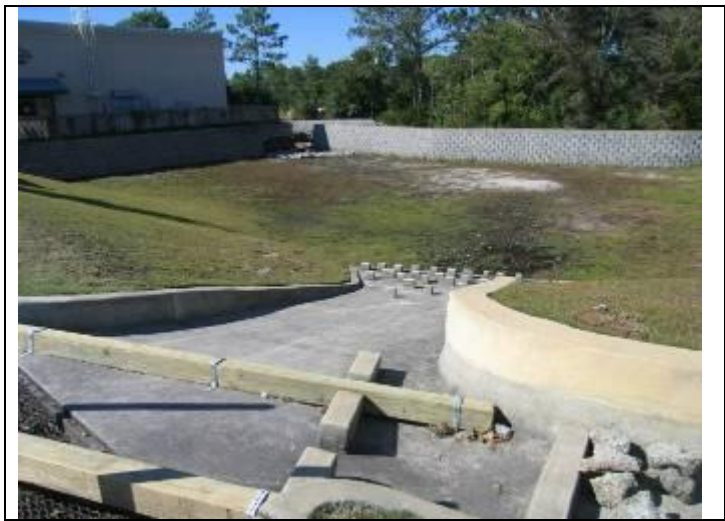
20. Site view of incomplete retention pond east of bldg 5916

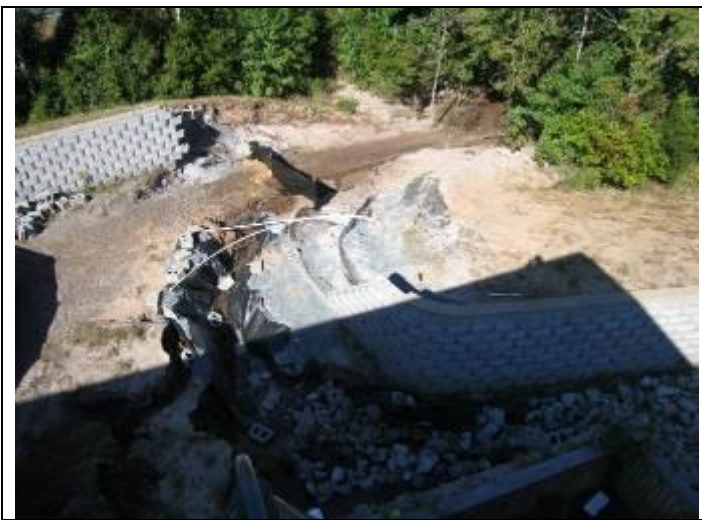
21. Roof view incomplete retention pond behind bldg 5916

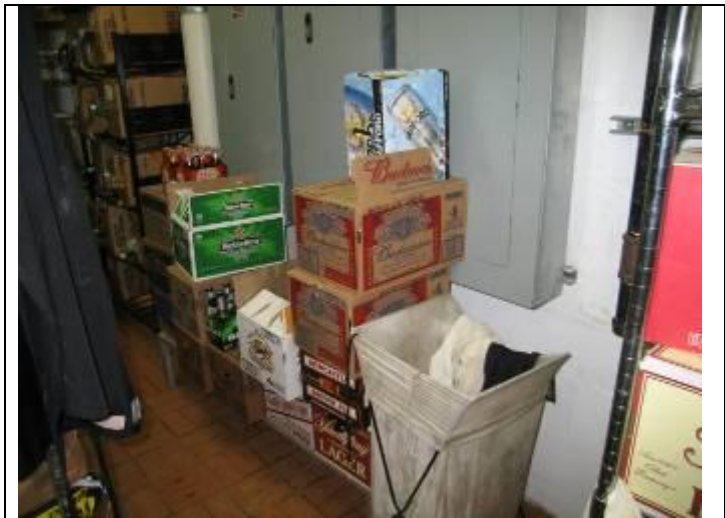
24. Blocked access to switchgear at rear of HoBoy Steakhouse

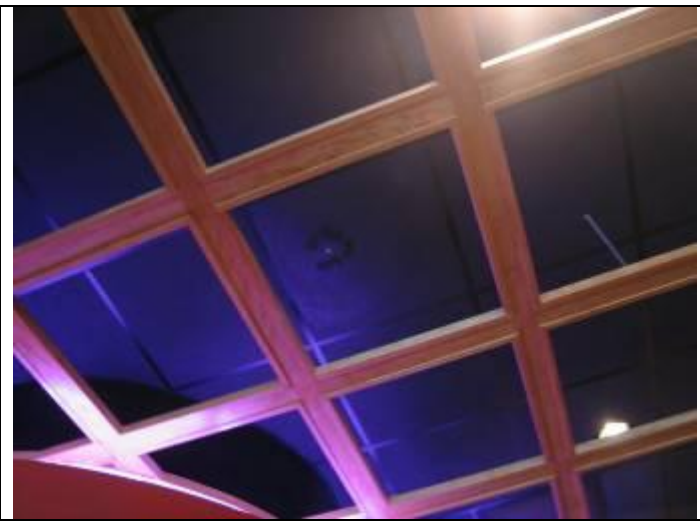
The roofing appears to be in good overall condition with the exception of reported active leakage in six locations at building 2460. Reports from tenants (PA interview) indicate the presence of six areas of active roof leakage as follows: Unit 110 the HoBoy Steakhouse, Unit 170 the Roastal Coaster and Unit 180 Poppas Pizza. Estimated costs to remedy the condition are included in the immediate needs table. Images are provided to document the respective roof leakage areas in the photo log.

25. One of two reported active roof leaks at HoBoy Steakhouse

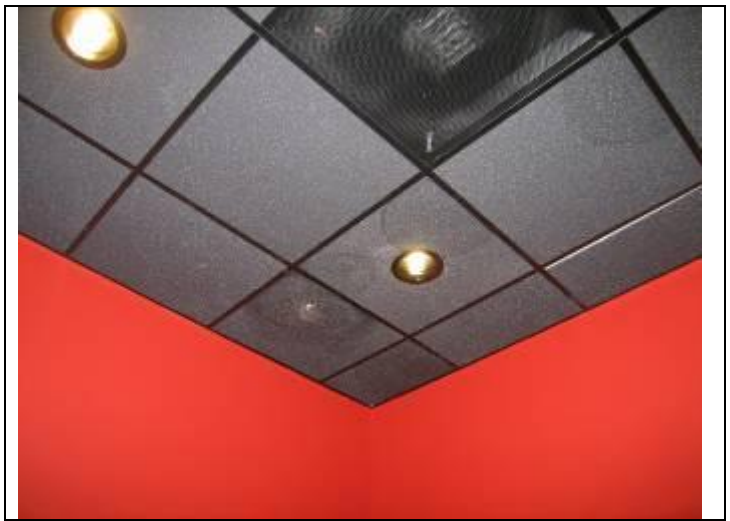
26. One of two reported active roof leaks at HoBoy Steakhouse

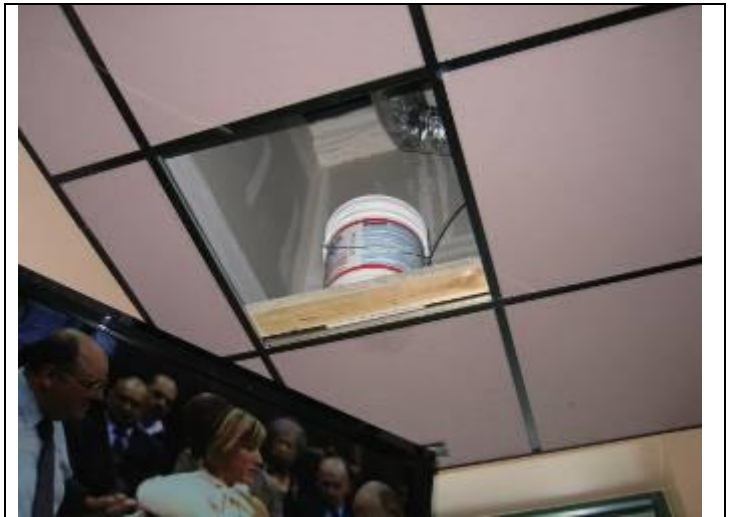
28. Reported (2) roof leaks bldg 5954 - 170 (area one of two)

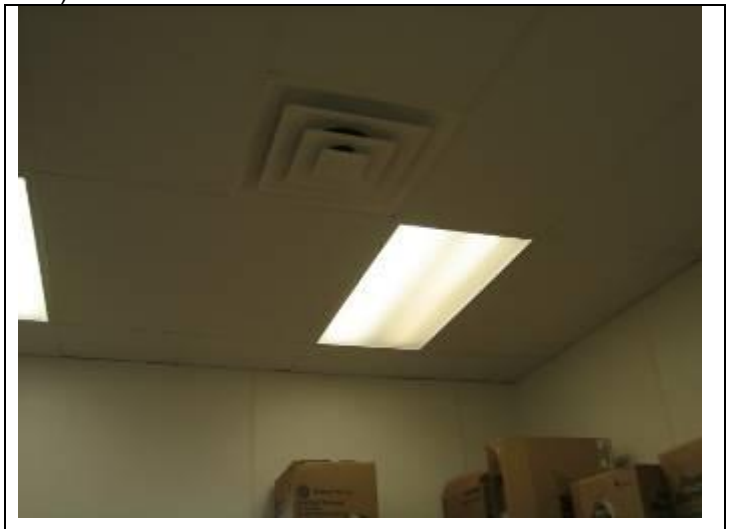
30. Area of reported roof leaks (2) Bldg 5954 Papas Pizza

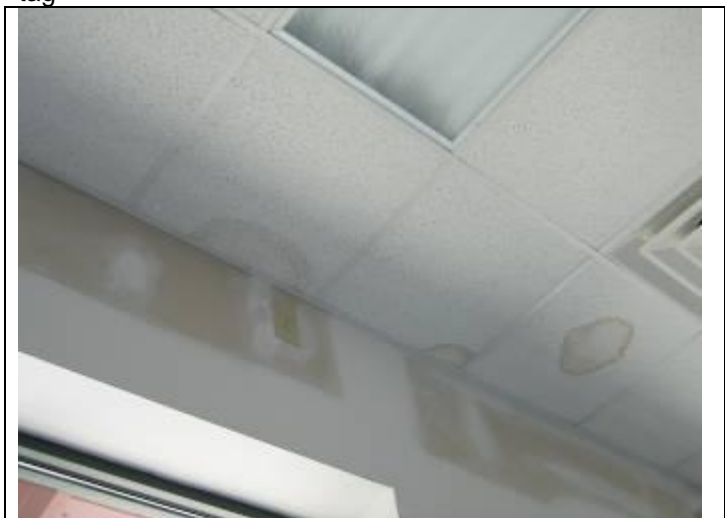
In addition to the above, ceiling stains were noted in the vacant unit 130 in building 2465. Armco was admitted to the unit by the neighbor tenant. The tenant had no knowledge of the history of the stains and/or whether they signify active leakage. As a part of the repairs indicated in the immediate needs table, this area of possible leakage should be examined with repairs as may be needed. Additional funds for this specific site are included in Table 1.

36. Building 5916 vacant unit 130 with suspect ceiling stains

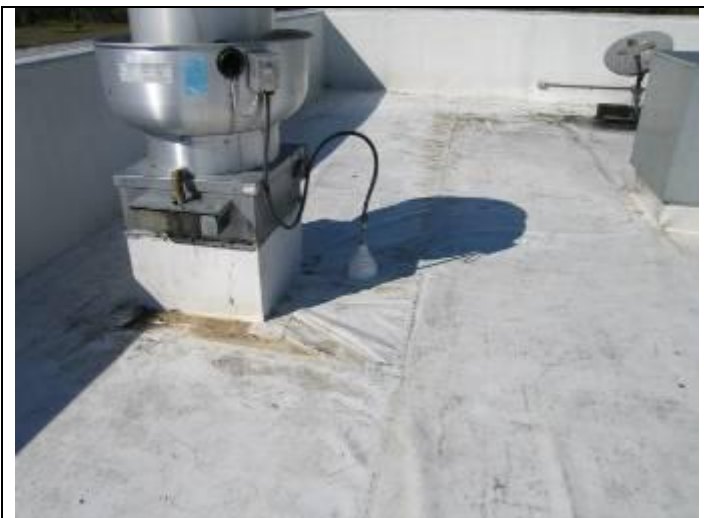
Also noted above building 2465 unit 110 is an area of grease accumulation at the rear of the roof at one surface drain. This accumulation appears to have resulted from an overflow of grease from one exhaust hood fan assembly. Note photographs 45 and 46. Armco did not determine if the roof membrane is damaged from the accumulation (no leaks reported) and recommends cleanup with further evaluation as a part of normal maintenance.

45. Building 5916 possible grease overflow above unit 110

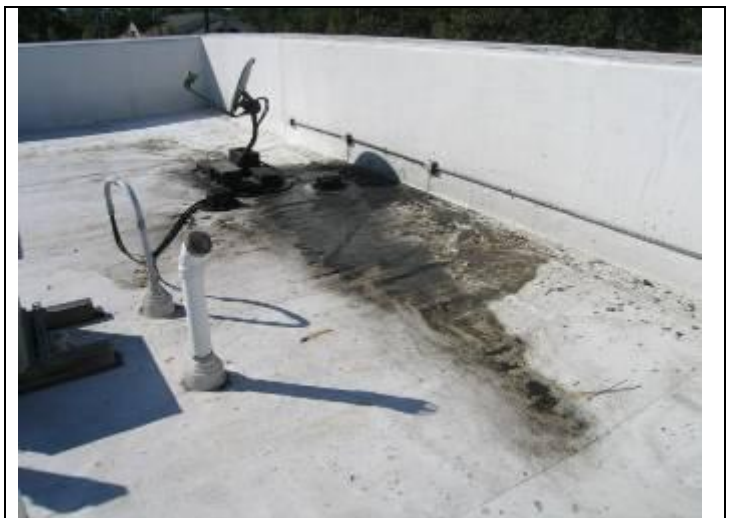
46. Building 5916 grease accumulation above unit 110
