## Inspection Report

# Bilco Renovations LLC

**Property Address:**  
2001 Widget Central Drive  
Walnut Cove ND 27499

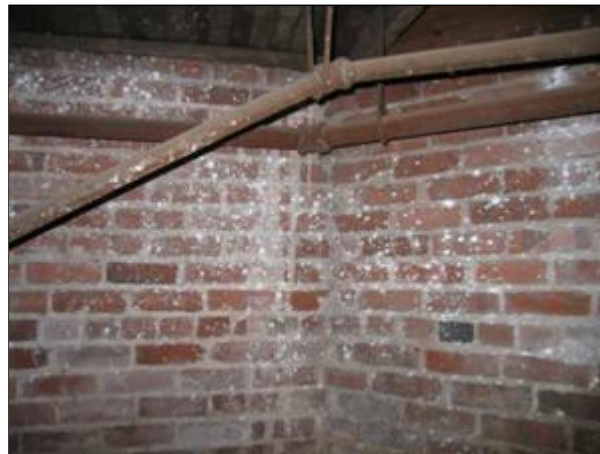
1.0 Picture 3

Photos 2,3 show areas of the main crawlspace that are similarly discolored and may contain organic growth of significant levels. Recommend additional evaluation to determine the composition of the discoloration with remedies as may be required.

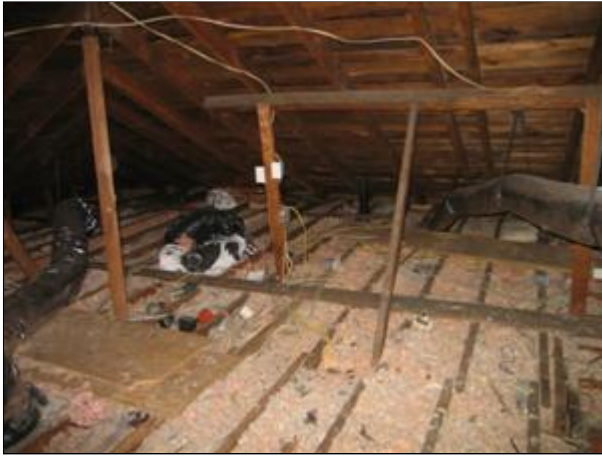
1.5 Picture 1

Typical second floor attic views

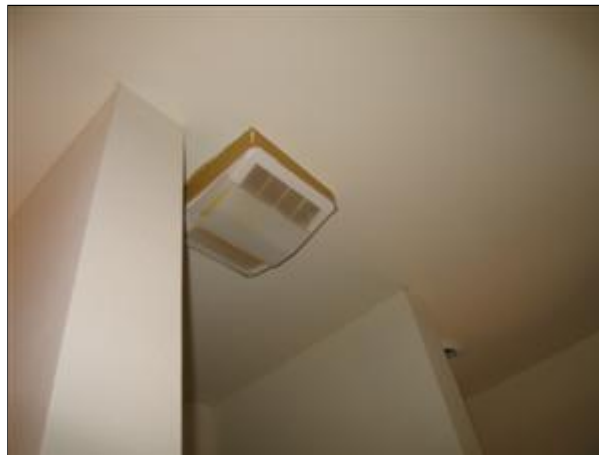
5.3 Picture 6

(3) The light section of this ceiling mounted combo fan/light located at the second floor bathroom did not operate when tested.

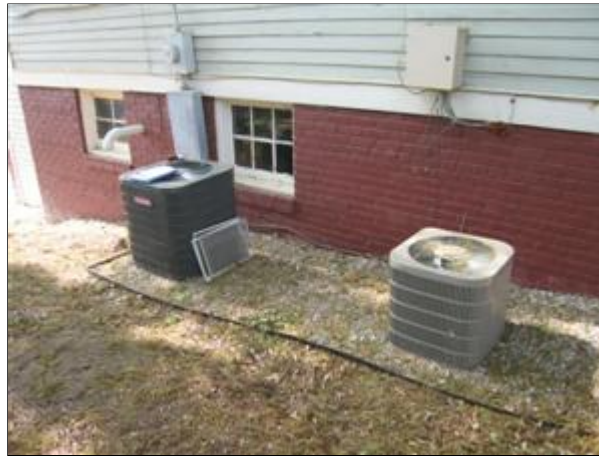
7.0 Picture 1

Both of of the air-conditioning condensing units operated as requested by the respective thermostats when in cool mode.
